# Dunkellin River and Aggard Stream Flood Relief Scheme

# Response to An Bord Pleanála

r					
Client:	Galway County Council	Galway County Council			
Project Title:	Dunkellin River and Aggard S	Dunkellin River and Aggard Stream Flood Relief Scheme			
Document Title:	Response to An Bord Pleanál	Response to An Bord Pleanála			
Document No:	MGE0260RP0012				
Text Pages:	48 Appendices: 6

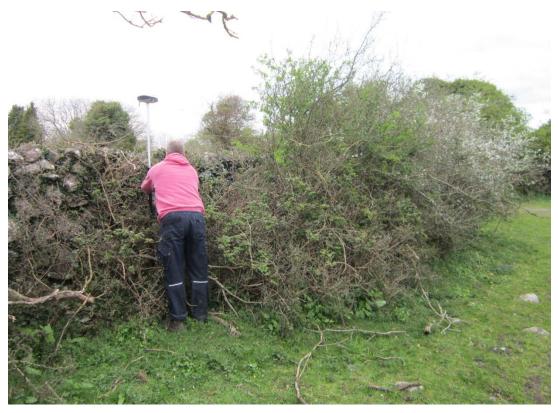
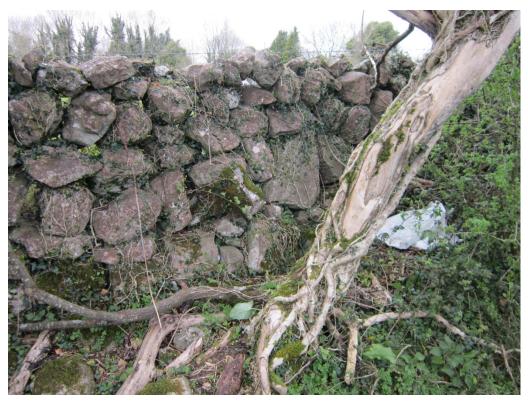
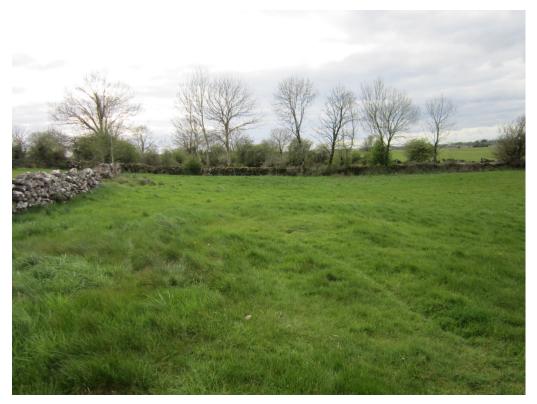
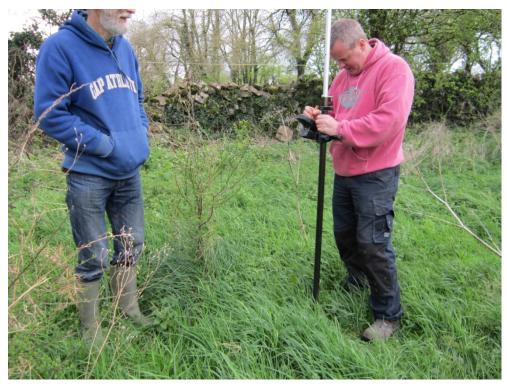
Images 1.1 to 1.4 below show the locations used in this site visit to establish this upper flood level.

Image 1.1 - Killeeneenmore (Northern Part of Turlough)

Image 1.2 - Killeeneenmore (Northern Part of Turlough)

Image 1.3 - Carrigeen East (Southern Part of Turlough)

Image 1.4 - Carrigeen East (Southern Part of Turlough)

It was considered that this 'top' height of Rahasane turlough was essential to maintain so this was built into the final design of the project. All the ground out to 16.5m will therefore continue to be inundated. The inundation period must change to some extent in view of the fact that water speed through the catchment will be increased by 1% but the scale of the change will be analogous to a series of slightly drier years and, it is thought, will result in minimal changes to the vegetation of the

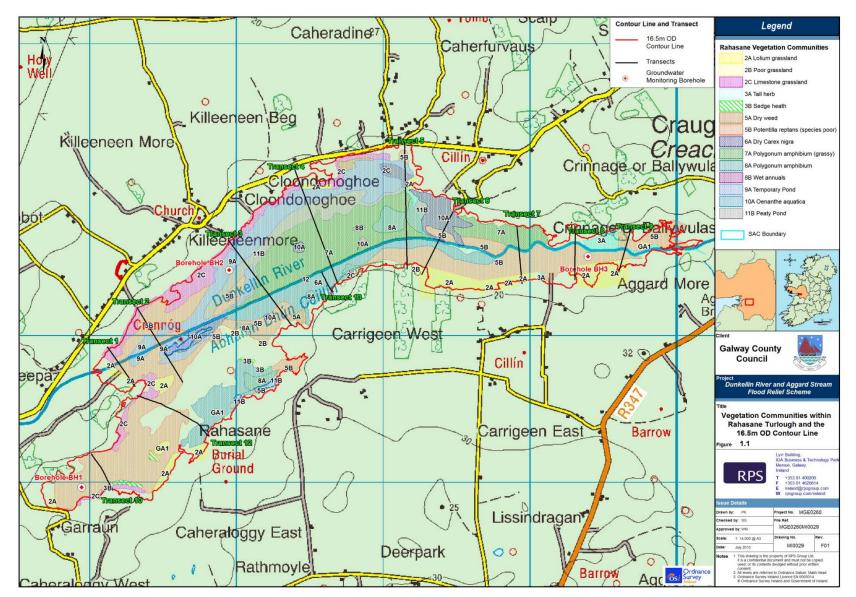
Figure 1.1 - Vegetation Communities, Transect Lines and 16.5 mO.D. Contour

To further investigate the 'ecologically critical turlough levels', a field visit was conducted on 10<sup>th</sup> June 2015 with Mr. Goodwillie and members of the RPS ecological team to identify further monitoring stations, in addition to the nine longitudinal transects identified in the EIS and NIS and to further validate the 16.5 mO.D. level. Three further transects were identified which were topographically surveyed on the 23<sup>rd</sup> June 2015.

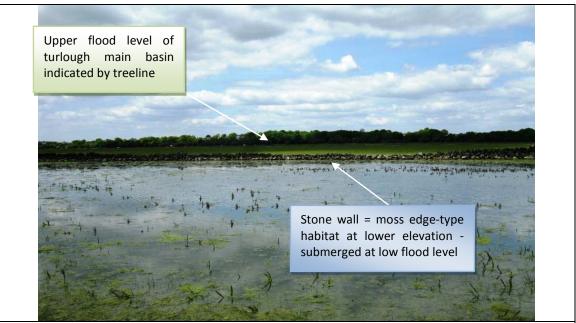
Image 1.5 - Rahasane Turlough main basin southern shore during receding, low water levels in June 2015.

In addition, waterbeetles (Coleoptera) of the main Rahasane basin have been sampled on a number of occasions (Bilton, 1989; O'Connor, 2001; Waldron 2003/ 2004 – see Appendix C5 of the EIS); including recently as part of studies conducted for this Further Information Request (see **Appendix B**). On each occasion a number of species characterising turloughs and the unique "moss-edge community" were recorded, e.g. Hygrotus quinquelineatus, Agabus nebulosus, and Hygrotus impressopunctatus. On one occasion the characteristic "moss edge dweller" Graptodytes bilineatus, an Irish Red Listed species (Near Threatened), was recorded (Waldron, 2004, Appendix C5 EIS). Unlike many more classical turlough basins that flood and empty completely and have a fairly defined "edge", Rahasane is vast and undulating and contains a mosaic of edge-type habitats present as rocky outcrops, stone walls and rocky vegetated islands over a range of elevations. A montage of pools and broad, shallow flooded wetlands and grasslands surround these outcrops, even when water levels are low in the turlough, as shown in Plates 1, 2 and 3, below. Rock outcrops

are covered in mosses, mainly *Cinclidotis fontinaloides* with submerged *Fontanalis antipyretica*. For this reason, "moss-edge" type habitat is effectively present across a wide range of water levels in the Rahasane main basin. Hence there is less likely (in this turlough) to be an "ecologically critical" water level for the beetle community associated with this habitat. Even so, it is recommended that Coleopteran sampling be carried out bi-annually (May and August) in the Rahasane main basin, and that samples are taken from different parts of the turlough including both southern and northern sides, the southern side being the more diverse in moss-edge type habitat.

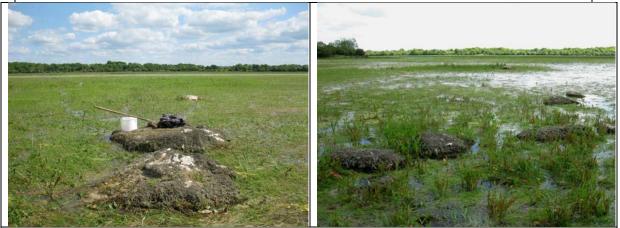
Image 1.6 - Rahasane Turlough main basin northern shore during receding, low water levels in June 2015

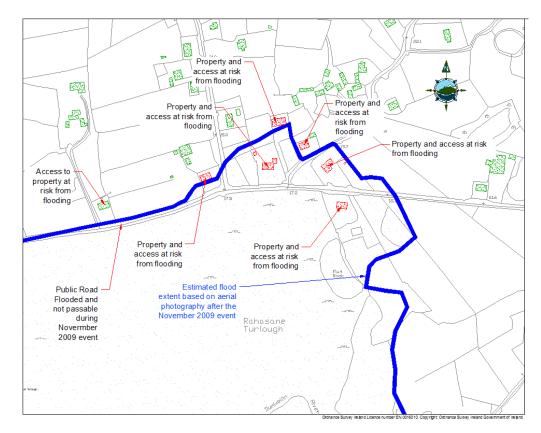
Figure 1.2 - Property owners along the northern shore of the Rahasane Turlough

Since the inception of the flood relief scheme in 2010/2011, and having considered the potential environmental impact of alternative schemes that would result in potential flood level reductions in the Rahasane Turlough, Galway County Council, the OPW and TOBIN Consulting Engineers have liaised with a number of the houses and property owners along the northern shore of the Rahasane Turlough. The location of the property owners is shown in **Figure 1.2** below.

These property owners were directly impacted by the November 2009 flood event and their dwellings were either cut off by the flood waters or were inundated by the Rahasane Turlough. Following written invitations from Galway County Council to the six property owners detailed in the above figure in March 2014, a meeting, with a number of the property owners was held on 25<sup>th</sup> March 2014 to discuss the implications of undertaking significant flood relief works within or adjacent to the Turlough. This meeting was attended by two of the six property owners and the purpose of the meeting was to inform the residents of the proposed works in advance of the Public Consultation process and to commence discussions on possible individual flood protection measures or alternative relocation procedures that may need to be considered by the individual property owners.

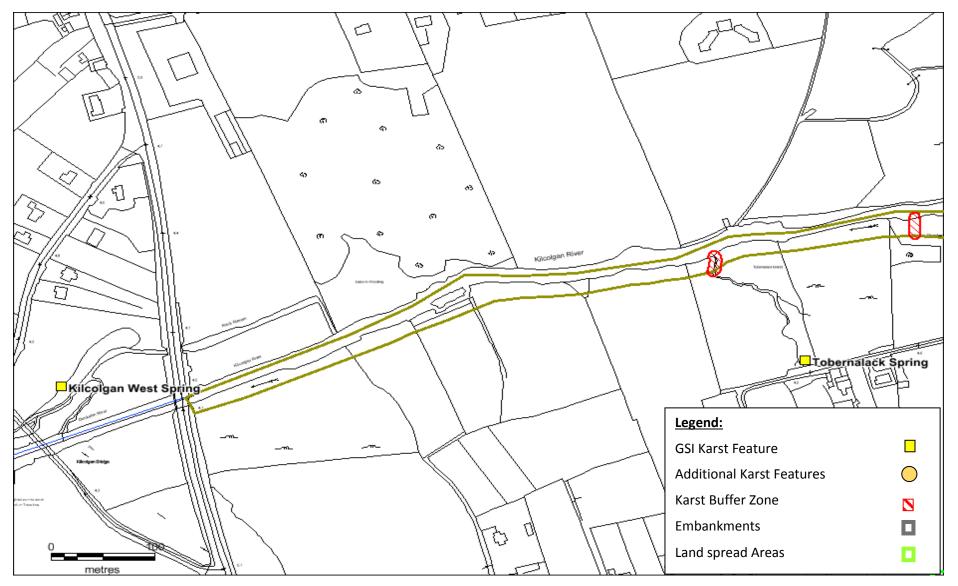
Figure 2.1 - Karst Features and Proposed Landspreading Areas (N18 Bridge, Kilcolgan to Tobernalack)

A review of the geophysics has shown no cavernous limestone features that would be subject to collapse. Areas of karst rock close to surface will have appropriate land spreading application methods to minimise the potential for direct sediment loss into the underlying karst fissure network. The most appropriate approach will be specified at detailed design based on the nature of sediments expected to be deposited at each area. The areas of rock close to surface are outlined in **Figure 2.1**. Further detail is provided below under **Section 2.2 below**.

There are also some small land parcels currently not farmed within the selected spoil spread areas that will require some site preparation in advance due to presence of loose rock and boulders, these have also been included in the areas zoned on **Figure 2.1**.

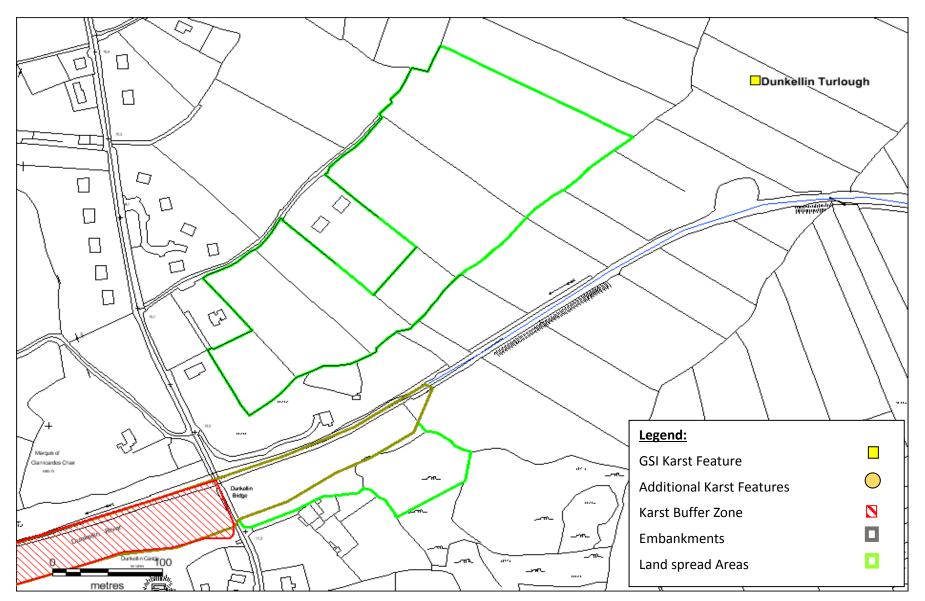
Figure 2.4 – Karst Features and Proposed Landspreading Areas (Dunkellin Bridge to Dunkellin Turlough)

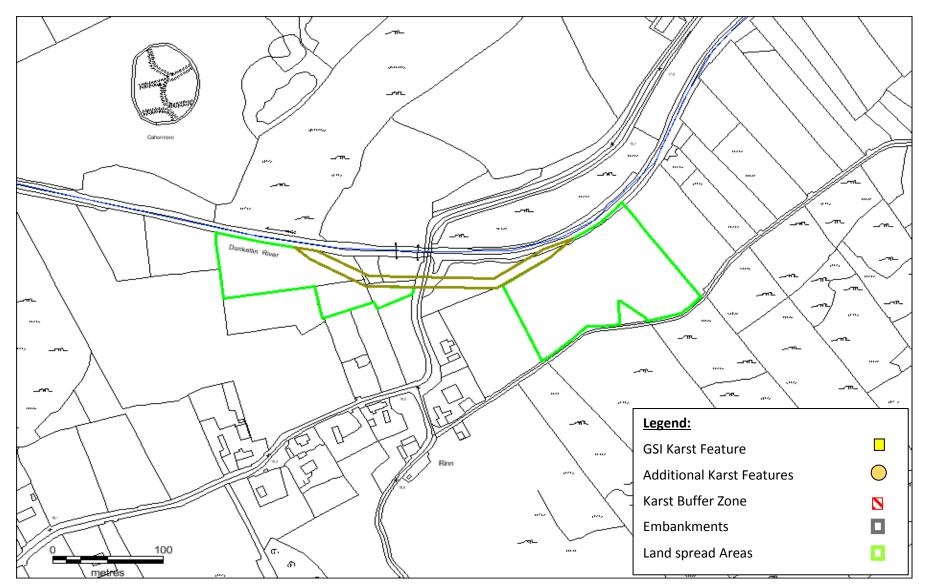
Figure 2.5 – Karst Features and Proposed Landspreading Areas (Dunkellin Turlough to Rinn Bridge)

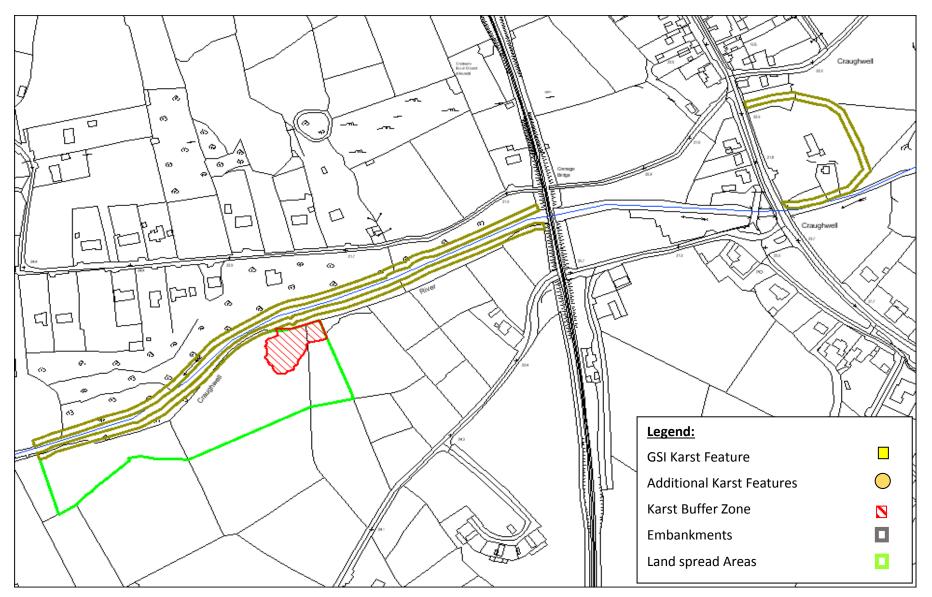
Figure 2.6 – Karst Features and Proposed Landspreading Areas (Crinnage to Grange Bridge, Craughwell)

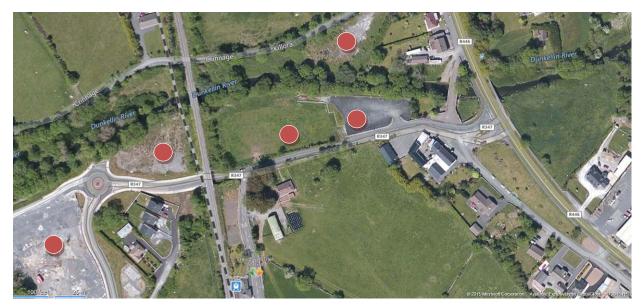
Figure 2.7 – Potential Site Compounds Locations at Craughwell

- 4. Site compound at Craughwell Village. It is envisaged that this compound may be placed at a number of locations in the village of Craughwell. A number of the possible locations are shown as a red circle in the following aerial view of the village. These are noted, in Chapter 10 of the EIS, as being "improved agricultural grassland", "scrub" and "Buildings and Artificial Surfaces". The potential locations of the site compounds at Craughwell are provided in Figure 1.1 below.

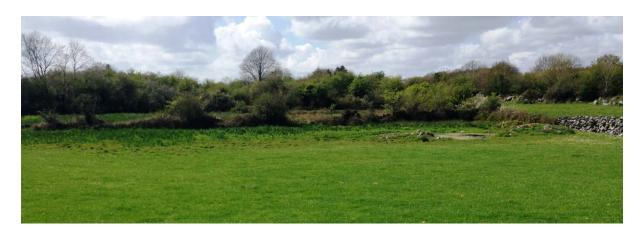
Image 2.1 - Karst Feature at Killeely Beg

The most significant anomaly identified in the geophysical surveys relates to a feature identified along survey section R3. The feature is an ephemeral pond surrounded by marshy land as shown in **Figure 2.2** and **Images 2.1 to 2.3**. The feature is shown on historical maps as a spring that originally flowed to the north to join the other springs at Killeely Beg before ultimately discharging back into the Dunkellin River further downstream. One of the other Killeely Beg springs to the north is noted in the GSI karst data base (Feature No. 1421SWk066). It would appear the field boundary walls now prevent the spring from overflowing. As a result a pond is formed, the level of which would relate to the hydraulic head driving the original spring. This feature may in effect function hydraulically in a similar fashion to a small turlough.

The geophysical survey sections R3 and R4 transect this area. Excerpts from the mapping are shown in **Images 2.1** and **2.2** below. R3 shows the strongest anomalous resistivity measured anywhere during this survey. R3 shows both shallow and deep karstification indicative of clay and water infilled cavities. In contrast R4, which lies between the feature and the Dunkellin River shows no anomalies at depth suggesting that the pool along R3 is not directly linked with a karst fissure to the river but rather connects to a deeper fissure which would have originally then overflowed to the north (see **Figure 2.8**).

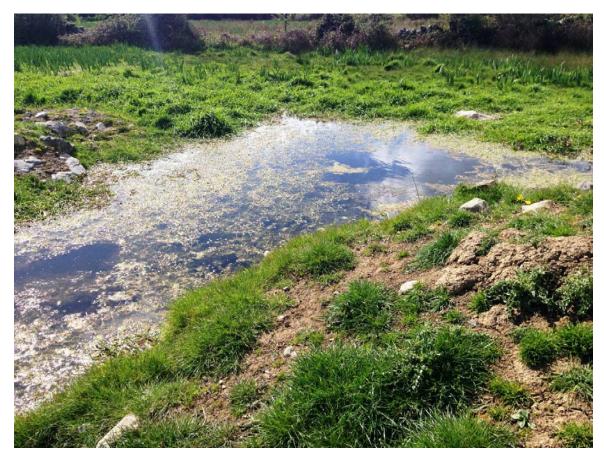
Image 2.2 - Pond within Karst Feature at Killeely Beg

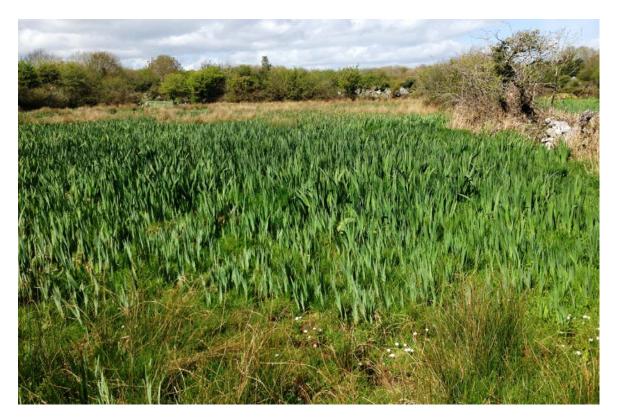
Image 2.3 - Vegetation at Karst Feature at Killeely Beg

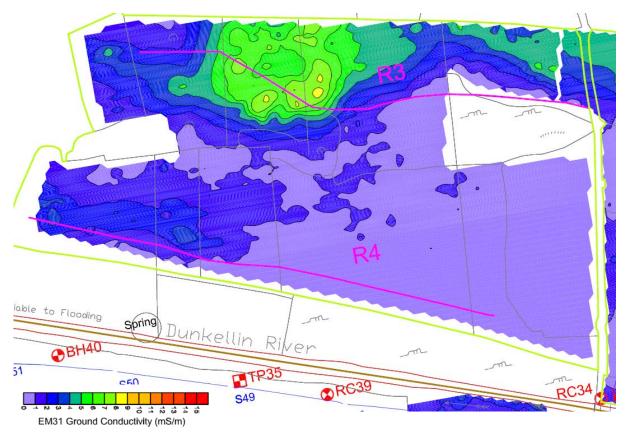
Figure 2.8 - EM31 Conductivity at Kelleely Beg Pool.

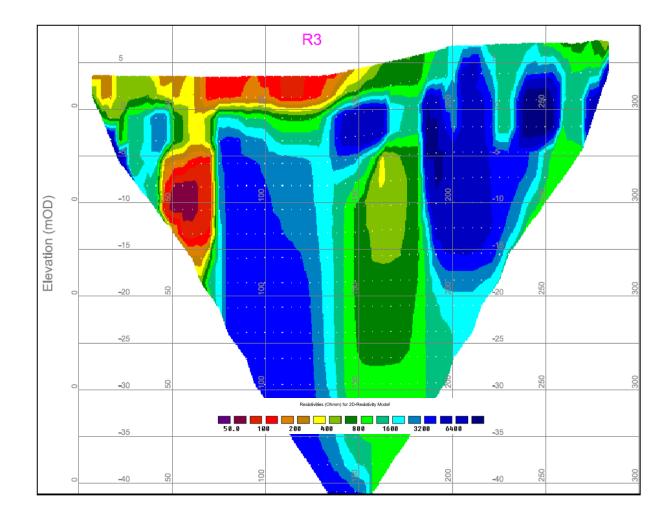
### Figure 2.9 - Resistivity Survey R3 through Pond Feature at Killeely Beg

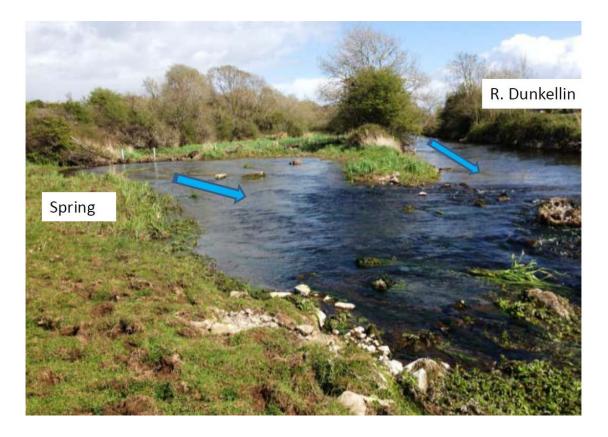
Image 2.4 - Spring at Carranhally looking upstream (Photo No. Img3655)

This is a large pool adjacent the Dunkellin River which overflows into the river, see **Figures 2.2 and Figure 2.10** and **Images 2.4 and 2.5** below. The overflow from the pool is significant, possibly up to 100 l/s. It is possible that when the Dunkellin River is in flood the spring is engulfed but at lower flows it appears to be a discrete feature. The feature does not appear on the historical maps for the location. The historical maps pre-arterial drainage indicate the feature was within the original river channel and may have functioned as an underwater discharge feature providing baseflow to the river. The historical maps post-arterial drainage show the narrower river channel but no clear spring is identified.

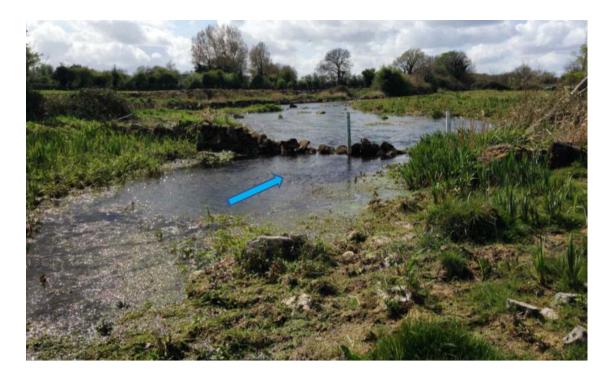
Image 2.5 - Spring at Carranhally looking downstream (Photo No. 3652)

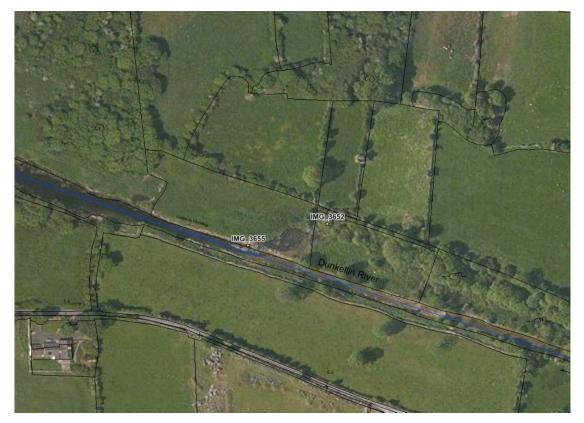
Figure 2.10 - Spring at Carranhally aerial photo and location of photographs.

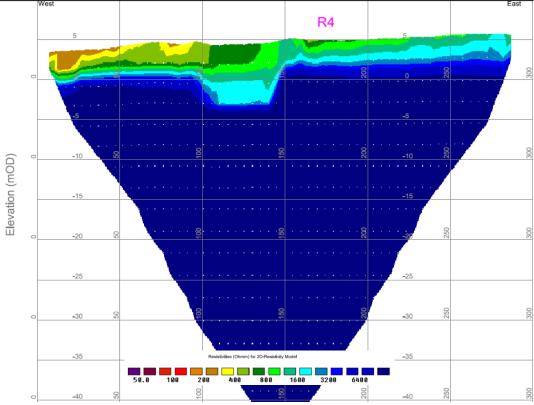
Figure 2.11 - Geophysical Section R4 with Spring Feature highlighted

There was no geophysical survey conducted in the immediate vicinity of the spring as there is no land spreading or embankment proposed at this location. Resistivity section R4 passes adjacent the feature to the north. The section shows a trough in the ground resistivity adjacent the spring which may relate to spring feature, see **Figure 2.11**.

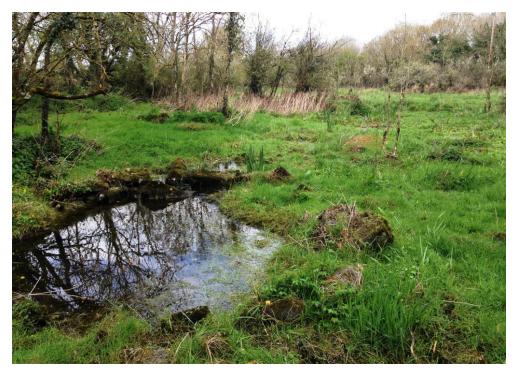
Image 2.6 - Ephemeral Spring at Killeely Beg, looking north towards R. Dunkellin

This feature appears as a small pool approximately 73m south of the Dunkellin River at Killeely Beg Bridge, see **Figure 2.2** and **Image 2.6**. The electrical conductivity of the water in the pool was measured on site and found to be 540  $\mu$ S/cm. This is indicative of groundwater in limestone aquifers rather than ponded surface water (pluvial water) where the conductivity would be much lower (<100  $\mu$ S/cm). There appears to be an overflow channel from the pool which flows north to the river. It is likely that when the hydraulic head in the aquifer is sufficiently high the water from the pond will rise to overflow down the channel into the river. The feature is located within the flood extent of the river and therefore once the river floods it will become engulfed by the main channel.

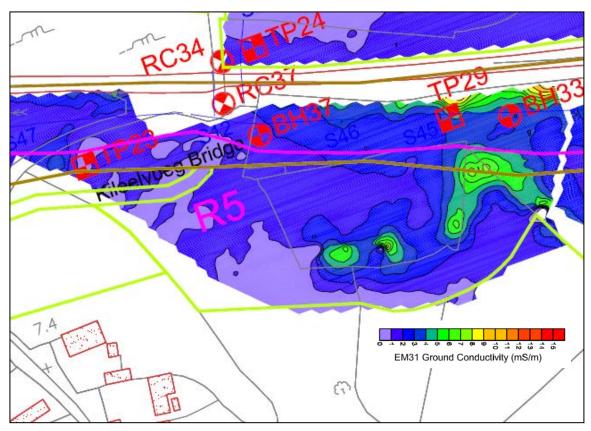
Figure 2.13 - EM Survey Results at Ephemeral Springs at Killeely Bridge

Site investigation results in the vicinity of the location at borehole RC37 indicate the depth to bedrock is 3.2m and the bedrock is slightly weathered. The geophysical survey in this area shows a string of small anomalies in the EM conductivity survey and a trough in the resistivity section (see **Figure 2.13**. These both indicate shallow karst features rather than fissure connected to deep conduits.

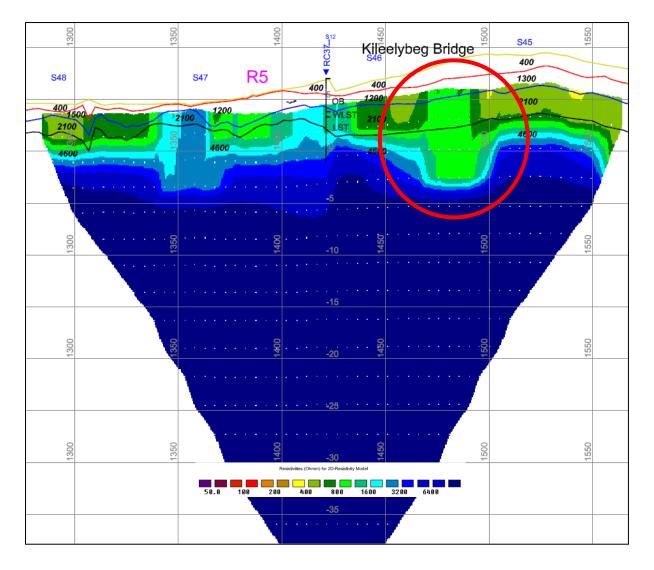
Figure 2.14 - Conductivity Section R5 with Ephemeral Spring at Killeely Beg Highlighted

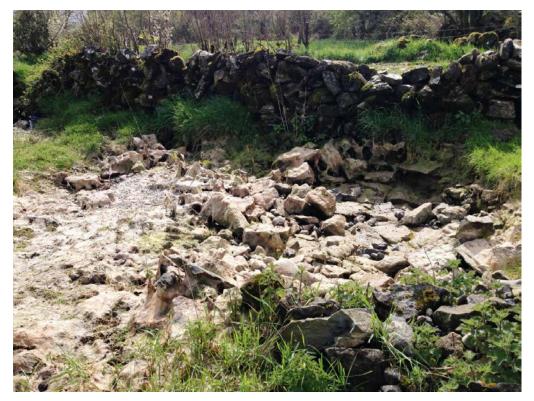
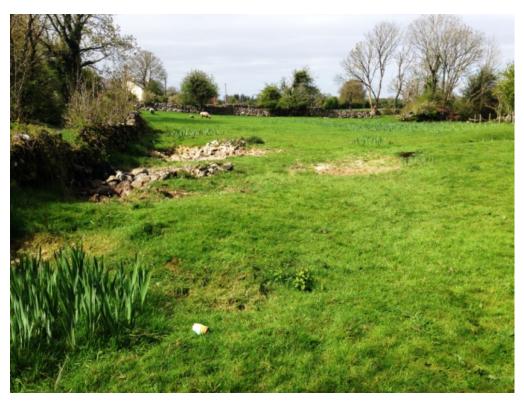
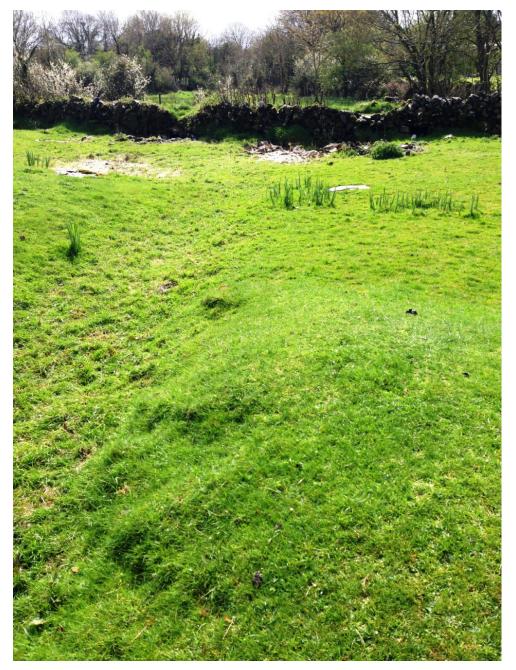
Image 2.7 - Karst feature K4

Image 2.8 - Karst feature K4

Image 2.9 - Karst feature K4

This feature was dry when visited during the walkover but the subdued nature of the ground and coating of the exposed rock in algal matter indicated that surface water had sank through the feature in draining the land see **Figure 2.2** and **Images 2.7 to 2.9**. It is likely the feature acts as a spring where the water-table is above ground level and then alternatively provides a sink for intermittent flood waters where these are at a higher elevation than the groundwater level. The geophysics does not show any significant anomaly in this location which implies this may be a less significant feature in terms of its connection to the overall karst fissure network, but may be a shallow connection to and from the river via the epikarst layer.

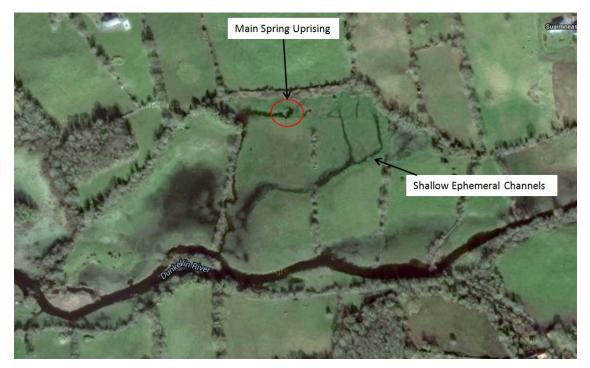
Figure 2.15 - Spring at Crinnage - Location on Aerial Photo

This spring is outside of the land spreading area and is therefore not shown on the maps but details are provided here for inclusion in the karst database. The spring is shown on the historical mapping, current OSI mapping and aerial photographs but is not in the GSI karst database, see **Figure 2.15** and **Image 2.10**. The spring channel is approximately one metre deep. The spring was dry during the site visit but it seemed clear from the depth of the channel, the sculpting and erosion patterns on the banks that there can be a considerable flow when the spring becomes active.

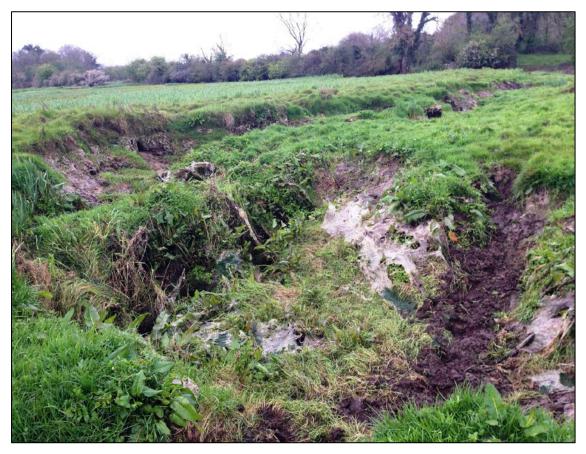
Image 2.10 - Spring at Upwelling Location, dry at time of site visit (28/04/2015)

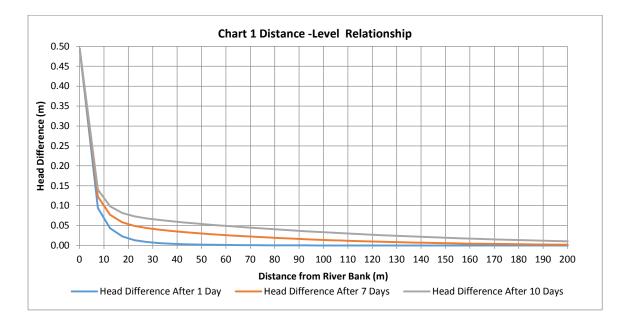
Figure 5.1 - 2D Model Illustrating Distance from River Bank and Level Relationship

In order to provide some quantitative prediction of impacts a representative groundwater 2D slice model was developed as illustrated in **Figure 5.1** below. The model is completed using the Modflow2005 groundwater flow modelling package. The model cannot represent the complexity of the karst fissure flow environment but is a useful tool to solve the groundwater flow equation based on representative boundary conditions and bulk aquifer parameter values. This is a risk based approach where if a significant potential impact is identified more complex modelling can then be undertaken.

The effect on the groundwater levels as a result of this change is presented in **Figure 5.1**. This illustrates that the change in groundwater levels drops off within a short distance of the river. It also illustrates the extent and magnitude of the change is dependent on time. As the predicted changes are related to short lived flooding events that occur intermittently there will be a limited and short lived influence on the groundwater environment that will reduce to negligible levels (<10cm) within 10m of the river corridor.

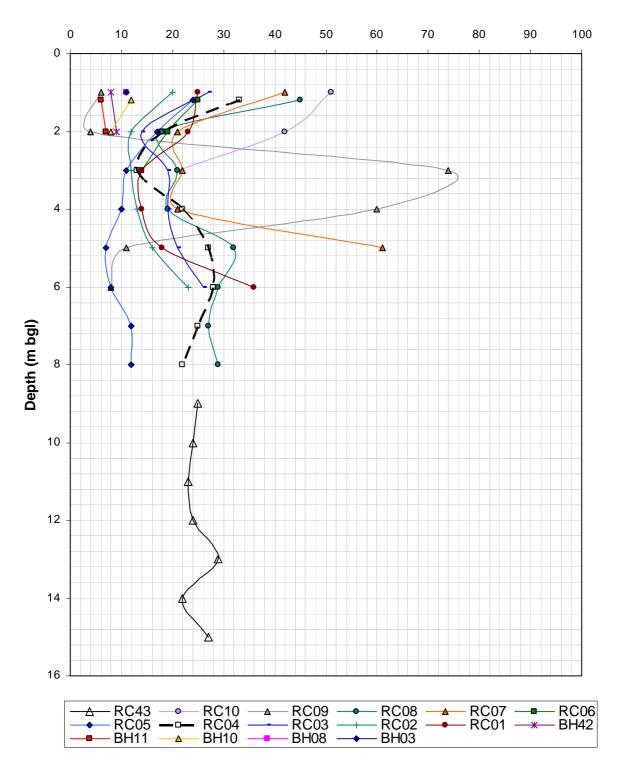
The distribution of uncorrected Standard Penetration Test, Nspt values with depth (m below existing ground level, bgl) is presented below for boreholes at Craughwell. Refusals, Nspt>50, where the complete set of 4 number 75mm increments were not achieved are not plotted.

#### **Uncorrected Nspt values Craughwell**

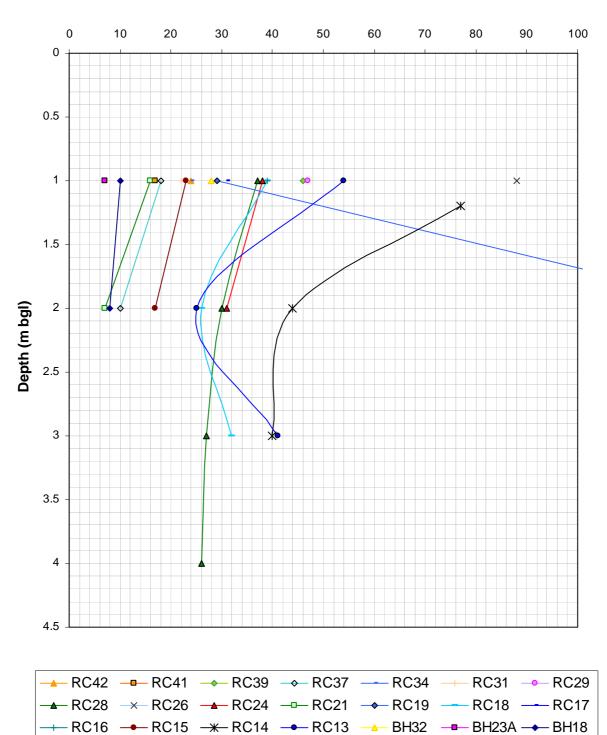
#### **Uncorrected Nspt values - Dunkellin River**

The distribution of uncorrected Standard Penetration Test, Nspt values with depth is presented below for boreholes at along the Dunkellin River to Kilcolgan. Refusals, Nspt>50, where the complete set of 4 number 75mm increments were not achieved are not plotted.

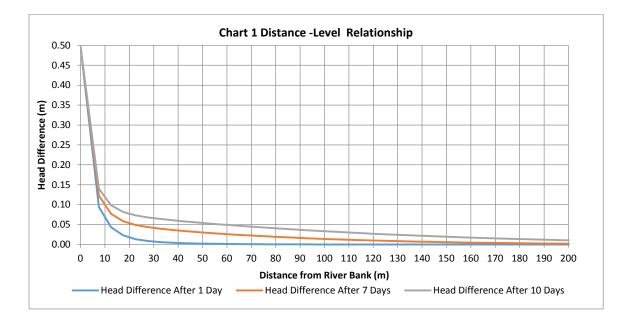
Figure 5.1 - 2D Model Illustrating Distance from River Bank and Level Relationship

In order to provide some quantitative prediction of impacts a representative groundwater 2D slice model was developed as illustrated in **Figure 5.1** below. The model is completed using the Modflow2005 groundwater flow modelling package. The model cannot represent the complexity of the karst fissure flow environment but is a useful tool to solve the groundwater flow equation based on representative boundary conditions and bulk aquifer parameter values. This is a risk based approach where if a significant potential impact is identified more complex modelling can then be undertaken.

The effect on the groundwater levels as a result of this change is presented in **Figure 5.1**. This illustrates that the change in groundwater levels drops off within a short distance of the river. It also illustrates the extent and magnitude of the change is dependent on time. As the predicted changes are related to short lived flooding events that occur intermittently there will be a limited and short lived influence on the groundwater environment that will reduce to negligible levels (<10cm) within 10m of the river corridor.

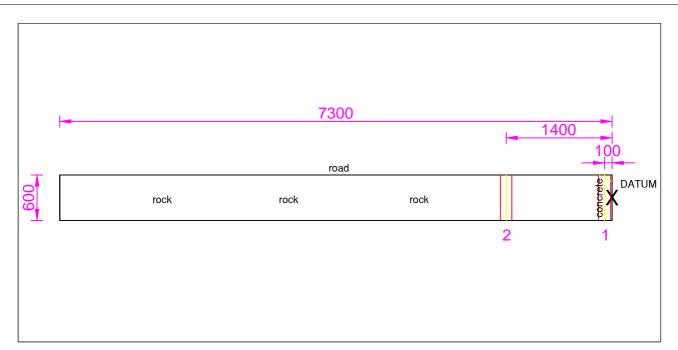
SLIT TRENCH PLAN, 1:50 ON A4

ORITY	$\rightarrow$			Т	riority Geotechnica el: 021 4631600 ax: 021 4638690	l Ltd.			Slit Trench N ST02	lo
GEOTE					W	ww.prioritygeotech	nical.ie			Sheet 1 of 1	1
Project	Nam	e:				Project No.	Co-ords:	55104	8E - 719993N	Date

1.60	20.54							-
			1.00	20.34			Slit Trer	nch Com	plete at 1.60 m		-
											-2
											-
											-
											-
											-
											-
											-3
											-
											-
											-4
											-
											-
											1
											-
											1
											-
Remarks	5:	See detailed sect	tion for ut	ility infor	mation.						
Groundw	vater:	None encountere	ed

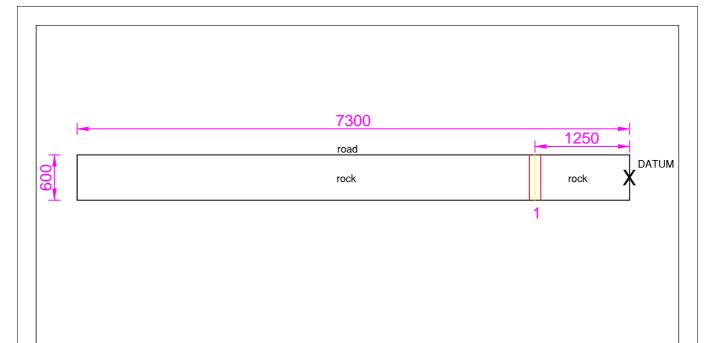
SLIT TRENCH PLAN, 1:50 ON A4

6		+			P	riority Geotechnica	I Ltd.		Slit Trench No
- V PRI	₩ ORITY				F	el: 021 4631600 ax: 021 4638690			ST03
GEOTE	CHNIC	AL			W	ww.prioritygeotech	nical.ie		Sheet 1 of 1
Project	Name	:				Project No.	<b>Co-ords:</b> 5510	026E - 720060N	Date
		& Aggard Stream F	lood Relie	ef Schem	ne	P12012	Level: 22.1	0 m AOD	02/07/2014
Locatio	on: C	o Galway					Dimensions:	7.30m	Scale
							Depth:		1:25
Client:	G	Galway Co Co					2.70m d		Logged By
Samp	oles & In	Situ Testing	Depth	Level	Langed				
Depth (m)	Туре	Results	(m)	(m AOD)	Legend	Hot Rolled Asphalt		Description

2.90	19.20			Slit Trench C	mplete at 2.70 m	-3
Dem 1		0							-
Remarks		See detailed sec		tility infor	mation.				
Groundv	vater:	None encounter	ed

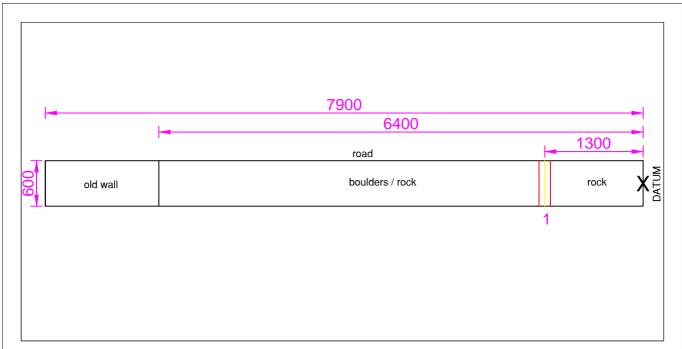
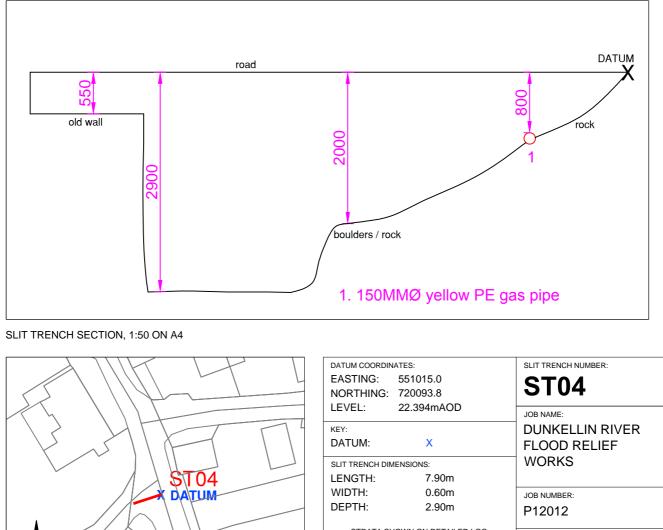
#### DRAWING NUMBER: P12012-ST04

1.00-2.00       B         1.00-2.00       B		-1 -1
2.90 19.49 Sitt Trench Complete at 2.90 m		-3.
Remarks:     See detailed section for utility information.		
Groundwater: None encountered

STRATA SHOWN ON DETAILED LOG DRAWN BY: DATE Gary Curtin 04/07/2014 LOGGED BY: DATE: I.D. 02/07/2014 220SCALE: APPROVED: REVISION SLIT TRENCH LOCATION PLAN, 1:1000 ON A4 AS STATED GH F01

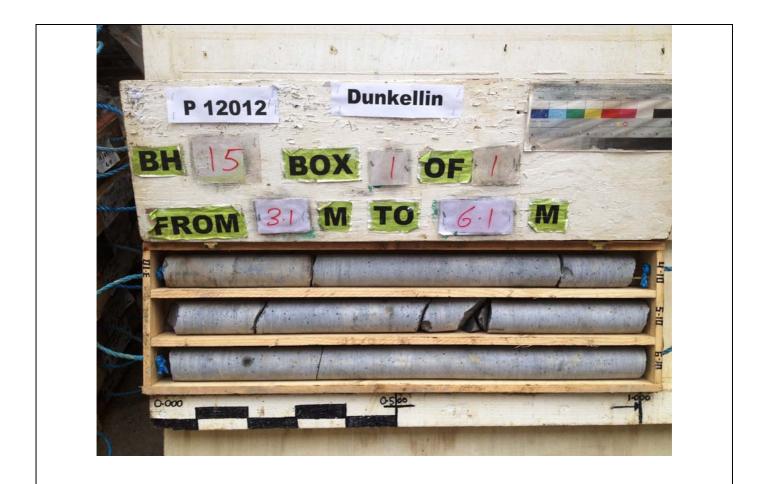
Number:	RC15	Project Project No Engineer	Dunkellin River Flood Relief Works P12012 TOBIN

GEO		NICAL				F	Tel: 02 Fax: 0	21 4631 21 4638				Drilled By AK Logged By DMC	R	ehole No RC15 et 1 of 1	
-		lame:	vacual C					<b>ject N</b> 2012	0.		Co-ords: 545525E -	718416N		le Type ary Cored	
		River & Ag		Stream	nrkv	V	Date			-				Scale	_
Cile	nt: G	alway Co.	Co.					7/2014			Level: 16.18 m AOI	0		1:50	
Well / Backfill	Water Strikes	San	nples &	& In Si	itu Tes	sting		Casing	Level	Depth	Stratur	n Description		Legend	
		Depth (m)	Туре		Res	sults		Flush	(m AOD)	(m)	Open hole boring. Drille	-	<u></u>

6.10	10.08	6.10	End of Bo	ehole at 6.10 m			7
															8
														-	_
		Depth (m)	TCR	SCR	RQD	Fracture space	<u> </u>	Casing		Depth	· · · · · · · · · · · · · · · · · · ·				_
Grou Struc	ndwa <sup>k</sup>	Rose to A	fter So -	ealed - Non	Comr ie enco	nent untered	Hole		rmatioi Hole Dia 1311 76n	ameter	Casing Diameter Depths	elling: s (m) Time (hhi to	mm)	Tool	
₹ema	rks:	Inspection pi	t dug to	1.2m. E	Borehol	e terminated	at req	uired dep	oth. S	Shift [	I Data: Groundwater Shift - 09, - 09,	(dd/mm/yyyy) Casing 07/2014 0.00m 07/2014 3.10m	depth Ro Sta En	emarks art of Boreho d of Borehol	e e
quip	ment	& Method	ds: De Co	eltaBase	e 520 sed air-	mist flush.

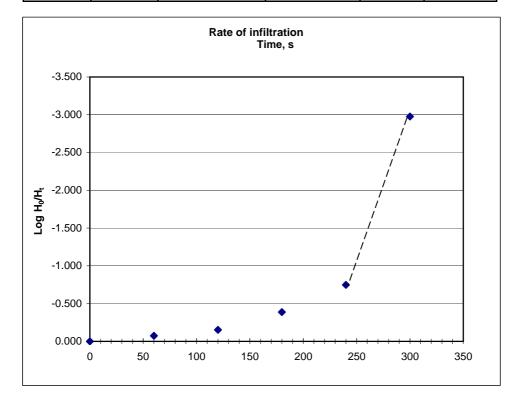
$H_{w/}H_{o}$ 9.5

Min	Sec	depth, m bgl	vol, cu.m	Ht	log H <sub>0</sub> /H <sub>t</sub>		
0	0	9.500	0.01864	9.50	0.000		
1	60	8.000	0.01570	8.00	-0.075		
2	120	6.700	0.01315	6.70	-0.152		
3	180	3.900	0.00765	3.90	-0.387		
4	240	1.700	0.00334	1.70	-0.747	<b>k</b> <sub>mean</sub>	1.68E-04 ms <sup>-1</sup>
5	300	0.000	0.00000	0.01	-2.978	$\mathbf{k}_{H} = \mathbf{k}_{V}$

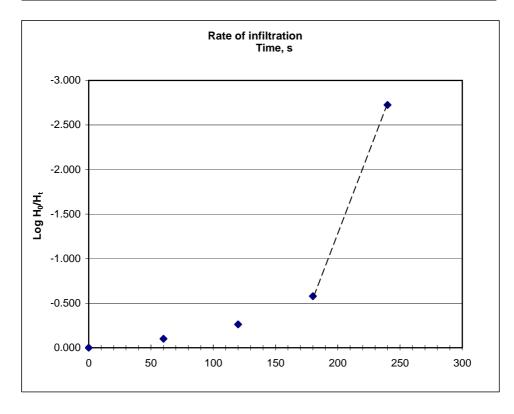
$H_{w/}H_{o}$ 5.3

Min	Sec	depth, m bgl	vol, cu.m	H <sub>t</sub>	log H <sub>0</sub> /H <sub>t</sub>		
0	0	5.300	0.01040	5.30	0.000		
1	60	4.200	0.00824	4.20	-0.101		
2	120	2.900	0.00569	2.90	-0.262		
3	180	1.400	0.00275	1.40	-0.578		
4	240	0.000	0.00000	0.01	-2.724	<b>k</b> <sub>mean</sub>	1.62E-04 ms
						k <sub>H</sub> = k <sub>v</sub>

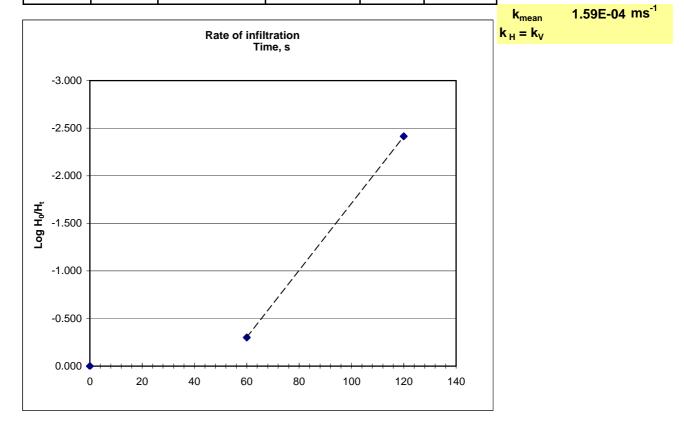
Location			
BH ID	RC32	H <sub>w/</sub> H <sub>o</sub> <b>2.6</b>	5
Casing diameter	<b>50</b> mm		
Casing depth	<b>3</b> m		
Borehole depth	<b>7</b> m		
Groundwater level	<b>1.6</b> mbgl		
Date	23/07/2014		
Strata	LIMESTONE

Min	Sec	depth, m bgl	vol, cu.m	Ht	log H <sub>0</sub> /H <sub>t</sub>
0	0	2.600	0.00510	2.60	0.000
1	60	1.300	0.00255	1.30	-0.301
2	120	0.000	0.00000	0.01	-2.415

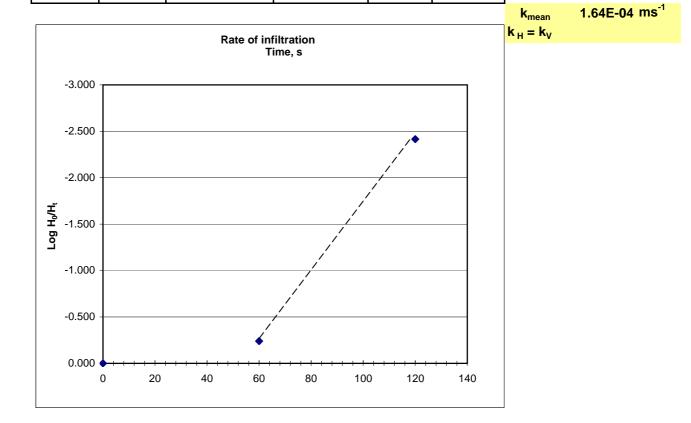
Location			
BH ID	RC37	H <sub>w/</sub> H <sub>o</sub>	2.6
Casing diameter	<b>50</b> mm		
Casing depth	<b>4</b> m		
Borehole depth	<b>8</b> m		
Groundwater level	<b>1.6</b> mbgl		
Date	23/07/2014		
Strata	LIMESTONE

Min	Sec	depth, m bgl	vol, cu.m	H <sub>t</sub>	log H <sub>0</sub> /H <sub>t</sub>
0	0	2.600	0.00510	2.60	0.000
1	60	1.500	0.00294	1.50	-0.239
2	120	1.600	0.00314	0.01	-2.415

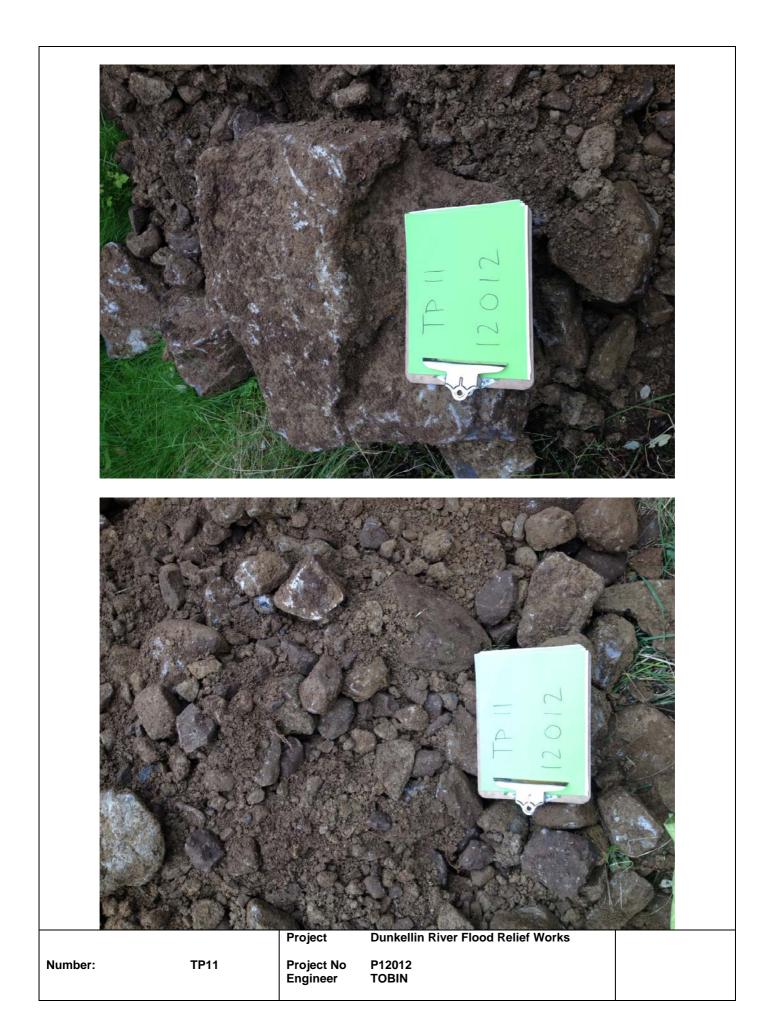
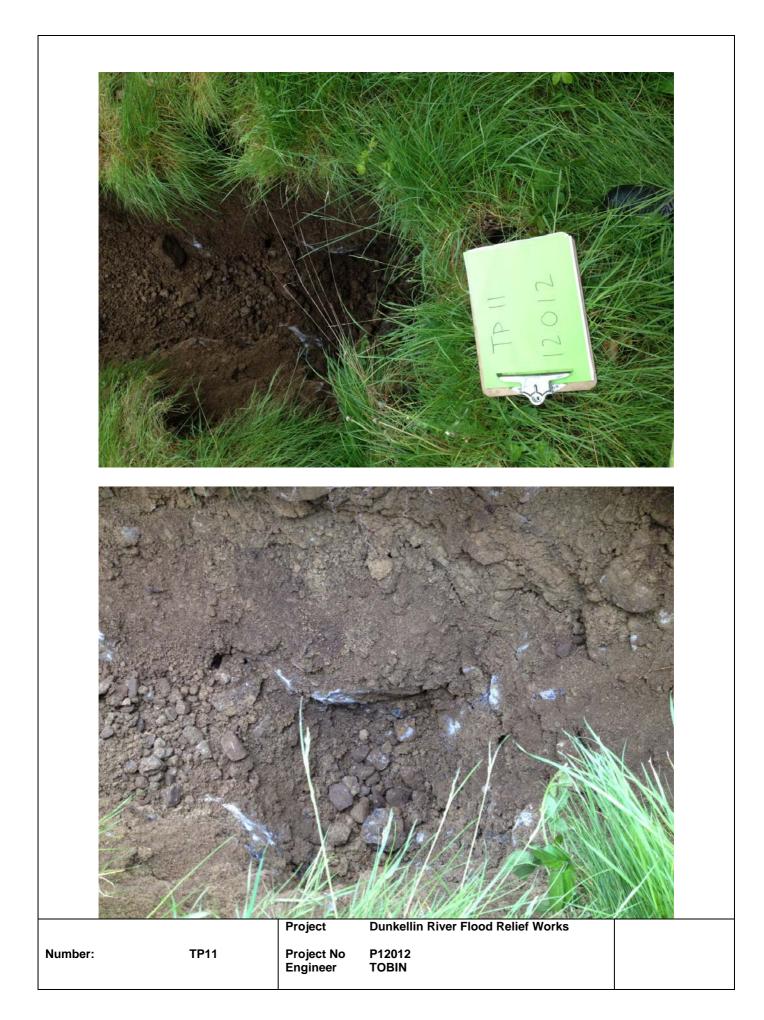
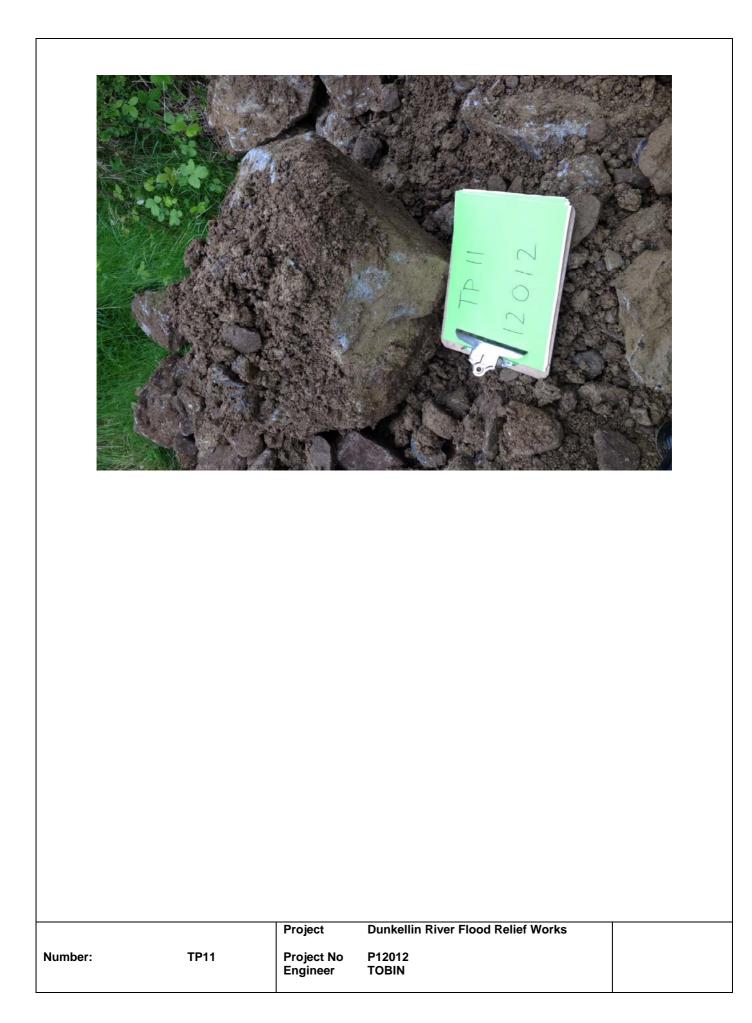
1.00-2.00 B 1.00-2.00 D 1.00-2.00 D 1.00-2.00 H 1.00-2.00 H 1.00-2	0.20 Topsoil: Soft, Firm, light gre content and lo coarse, subar	y/ brown, slightly sandy gra w boulder content. Sand is aular to subrounded. Cobb	slightly gravelly SILT with rootlet velly SILT with medium cobble fine to coarse. Gravel is fine to les are subangular to subround to subrounded, 200-700mm dia	ed.		
Water         Depth (m)         Type         Results         Level	Depth					ated 27th N
Stability:       Poor         Plant:       JCB         Backfill:       Arisings         Remarks:       Trial pit terminated at required depth.		oundwater: None en	countered			)BASE III (Bid 426.58) Standard Trialpit Log v2 de

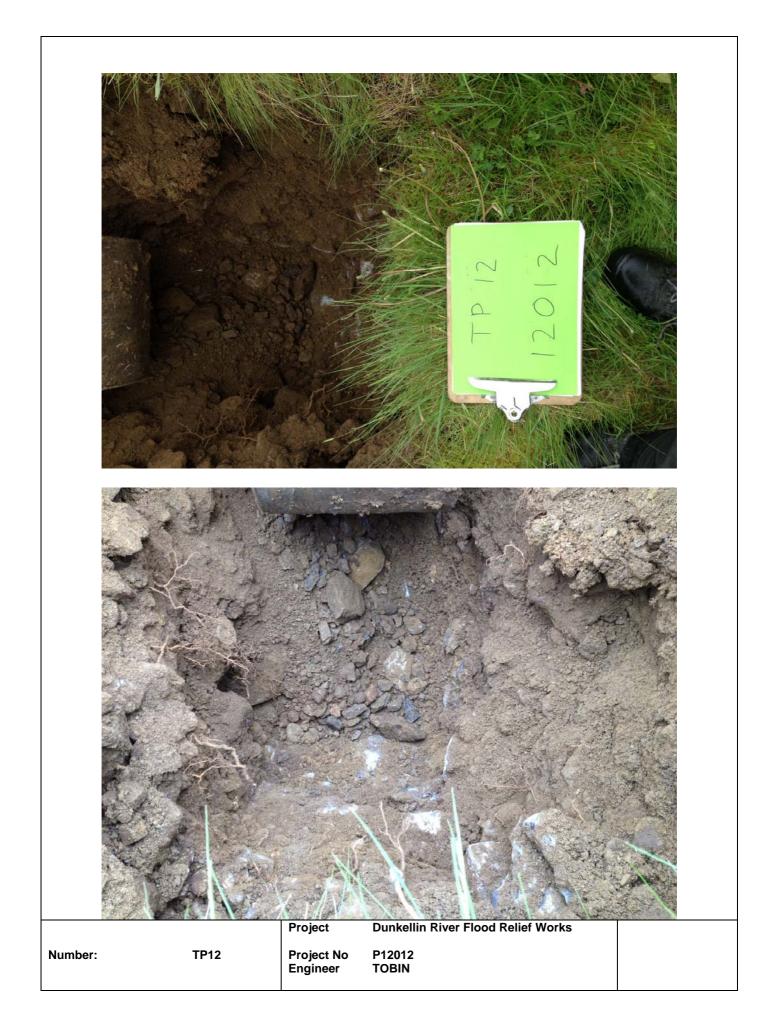
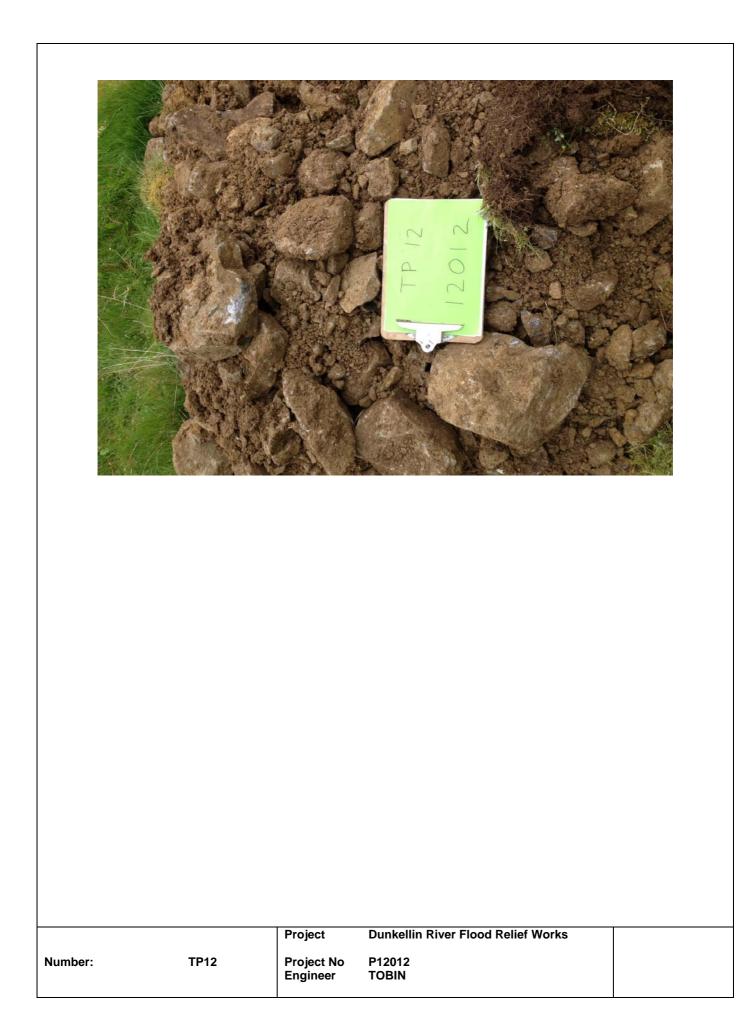
PRIORIT OTECHN					Priority Geotechnica Tel: 021 4631600 Fax: 021 4638690 www.prioritygeotech				T	Pit No <b>P12</b> et 1 of 1	]
Pro	ject Nan	ne:			Pro	ject No.	Co-ords:	54536	0E - 718424N		ate

-		ard Stream Flood Rel	ef Schem		2012	Level:		m AOD	14/0	5/2014	
Loc	ation:	Co Galw	ray				Dimensio	ns:	3.20m		cale	
							Depth	E		1	:25	_
Clie	ent: Galv						2.30m	1.60m			ged By ID	
Water	Depth (m)		& In Situ Testing Results	Level (m AOD)	Depth (m)				Description		Legend

20.11	0.10		-		slightly gravelly SILT with rootle		* * * × ×	
	20.11 1.00-2.00 B 1.00-2.00 D 17.91					coarse, subangu	lar to subrounde louiders are sub	ed. Cobb bangular	sandy SILT with medium cobb fine to coarse. Gravel is fine to les are subangular to subround to subrounded, 200-450mm di subrounded, 200-450mm di	led,		
Stabi Plant Back	Depth (m) lity: Ver :: JCB fill: Aris arks: Tri	y poor ings	Results		Depth	Grou	ndwater:	None en	countered			ASEE III (BH 426.58). Standard Triabit Loov.2 dated 22 th Nov.03
