# Dunkellin River and Aggard Stream Flood Relief Scheme

# Response to An Bord Pleanála

r					
Client:	Galway County Council	Galway County Council			
Project Title:	Dunkellin River and Aggard S	Dunkellin River and Aggard Stream Flood Relief Scheme			
Document Title:	Response to An Bord Pleanál	Response to An Bord Pleanála			
Document No:	MGE0260RP0012				
Text Pages:	48 Appendices: 6

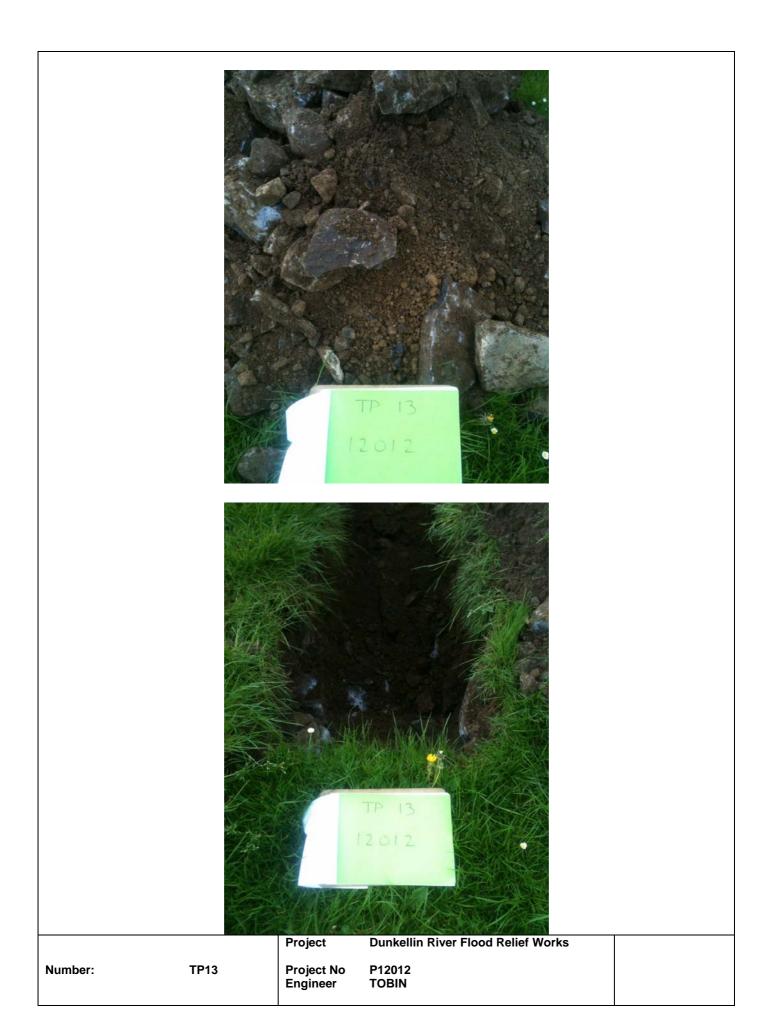
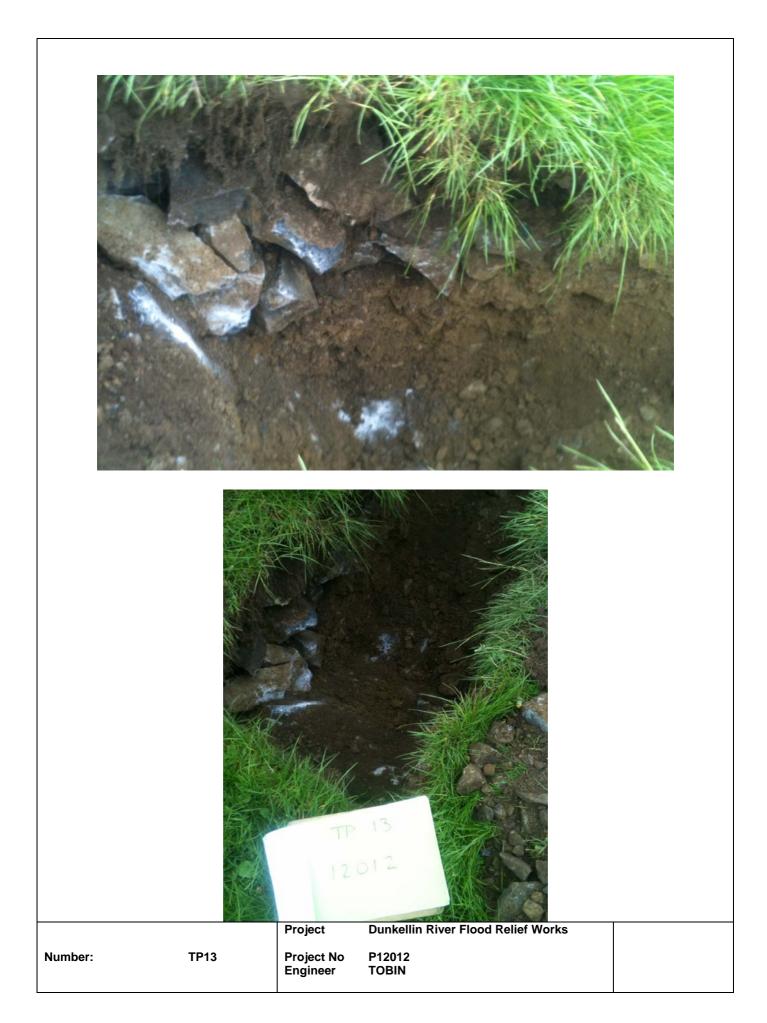
15.80	0.20	Liaht brown. slia	ntly sandy SILT with I	dy SILT with rootlets. high boulder content. Sand is fi bunded, 200-500mm dia.	ne to		
	1.00 1.00	B D		15.40	0.60	content. Sand is subrounded. Cot	fine to coarse. Grave	low cobble content and low bo el is fine to coarse, subangular t ubrounded, 60-100mm dia. Bo lia.	to

14.70	1.30		Trial pit comp	leted at 1.30 m		× · · · · · ·	- - -
											-2
											- 3
											n n
											7th Nov.03
	Depth (m)		Results	Level	Depth						
Plant	lity: Mo : JCB fill: Arisi					Grou	ndwater: None	encountered			tandard Trialnit   on v2
Rema	<b>arks:</b> Tri	al pit terr	minated due to obstru	uction.		•					DR FRIS
											SE III (BM 2
											HoleBA

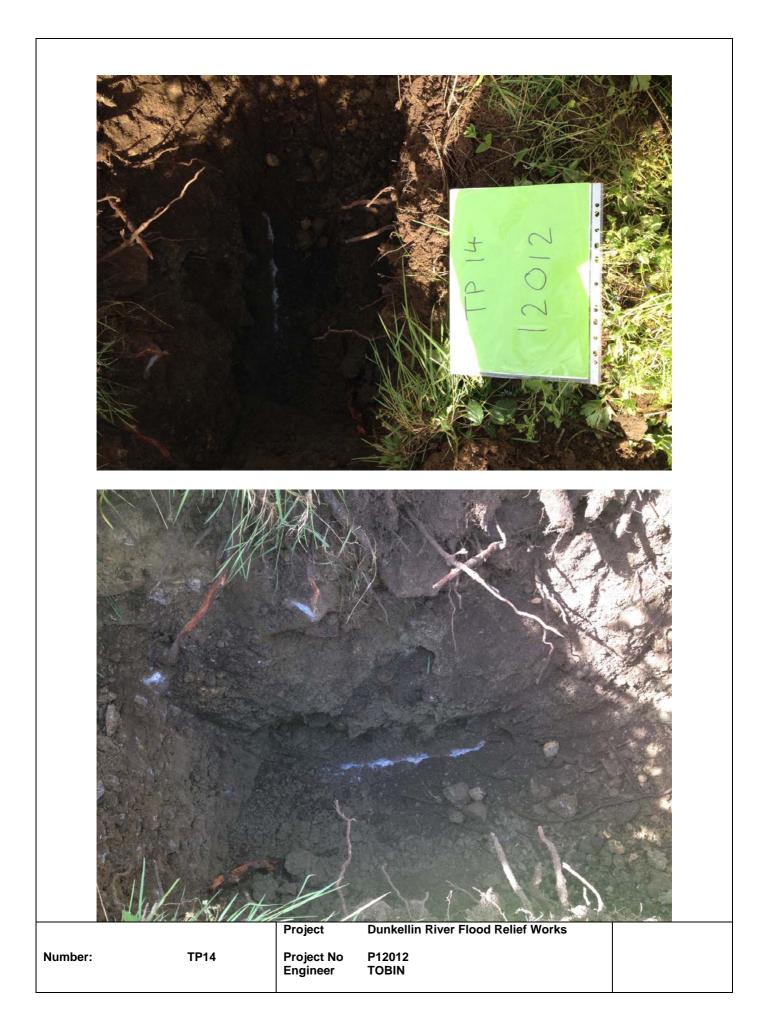
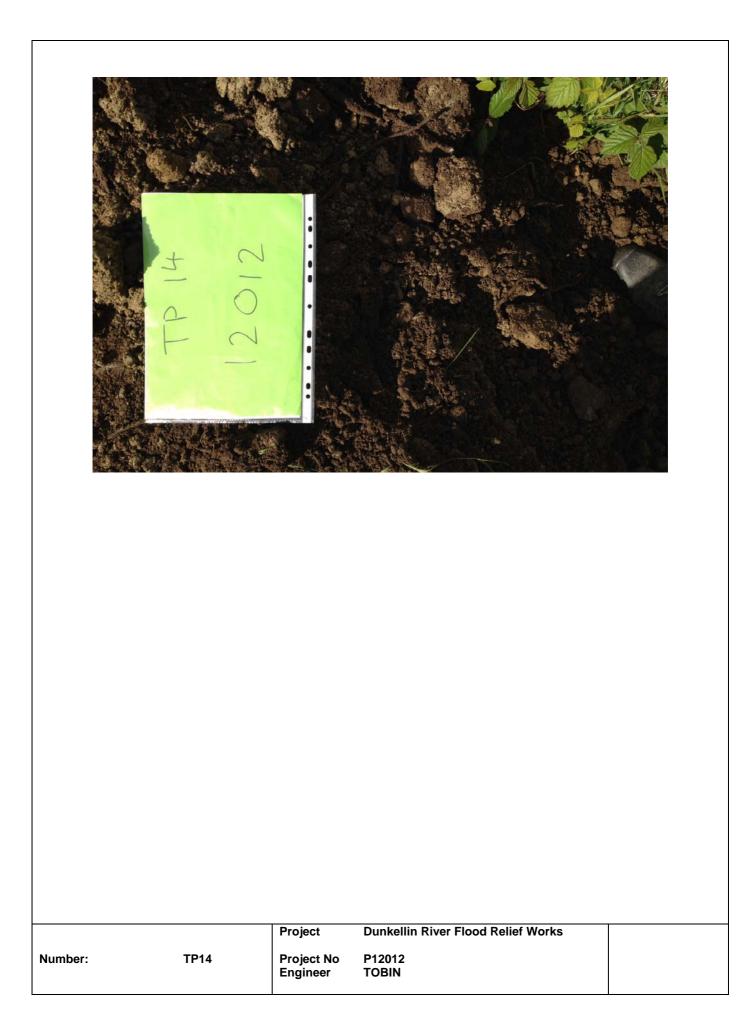
Stabi Plant Back	Depth (m) ility: Poo :: JCB fill: Aris	or ings	Results	· ·	Depth	Gr	oundwater:	None er	countered			Standord Triabili Loo v2 datas 9746 Nov /03
Rema	<b>arks:</b> Tr	ial pit ter	minated due to obst	ruction.		L L L L L L L L L L L L L L L L L L L						HAINER ASE III (RM 426.58)

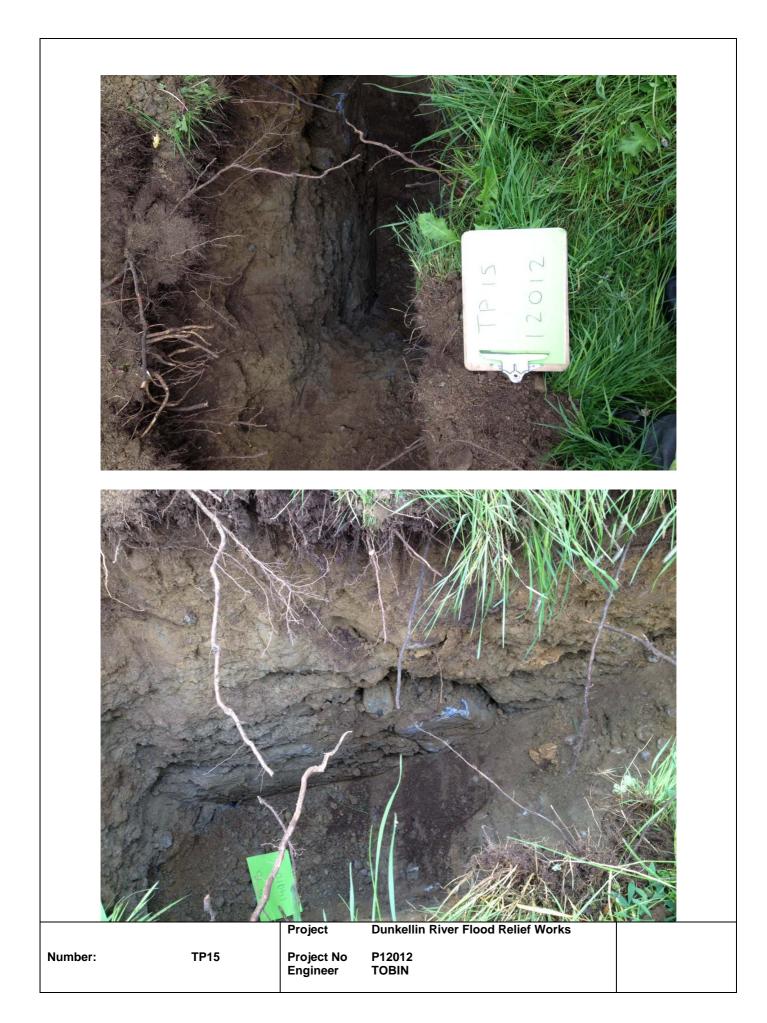
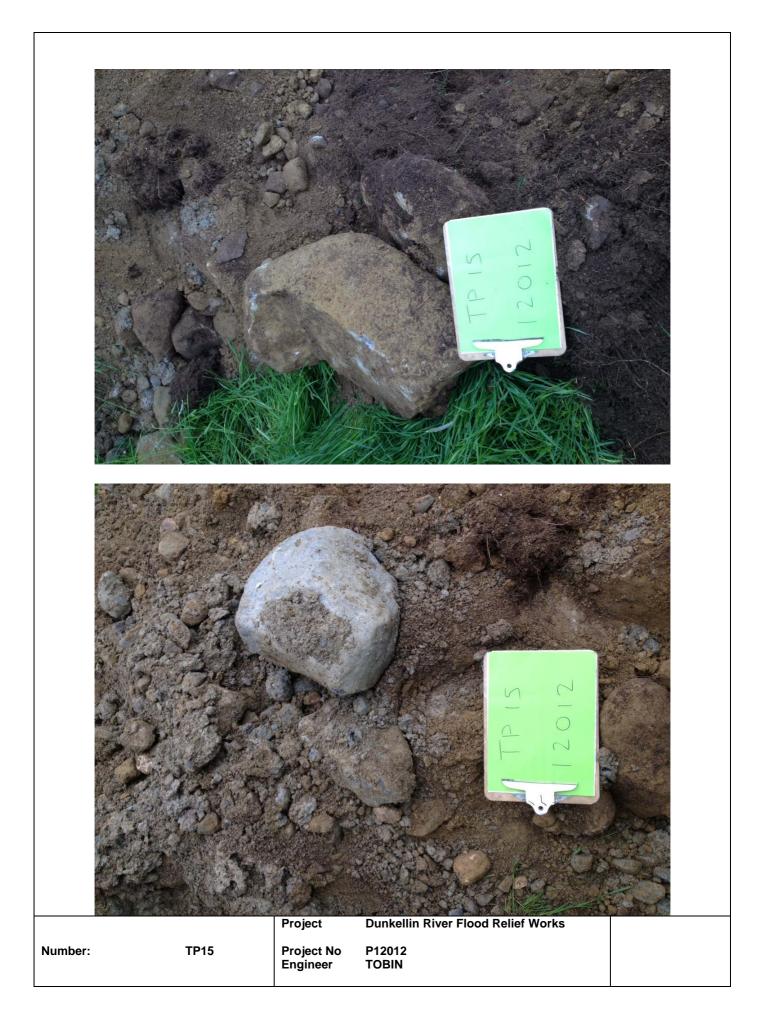
0.00-1.00 0.00-1.00 1.00-2.00 1.00-2.00	B D B		15.99	0.20	Firm, light cobble co to coarse.	t grey/ bro ontent and	brown, slightly g low boulder lar to subrou ulders are sul	y sandy s ravelly sl nded. Co bangular	SILT with rootlets. lightly sandy SILT with medium Sand is fine to coarse. Gravel is bbles are subangular to subrou to subrounded, 200-800mm dis add at 2.10 m	inded.		
Water	Depth (m)	Туре	Results	Level	Depth								ited 27th N
Stabi Plant Back	lity: Poo : JCB fill: Aris	or ings	minated due to obstru				Groun	dwater:	None en	countered			III (Bid 426.58) Standard Trialbit Log v2 dá
													HoleBASE

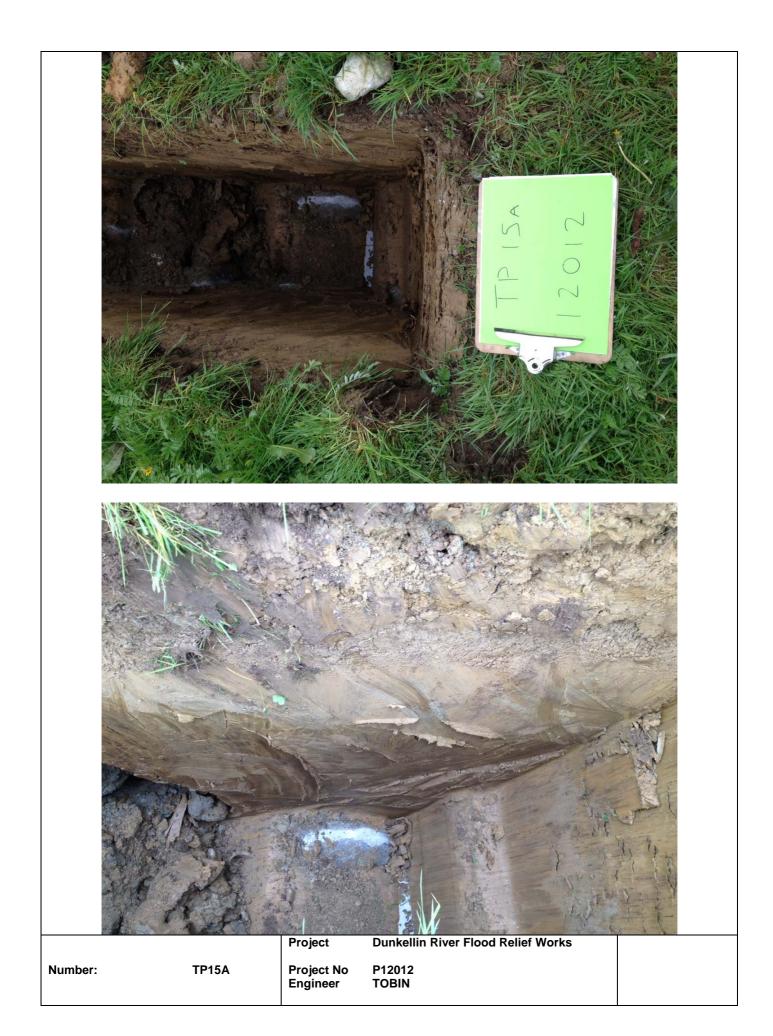
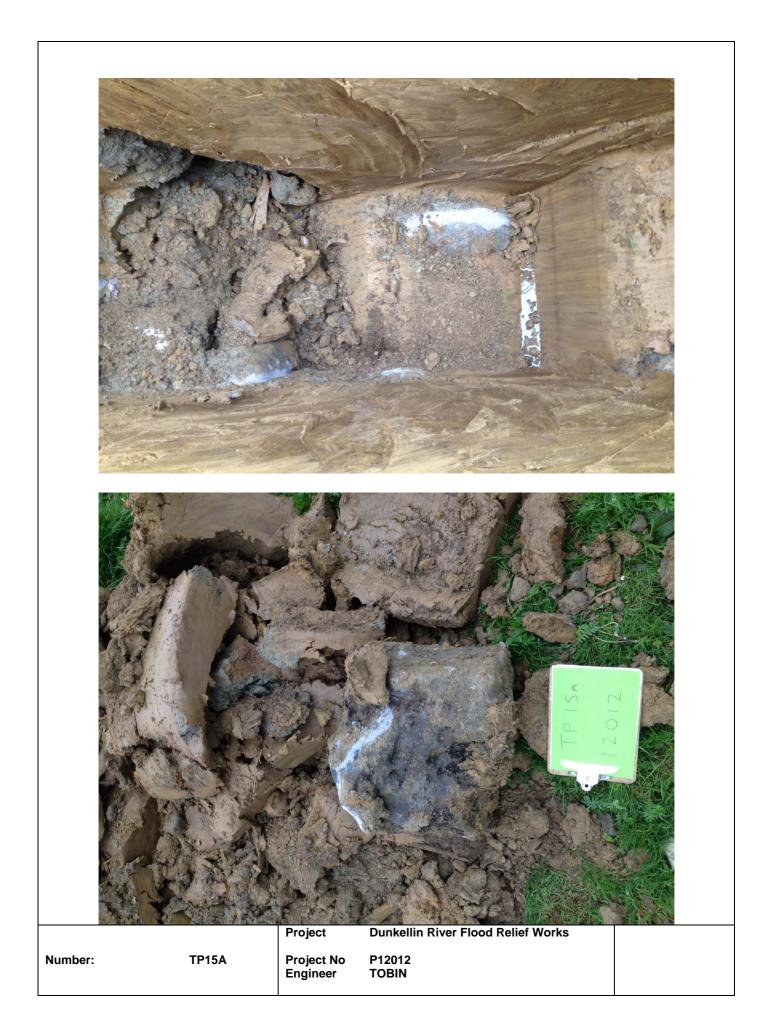
14.69	0.10	· · · · · · · · · · · · · · · · · · ·	rk brown, slightly sandy			* * * *.*		
	0.00-1.00 0.00-1.00 1.00-1.60 1.00-1.60	D		13.19	1.60	coarse, subangu	lar to subrounded. Cobl	sandy SILT with medium cobble s fine to coarse. Gravel is fine to oles are subangular to subround to subrounded, 200-600mm di ed at 1.60 m	led,			
Water       Depth (m)       Type       Results       Level       Depth         Stability:       Poor       Plant:       JCB       JCB       JCB         Backfill:       Arisings       Arisings       Each due to obstruction.       Each due to address the structure of the str						Grou	ndwater: None e	ncountered			3id 426.58) Standard Trialoit Loo v2 da	
											HoleBASE III (E

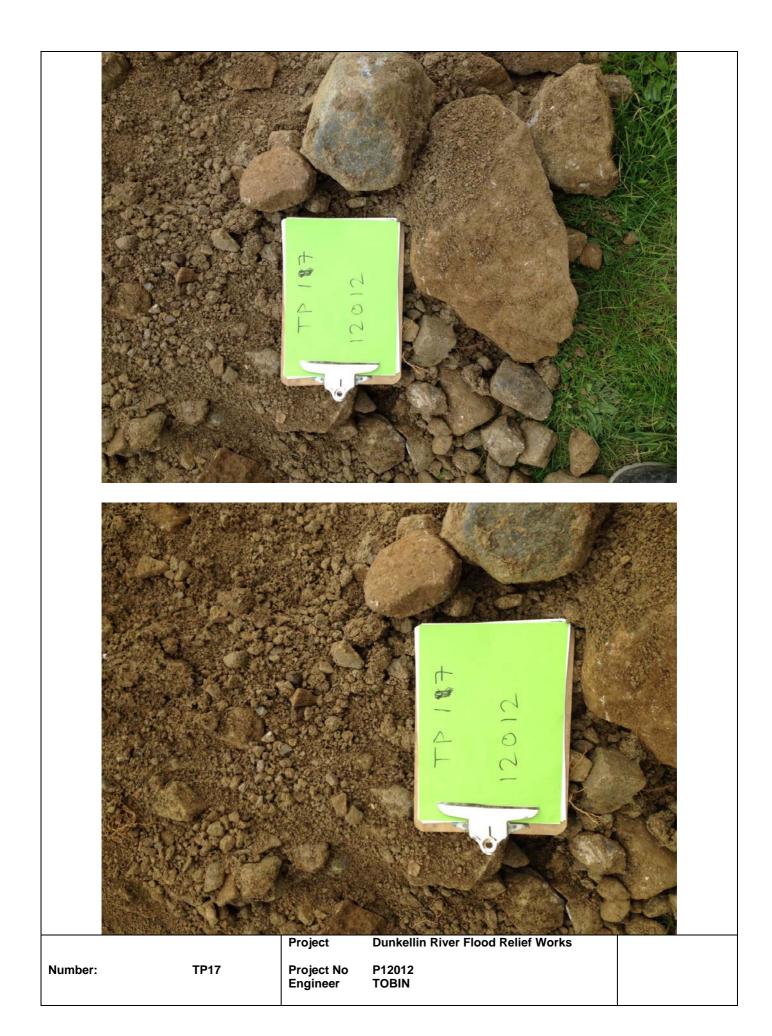
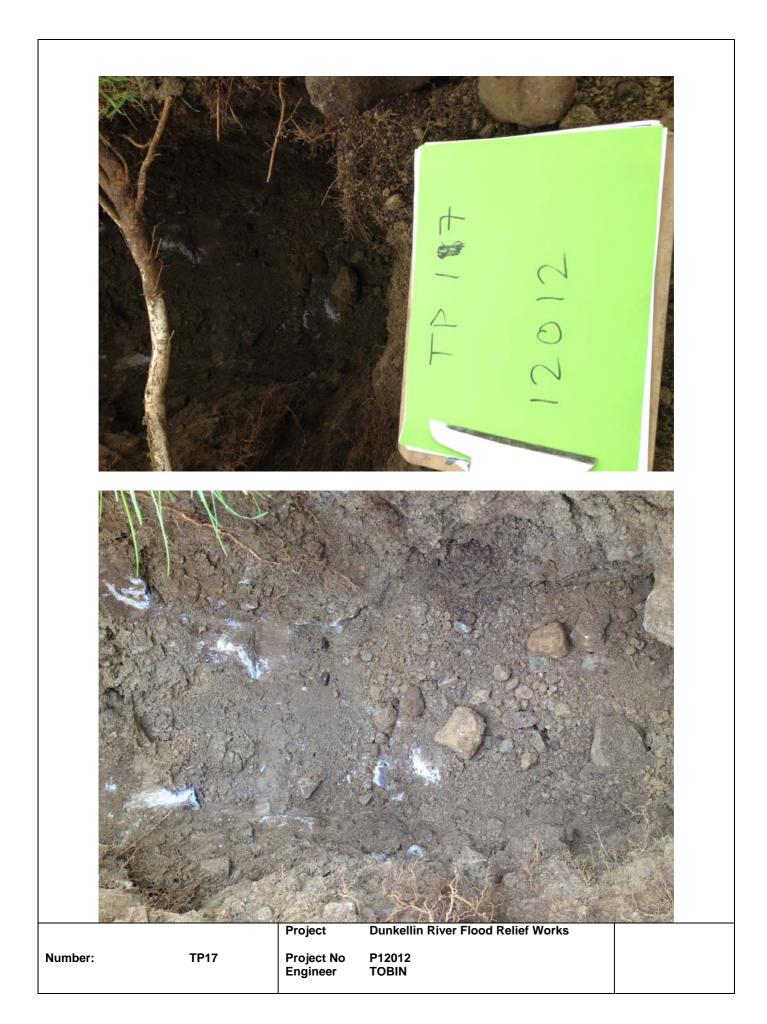
0.20-1.00 0.20-1.00			14.74	0.20	content and low coarse, subance	v boulder content. San gular to subrounded. C	nd is fine Cobbles	ndy SILT with low cobble e to coarse. Gravel is fine are subangular to subrou ubrounded, 200-800mm	nded,		-1

13.74	1.20		Trial pit completed at 1.20 m					•	
												-2	
Water         Depth (m)         Type         Results         Level         Depth						i						2 clated 2	
Plant: JCB Backfill: Arisings							oundwater: None	e encou	intered			3) Standard Trialoit Loo v5	
Rema	<b>arks:</b> Tri	al pit ter	minated due to obstr	uction.								H 476 581	
		L L L L L L L L L L L L L L L L L L L

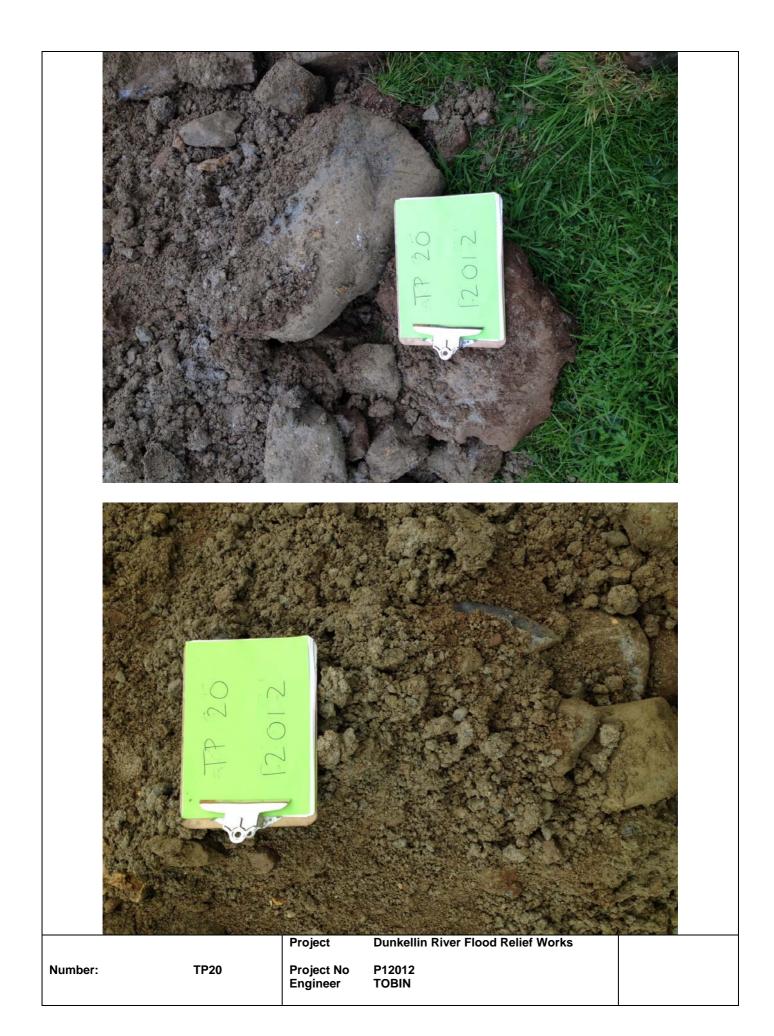
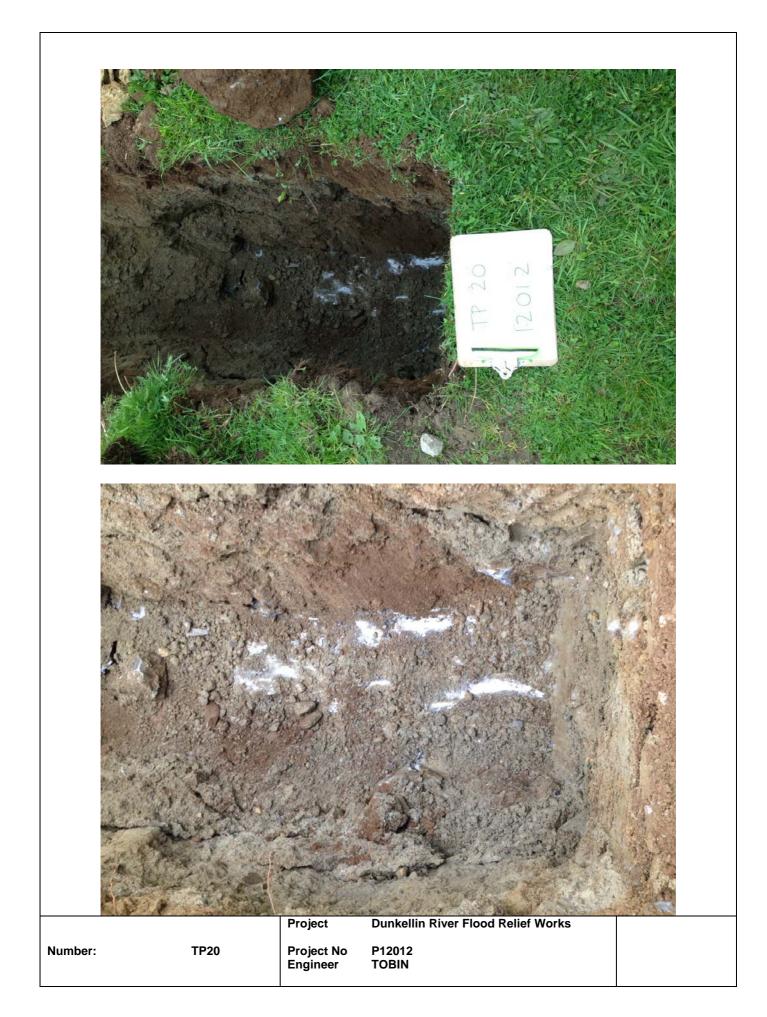
0.50-1.50	BD		14.90	0.20	Firm, light gre content and lo coarse, suban	y/ brown, slightly s w boulder content gular to subround a. Boulders are sub	andy gra Sand is ed. Cobb bangular	slightly gravelly SILT with rootlet velly CLAY with medium cobble fine to coarse. Gravel is fine to les are subangular to subrounde to subrounded, 200-650mm dia d at 1.90 m	ed.		
Water	Depth (m)	Type	Results	Level	Depth							ad 27th No
Stabi Plant Back	lity: Poo : JCB fill: Aris	or ings	minated due to obstru		20011	Gro	oundwater:	None en	countered			(Bid 426.58) Standard Trialbit Log v2 dat
												HoleBASE

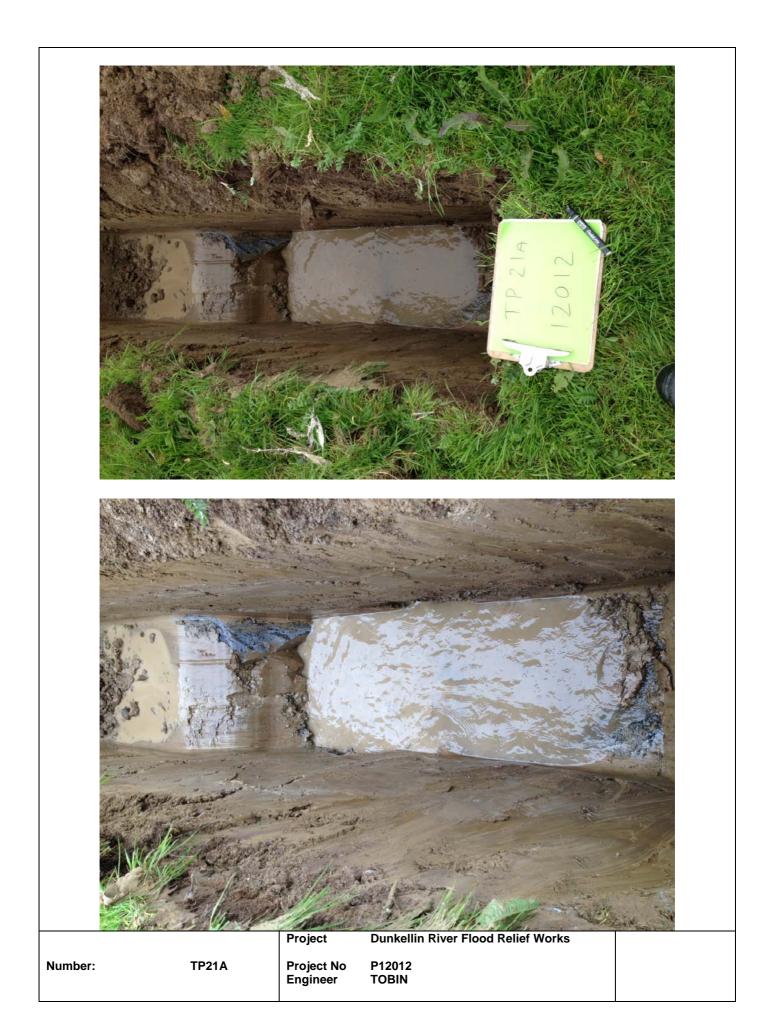
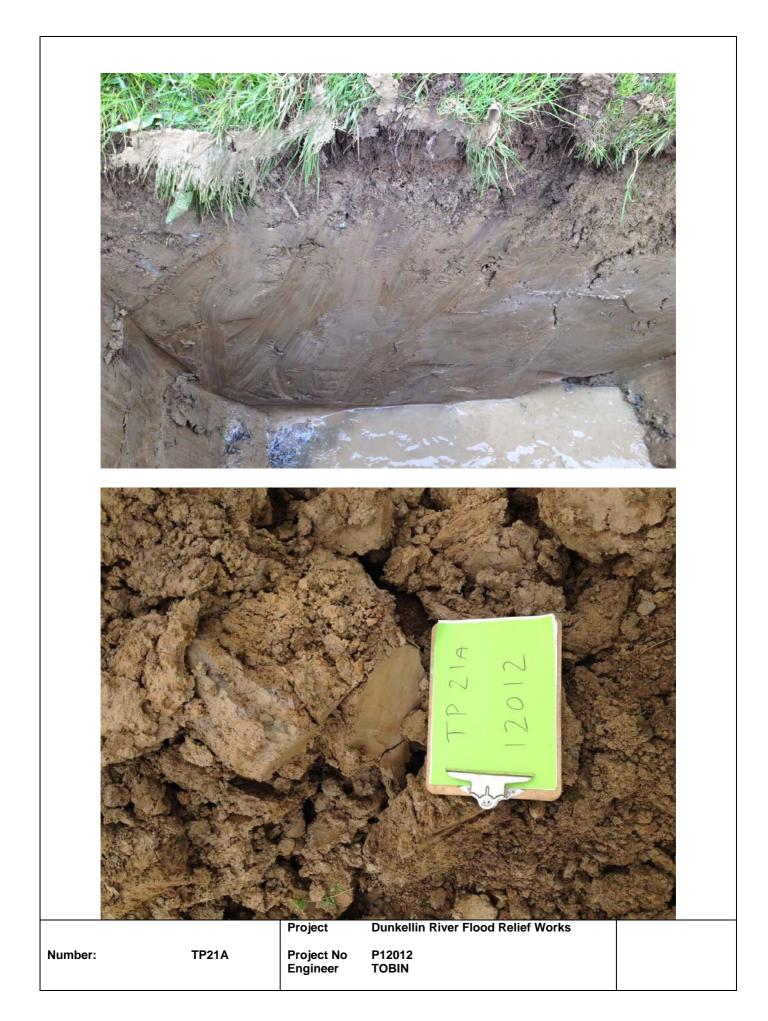
PRIORII OTECHN					Priority Geotechr Tel: 021 4631600 Fax: 021 463869 www.prioritygeote	0 90			TP	Pit No <b>21A</b> et 1 of 1	
Pro	ject Nan	ne:			Pro	oject No.	Co-ords:	54464	3E - 718661N		ate

-		rd Stream Flood Reli	ef Schem		2012			m AOD	14/0	5/2014	
Loc	ation:	Co Galw	ay				Dimensions	<b>s:</b>	3.30m		cale	
			-				Depth	E			:25	_
Clie	ent: Galv						1.60m	0.80m		Log	<b>ged By</b> ID	
Water	Depth (m)		& In Situ Testing Results	Level (m AOD)	Depth (m)		Stra	tum D	escription		Legend	
	✓ 0.40-1.40 B 0.40-1.40 D			0.20	Soft to firm, li cobble conter to coarse, su	ght brown/ grey, sligh nt and low boulder co bangular to subround a. Boulders are suba	ntly grav ontent. S led. Col ngular	y gravelly SILT with rootlets. relly slightly sandy CLAY with Io Sand is fine to coarse. Gravel is obles are subangular to subrou to subrounded, 200-300mm dia d at 1.60 m	nded.			
												27th Nov 6
Stabi Plant Back	Depth (m) lity: Poo : JCB fill: Aris arks: Tri	or ings	Results minated due to obstru	Level	Depth	Gr	roundwater: Tri	ickle a	t 0.8m.		<u> </u>	E III (Bid 426.58) Standard Trialpit Log v2 dated.

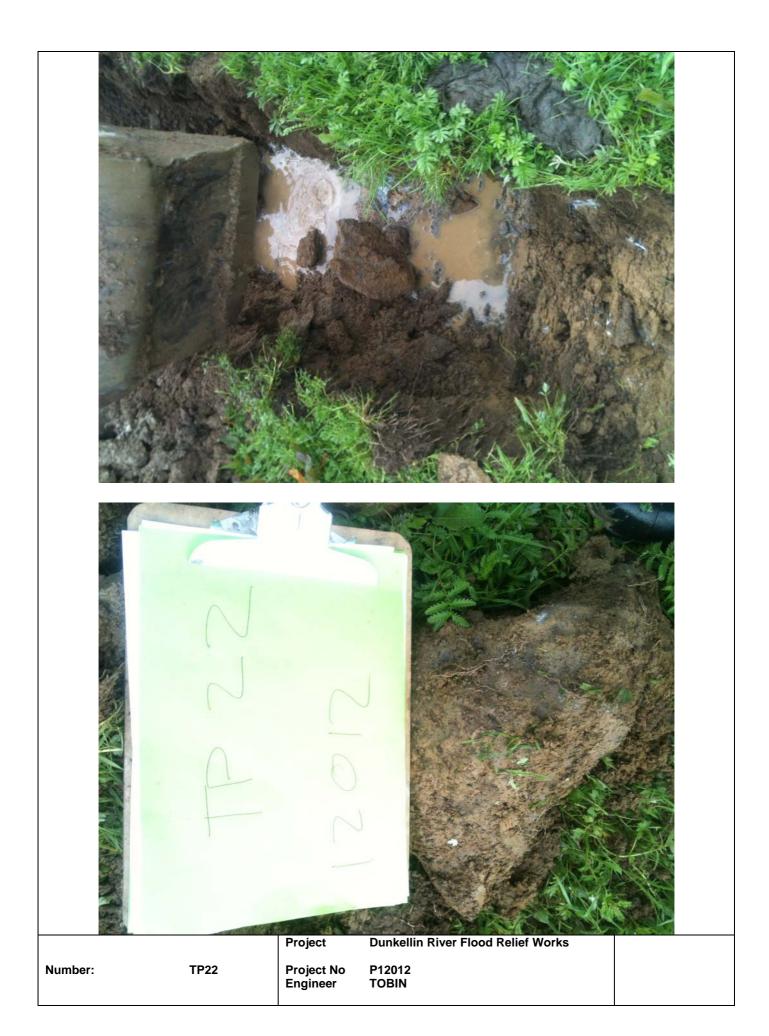
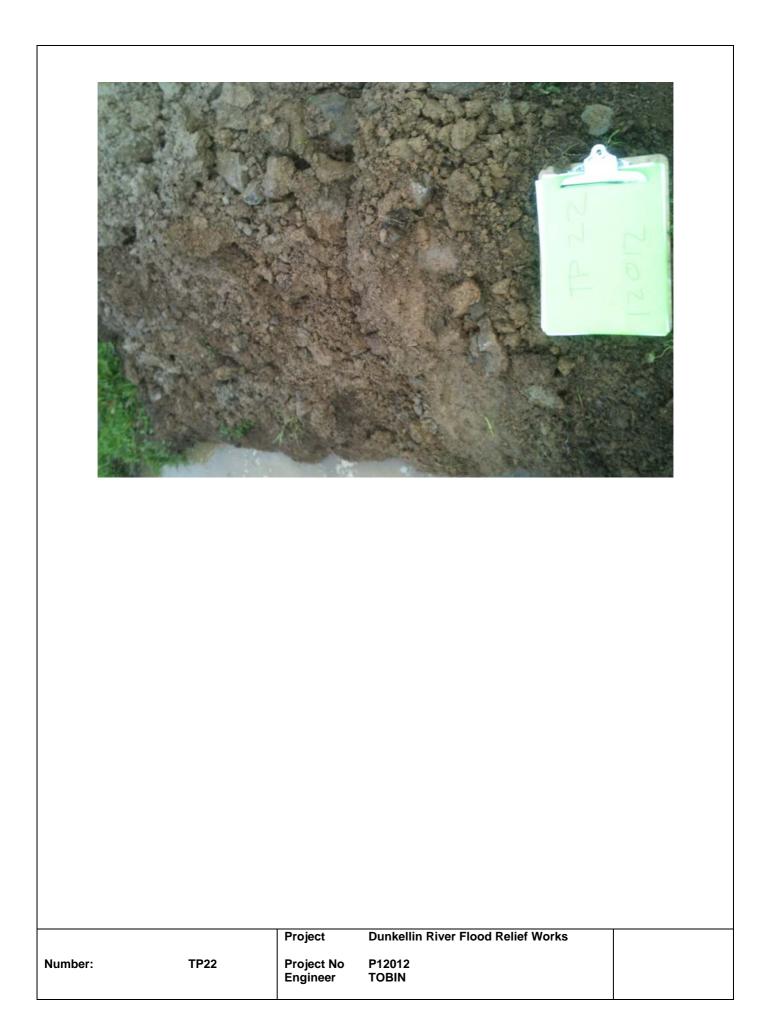
PRIORIT					Priority Geotechnica Tel: 021 4631600 Fax: 021 4638690 www.prioritygeotech				Т	l Pit No <b>P22</b>	
	ject Nan				Pro	oject No.	Co-ords: 544	4270	E - 718511N	_	et 1 of 1 ate	_

-		rd Stream Flood Reli	ef Schen		2012			AOD		5/2014	
	ation:						Dimensions:	_	2.10m		cale	
		ee eam	ay .				Depth	ε		1	:25	
Clie	ent: Galv						0.80m	0.60m			<b>ged By</b> BG	
Water	Depth (m)		& In Situ Testing Results	Level (m AOD)	Depth (m)		Stratur	m De	scription		Legend

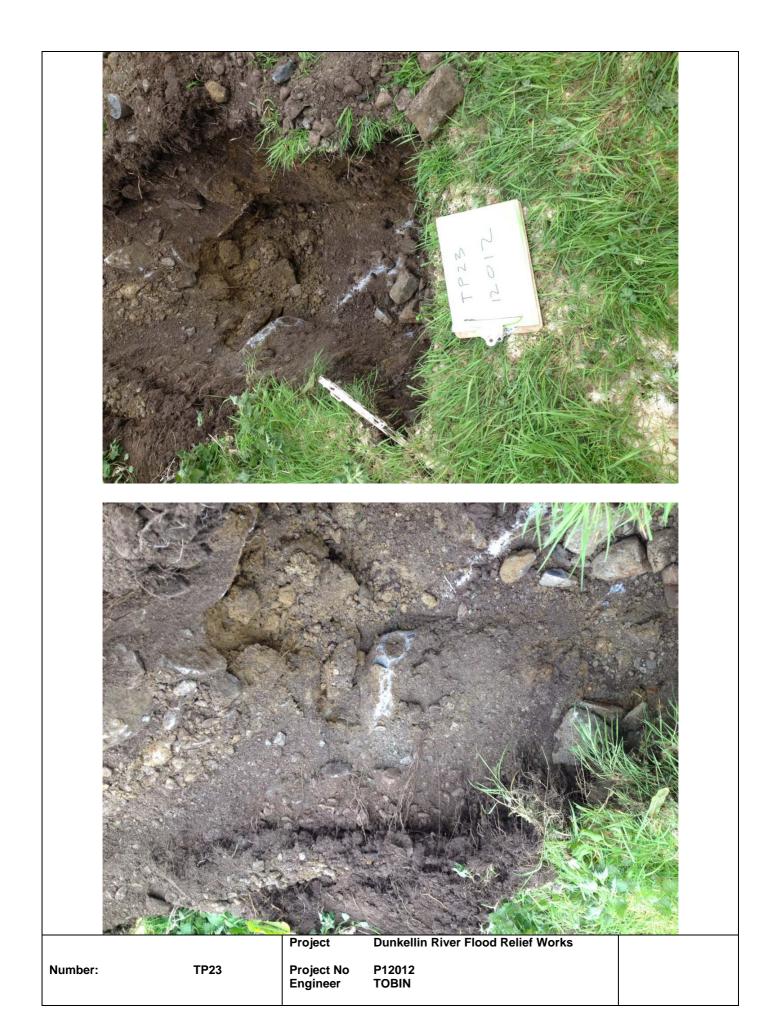
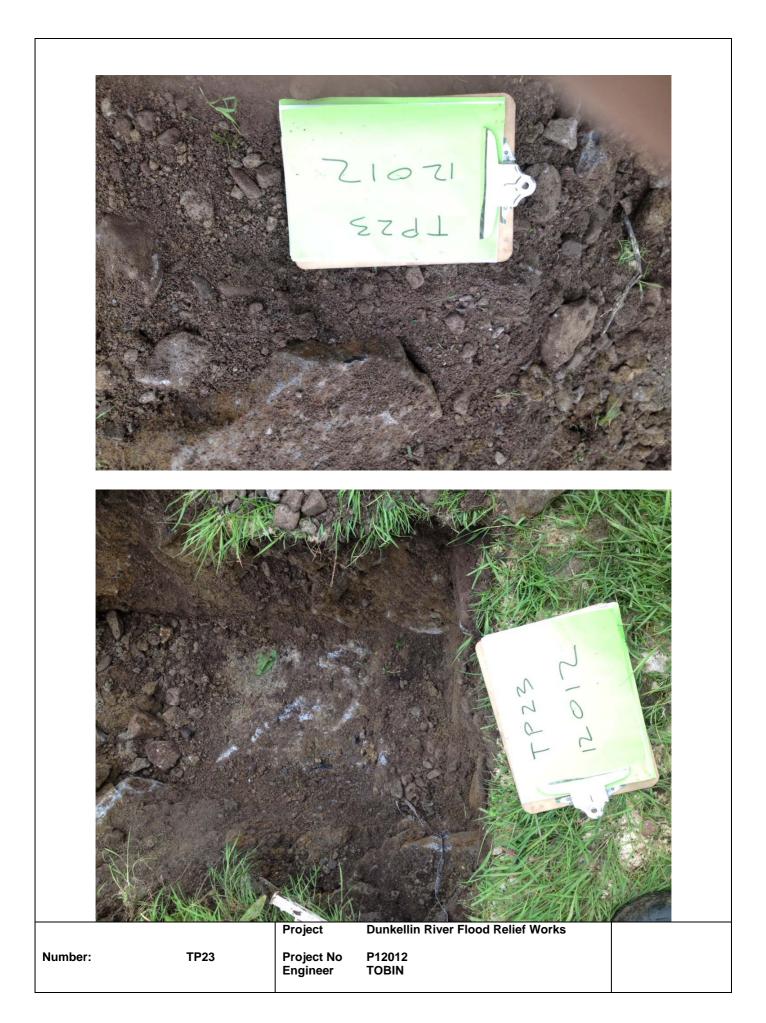
<b>⊒</b> () PRIORI GEOTECHM					Priority Geotechnica Tel: 021 4631600 Fax: 021 4638690 www.prioritygeotech			T	Pit No <b>P23</b>	
Project Na				Dro	oject No.				et 1 of 1 ate	-

-		rd Stream Flood Reli	ef Scherr		2012		79E - 718546N n AOD		5/2014	
Location:				-	-	Dimensions:	1.40m	S	cale	
	C0 Gaiw	ау				Depth E		1	:25	
Client: Ga						Depth E			<b>ged By</b> BG	
Water Depth (m		& In Situ Testing Results	Level (m AOD)	Depth (m)		Stratum	Description		Legend

4.35	0.80		Trial pit complet	ed at 0.80 m			
Water Depth (m Stability: Po Plant: JCB Backfill: Aris Remarks: T	or sings	Results minated due to obstru	Level ction.	Depth	Grou	ndwater: None er	ncountered			and A ROTE (10 FORM and 10 FORM) A ROTE OF A

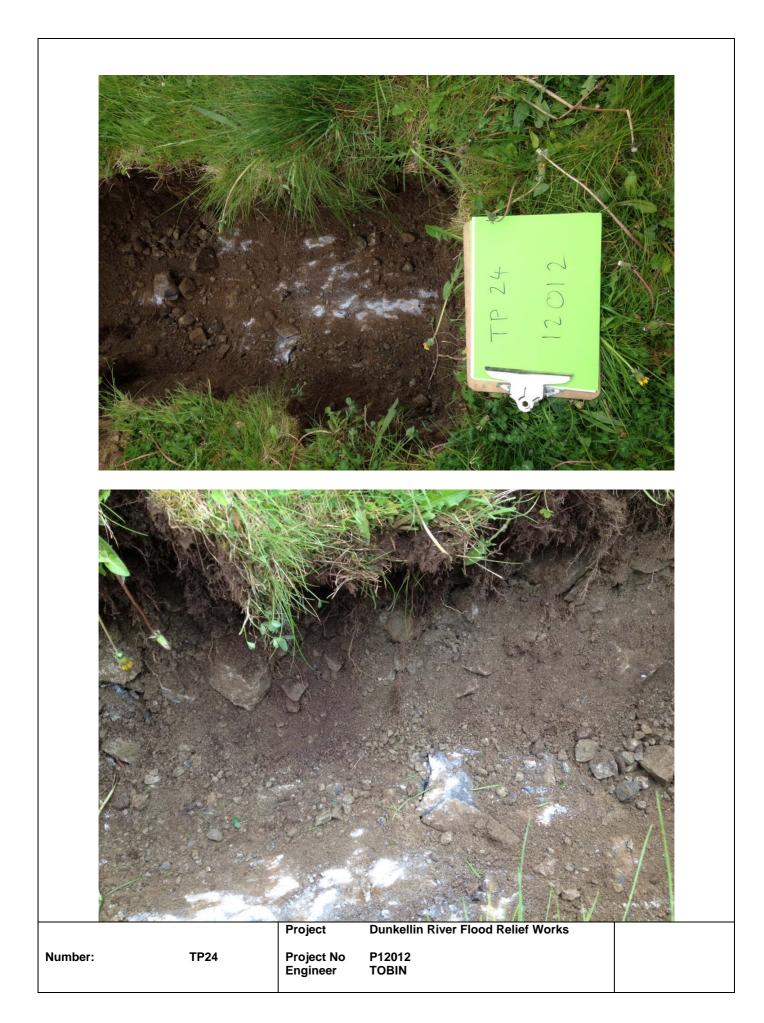
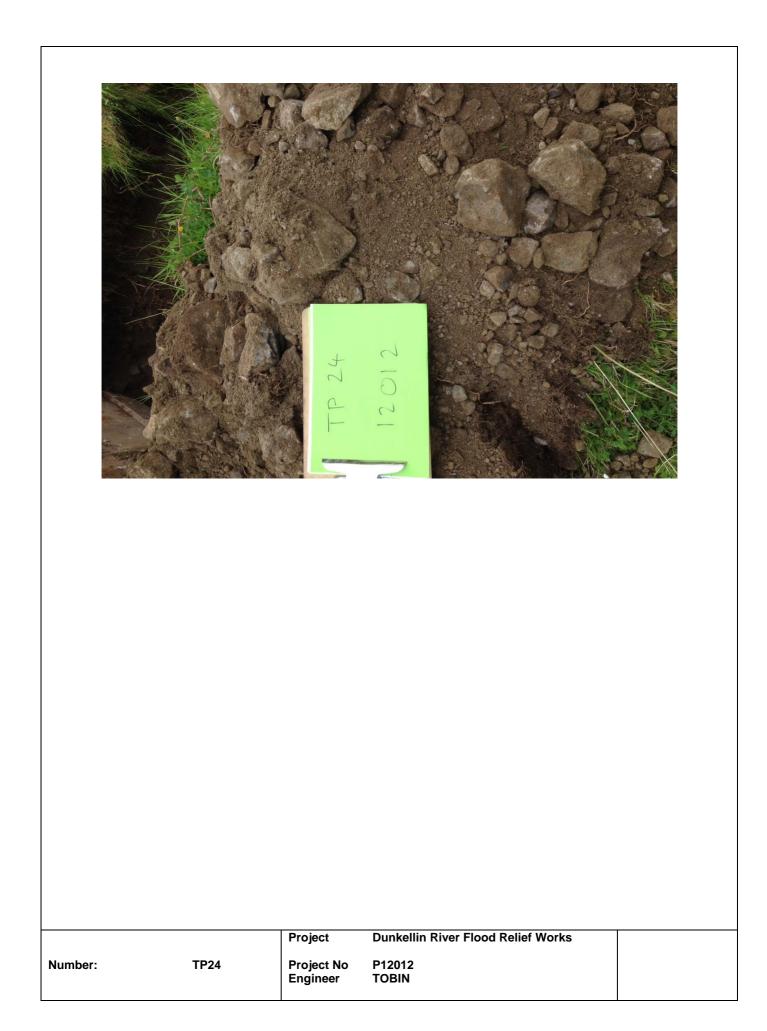
PRIORIT					Priority Geotechnie Tel: 021 4631600 Fax: 021 4638690 www.prioritygeotec				Т	Pit No <b>P24</b>	
	ject Nan				Pro	ject No.	Co-ords:	54314	7E - 718564N		et 1 of 1

-		rd Stream Flood Reli	ef Schem		012	Level:	8.13 m		02/0	5/2014	
Loc	ation:	Co Galw	ay				Dimensio	ns:	1.30m		cale	
			-				Depth	ш			:25	_
Clie	ent: Galv						0.50m	0.60m		Log	<b>ged By</b> ID	
Water	Depth (m)		& In Situ Testing Results	Level (m AOD)	Depth (m)				Description		Legend

7.63	0.50		Trial pi	t complete	d at 0.50 m			
	Depth (m)		Results	Level	Depth	1						dated 2
Plant Back	lity: Poo : JCB fill: Arisi	ngs	ninated due to obstru	Iction		Gro	oundwater:	None en	countered			58) Standard Trialbit Loo v2
Terric	ang.											HologASE III (BM 426.5

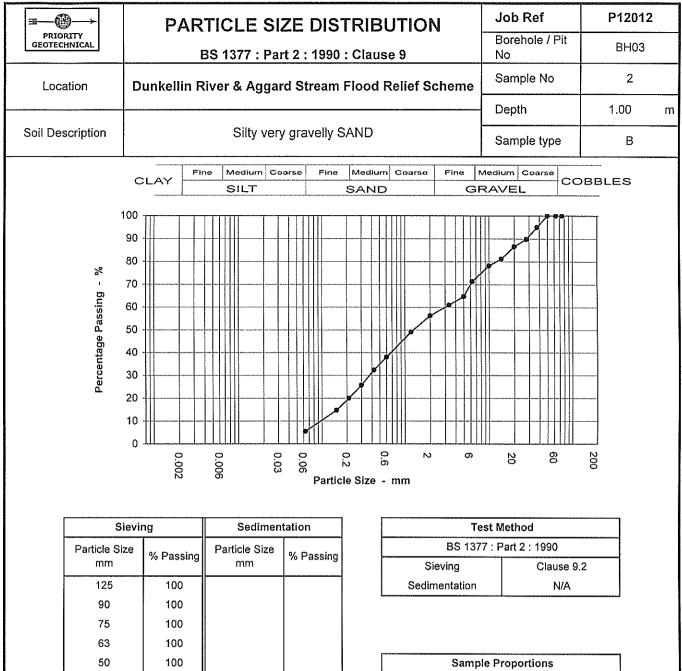
Particle Size mm	% Passing	Particle Size mm	% Passing
125	100		
90	100		
75	100		
63	100		
50	100		
37.5	95		
28	90		
20	87		
14	81		
10	78		
6.3	71		
5	65		
3.35	61		
2	56		
1.18	49		
0.6	38		
0.425	32		
0.3	26		
0.212	20		
0.15	15		
0.063	5

Sedimentation	N/A
Sample Propo	ortions
Cobbles	0.0
Gravel	43.7

Sand	50.8
Silt & Clay	5.5

Grading Analysis	
D100	50.000
D60	3.077
D10	0.106
Uniformity Coefficient	29

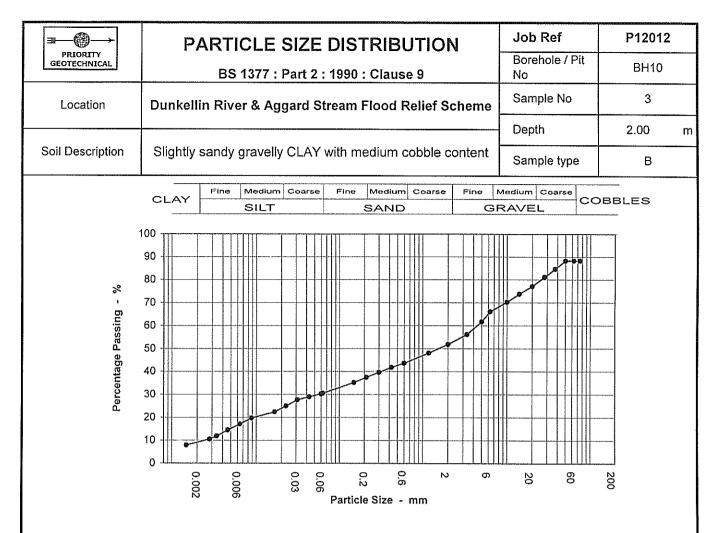
Sievir	ng	Sediment	tation
Particle Size mm	% Passing	Particle Size mm	% Passing
125	100	0.060	30
90	100	0.043	29
75	88	0.031	28
63	88	0.023	25
50	88	0.017	22
37.5	85	0.009	20
28	81	0.006	17
20	77	0.005	14
14	74	0.003	12
10	70	0.003	11
6.3	66	0.002	8
5	62		
3.35	56		
2	52		
1.18	48		
0.6	44		
0.425	42		
0.3	40		
0.212	37		
0.15	35		
0.063	30	1

Test N	lethod
BS 1377 : F	Part 2 : 1990
Sieving	Clause 9.2
Sedimentation	Clause 9.5

Sample Proportions	
Cobbles	11.8
Gravel	36.4
Sand	21.6
Silt	21.3
Clay	8.9

Grading Analysis	
D100	90.000
D60	4.505
D10	0.003
Uniformity Coefficient	1772

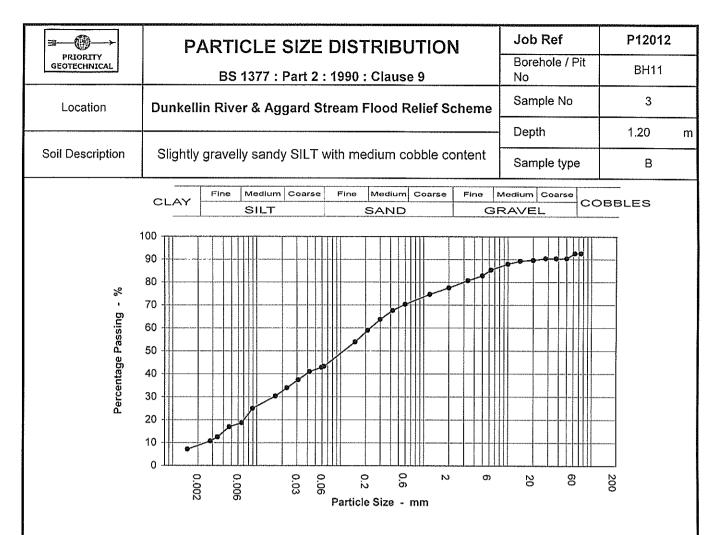
Sievir	ıg	Sediment	tation
Particle Size mm	% Passing	Particle Size mm	% Passing
125	100	0.059	43
90	100	0.043	41
75	93	0.031	37
63	93	0.023	34
50	90	0.017	30
37.5	90	0.009	25
28	90	0.007	19
20	90	0.005	17
14	89	0.003	12
10	88	0.003	11
6.3	85	0.002	7
5	83		
3.35	81		
2	77		
1.18	75		
0.6	70		
0.425	68		
0.3	64		
0.212	59		
0.15	54		
0.063	43

Test Method		
BS 1377 : Part 2 : 1990		
Sieving	Clause 9.2	
Sedimentation Clause 9.5

Sample Proportions		
Cobbles	8.0	
Gravel	14.6	
Sand	34.6	
Silt	34.4	
Clay	8.5

Grading Analysis		
D100	90.000	
D60	0.233	
D10	0.003	
Uniformity Coefficient 92

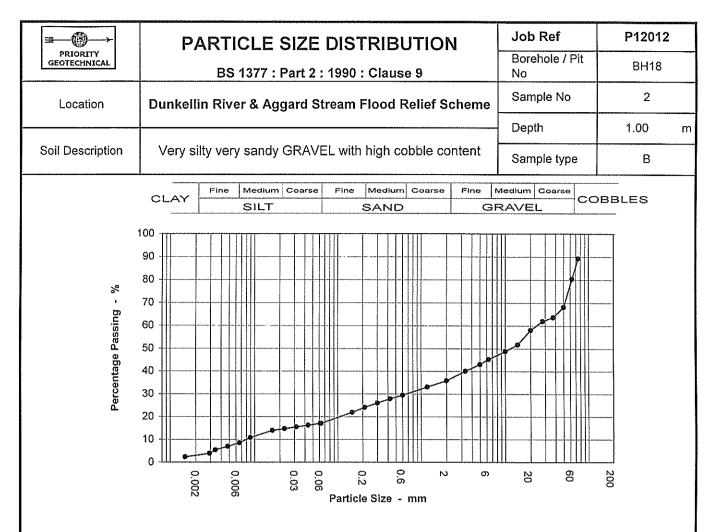
Sievir	۱g	Sedimen	tation
Particle Size mm	% Passing	Particle Size mm	% Passing
125	100	0.061	17
90	89	0.044	16
75	89	0.032	15
63	80	0.023	15
50	68	0.016	14
37.5	64	0.009	11
28	62	0.007	8
20	58	0.005	7
14	52	0.003	5
10	49	0.003	4
6.3	45	0.002	2
5	43		
3.35	40		
2	36		
1.18	33		
0.6	29		
0.425	28		
0.3	26		
0.212	24		
0.15	22		
0.063	17

Test Method		
BS 1377 : Part 2 : 1990		
Sieving Clause 9.2		
Sedimentation Clause 9.5

Sample Proportions		
Cobbles	22.4	
Gravel	41.7	
Sand	18.9	
Silt	14.1	
Clay	2.9

Grading Analysis		
D100	125.000	
D60	23.922	
D10	0.008	
Uniformity Coefficient 2954

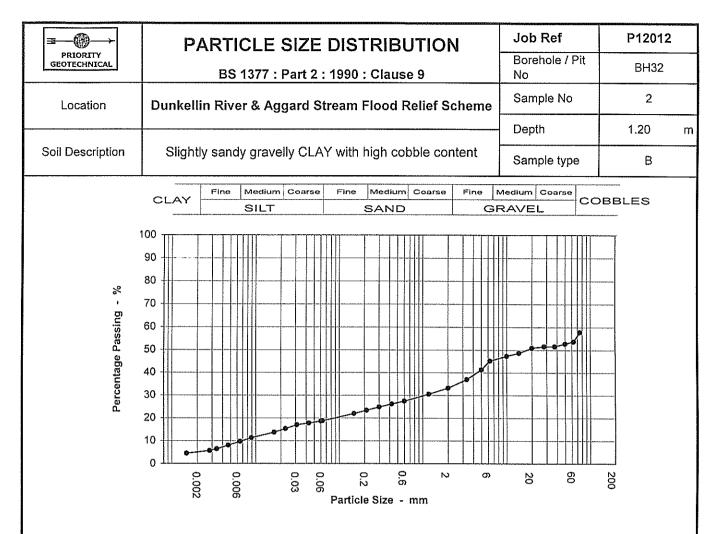
Slevir	ıg	Sedimen	tation
Particle Size mm	% Passing	Particle Size mm	% Passing
125	58	0.060	19
90	58	0.043	18
75	58	0.031	17
63	54	0.023	15
50	53	0.017	14
37.5	52	0.009	11
28	52	0.007	10
20	51	0.005	8
14	49	0.003	6
10	47	0.003	6
6.3	45	0.002	4
5	41		
3.35	37		
2	33		
1.18	31		
0.6	27		
0.425	26		
0.3	25		
0.212	23		
0.15	22		
0.063	19

Test Method		
BS 1377 : Part 2 : 1990		
Sieving Clause 9.2		
Sedimentation Clause 9.5

Sample Proportions		
Cobbles	46.5	
Gravel	20.3	
Sand	14.6	
Silt	13.7	
Clay	4.9

Grading Analysis		
D100	125.000	
D60	125.000	
D10	0.007	
Uniformity Coefficient 18000

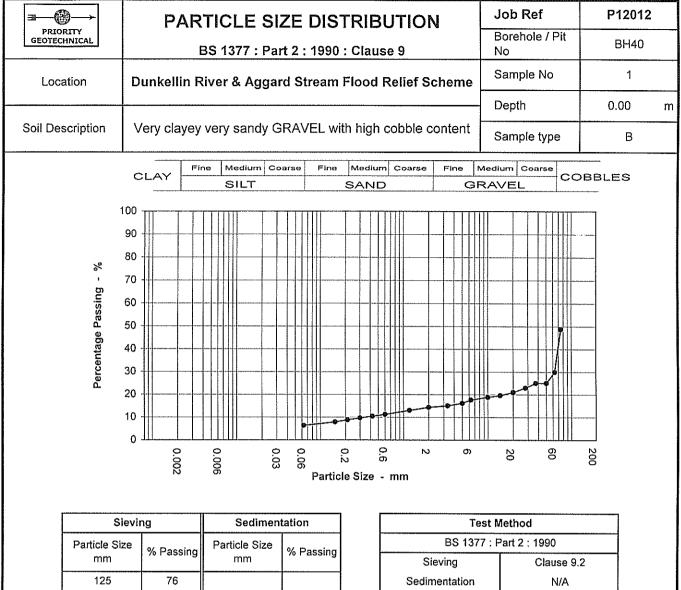
mm	% Passing	mm	% Passing
125	76		
90	64		
75	49		
63	30		
50	25		
37.5	25		
28	23		
20	21		
14	20		
10	19		
6.3	18		
5	16		
3.35	15		
2	14		
1.18	13		
0.6	11		
0.425	10		
0.3	10		
0.212	9		
0.15	8		
0.063	6

71.2
14.5
8.0
6.4

Grading Analysis		
D100	125.000	
D60	85.743	
D10	0.360	
Uniformity Coefficient	239

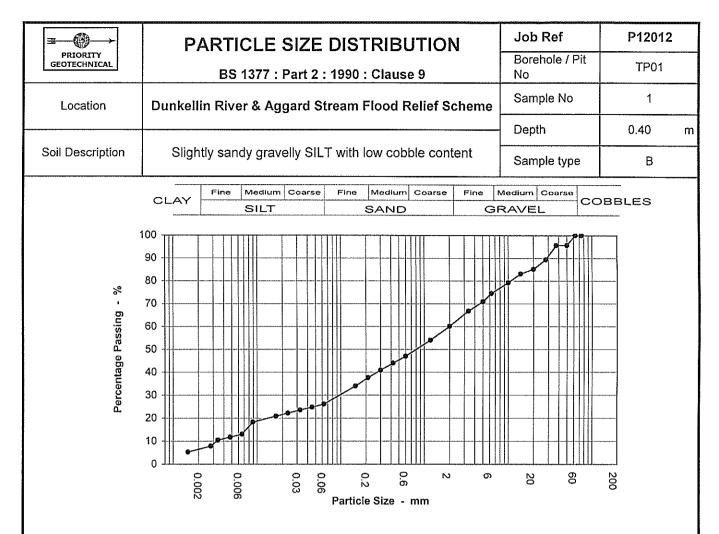
Sievir	Sieving		tation
Particle Size mm	% Passing	Particle Size mm	% Passing
125	100	0.063	26
90	100	0.045	25
75	100	0.033	23
63	100	0.023	22
50	96	0.017	21
37.5	96	0.009	18
28	89	0.007	13
20	85	0.005	12
14	83	0.003	10
10	79	0.003	8
6.3	75	0.002	5
5	71		
3.35	67		
2	60	:	
1.18	54		
0.6	47		
0.425	44		
0.3	41		
0.212	38		
0.15	34		
0.063	26

Test Method		
BS 1377 : Part 2 : 1990		
Sieving	Clause 9.2	
Sedimentation	Clause 9.5

Sample Proportions			
Cobbles	1.0		
Gravel	38.9		
Sand	34.2		
Silt	19.6		
Clay	6.2

Grading Analysis		
D100	63.000	
D60	1.992	
D10	0.003	
Uniformity Coefficient	604

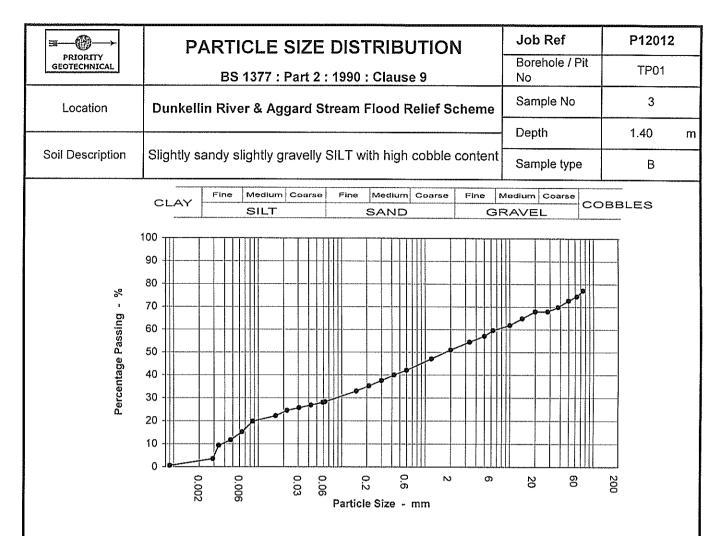
Sievii	Sieving		tation
Particle Size mm	% Passing	Particle Size mm	% Passing
125	77	0.059	28
90	77	0.043	27
75	77	0.031	26
63	75	0.022	24
50	73	0.016	22
37.5	70	0.009	20
28	68	0.006	15
20	68	0.005	12
14	65	0.003	9
10	62	0.003	4
6.3	60	0.001	1
5	57		
3.35	54		
2	51		
1.18	47		
0.6	42		
0.425	40		
0.3	38		
0.212	35		
0.15	33		
0.063	28

Test Method		
BS 1377 : Part 2 : 1990		
Sieving	Clause 9.2	
Sedimentation Clause 9.5

Sample Proportions		
Cobbles	25.9	
Gravel	23.2	
Sand	22.9	
Silt	25.9	
Clay	2.2

Grading Analysis		
D100	125.000	
D60	6.971	
D10	0.004	
Uniformity Coefficient	1847

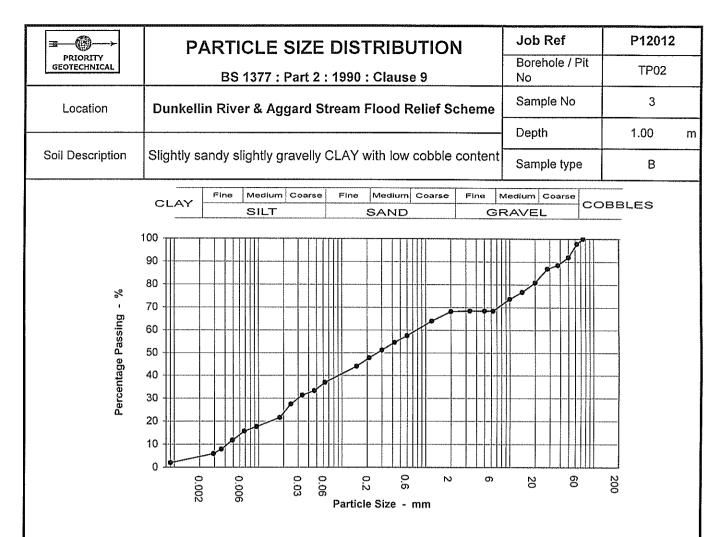
Sievir	ıg	Sedimen	tation
Particle Size mm	% Passing	Particle Size mm	% Passing
125	100	0.063	37
90	100	0.047	33
75	100	0.034	31
63	98	0.024	27
50	92	0.018	22
37.5	89	0.010	18
28	87	0.007	16
20	81	0.005	12
14	77	0.004	8
10	74	0.003	6
6.3	68	0.001	2
5	68		
3.35	68		
2	68		
1.18	64		
0.6	58		
0.425	55		
0.3	51		
0.212	48		
0.15	44		
0.063	37

Test Method		
BS 1377 : Part 2 : 1990		
Sieving Clause 9.2		
Sedimentation	Clause 9.5
