# Dunkellin River and Aggard Stream Flood Relief Scheme

# Response to An Bord Pleanála

r					
Client:	Galway County Council	Galway County Council			
Project Title:	Dunkellin River and Aggard S	Dunkellin River and Aggard Stream Flood Relief Scheme			
Document Title:	Response to An Bord Pleanál	Response to An Bord Pleanála			
Document No:	MGE0260RP0012				
Text Pages:	48 Appendices: 6

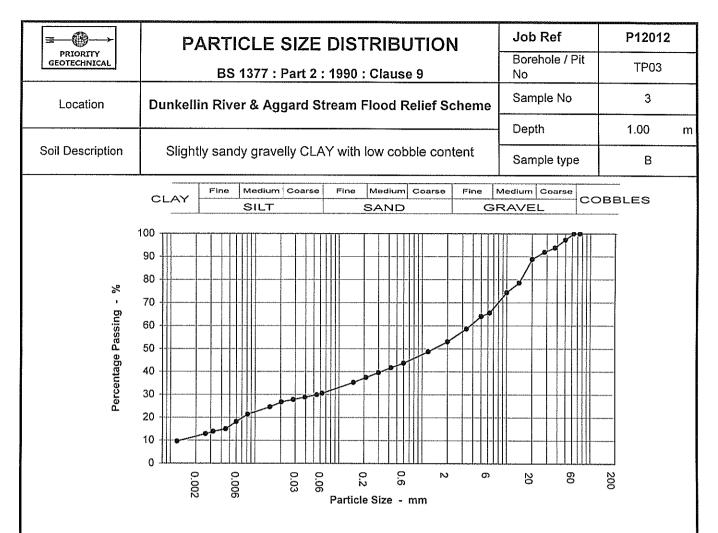
Sample Proportions		
Cobbles	3.5	
Gravel	28.3	
Sand	31.9	
Silt	32.2	
Clay	4.1

Grading Analysis		
D100	75.000	
D60	0.823	
D10	0.004	
Uniformity Coefficient	191

Sievir	Sieving		Sedimentation	
Particle Size mm	% Passing	Particle Size mm	% Passing	
125	100	0.054	30	
90	100	0.039	29	
75	100	0.028	28	
63	100	0.021	27	
50	97	0.015	25	
37.5	94	0.008	21	
28	92	0.006	18	
20	89	0.005	15	
14	79	0.003	14	
10	74	0.003	13	
6.3	65	0.001	10	
5	64			
3.35	59			
2	53			
1.18	49			
0.6	44			
0.425	42			
0.3	40			
0.212	37			
0.15	35			
0.063	31

Test Method		
BS 1377 : Part 2 : 1990		
Sieving	Clause 9.2	
Sedimentation	Clause 9.5

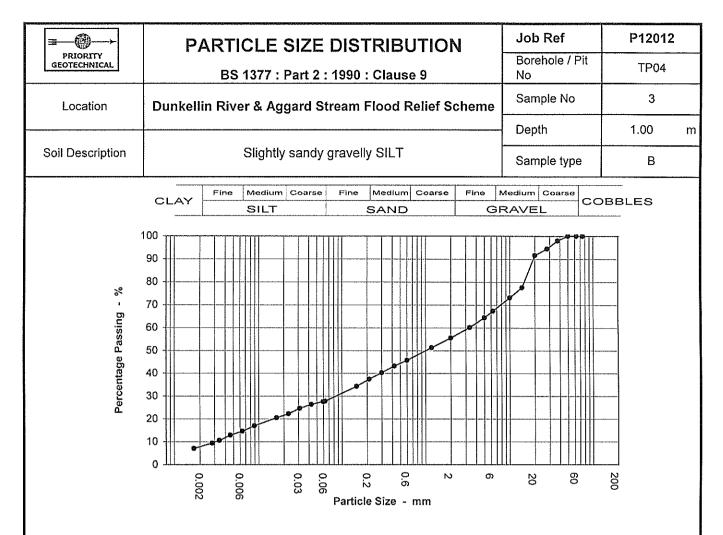
Sample Proportions		
Cobbles	0.6	
Gravel	46.4	
Sand	22.7	
Silt	18.9	
Clay	11.4

Grading Analysis			
D100	63.000		
D60	3.787		
D10	0.001		
Uniformity Coefficient	2763

Sievir	Sieving		Sedimentation	
Particle Size mm	% Passing	Particle Size mm	% Passing	
125	100	0.060	28	
90	100	0.043	26	
75	100	0.031	25	
63	100	0.023	22	
50	100	0.016	21	
37.5	98	0.009	17	
28	94	0.006	15	
20	92	0.005	13	
14	78	0.003	11	
10	73	0.003	9	
6.3	67	0.002	7	
5	64			
3.35	60			
2	56			
1.18	51			
0.6	46			
0.425	43			
0.3	40			
0.212	37			
0.15	34			
0.063	28

Test Method		
BS 1377 : Part 2 : 1990		
Sieving Clause 9.2		
Sedimentation Clause 9.5

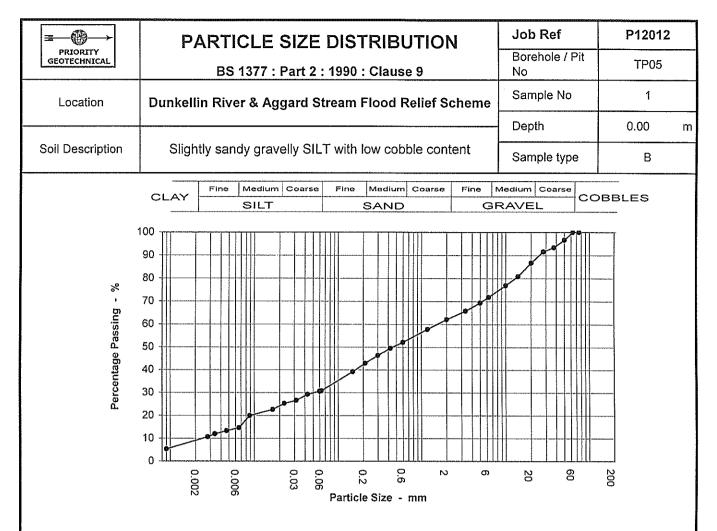
Sample Proportions		
Cobbles 0.0		
Gravel	44.5	
Sand	28.0	
Silt	19.9	
Clay	7.7

Grading Analysis		
D100	50.000	
D60	3.289	
D10	0.003	
Uniformity Coefficient 1055

Sievir	Sieving		Sedimentation	
Particle Size mm	% Passing	Particle Size mm	% Passing	
125	100	0.060	31	
90	100	0.043	29	
75	100	0.032	27	
63	100	0.023	25	
50	97	0.017	23	
37.5	93	0.009	20	
28	92	0.007	15	
20	87	0.005	13	
14	81	0.003	12	
10	77	0.003	11	
6.3	72	0.001	5	
5	69			
3.35	66			
2	62			
1.18	58			
0.6	52			
0.425	49			
0.3	46			
0.212	43			
0.15	39			
0.063	31

Test Method		
BS 1377 : Part 2 : 1990		
Sieving Clause 9.2		
Sedimentation Clause 9.5

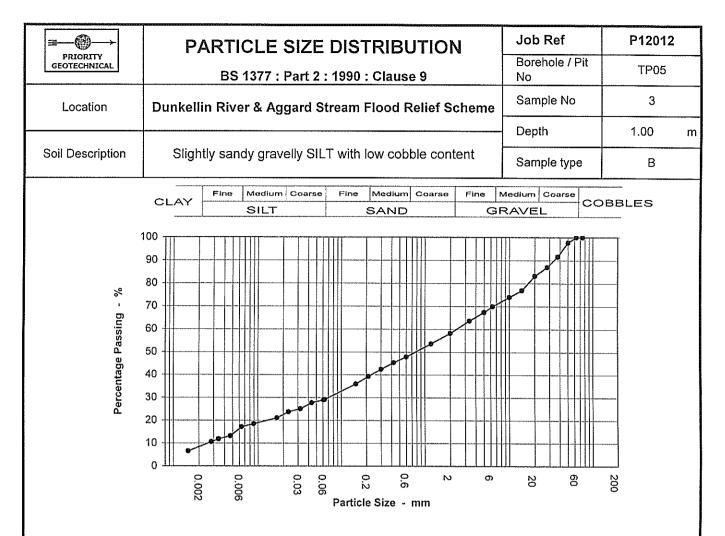
Sample Proportions			
Cobbles 0.8			
Gravel	37.2		
Sand	31.5		
Silt	22.2		
Clay	8.4

Grading Analysis		
D100	63.000	
D60	1.603	
D10	0.003	
Uniformity Coefficient	623

Sievir	Sieving		Sedimentation	
Particle Size mm	% Passing	Particle Size mm	% Passing	
125	100	0.061	29	
90	100	0.044	28	
75	100	0.032	25	
63	100	0.023	24	
50	98	0.017	21	
37.5	92	0.009	18	
28	87	0.006	17	
20	83	0.005	13	
14	77	0.003	12	
10	74	0.003	11	
6.3	70	0.002	7	
5	67			
3.35	64			
2	58			
1.18	54			
0.6	48			
0.425	45			
0.3	42			
0.212	39			
0.15	36			
0.063	29

Test Method		
BS 1377 : Part 2 : 1990		
Sieving	Clause 9.2	
Sedimentation Clause 9.5

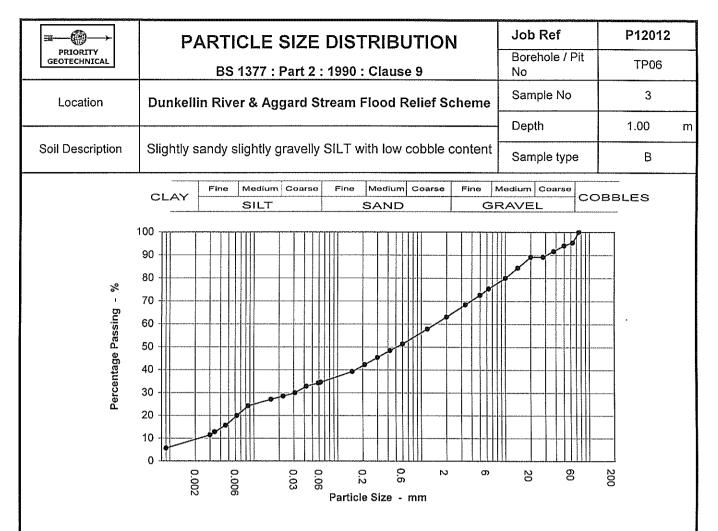
Sample Proportions			
Cobbles 0.5			
Gravel	41.3		
Sand	29.3		
Silt	20.8		
Clay	8.1

Grading Analysis		
D100	63.000	
D60	2.447	
D10	0.003	
Uniformity Coefficient	933

Sievir	Sieving		Sedimentation	
Particle Size mm	% Passing	Particle Size mm	% Passing	
125	100	0.059	34	
90	100	0.043	33	
75	100	0.031	30	
63	95	0.022	29	
50	94	0.016	27	
37.5	92	0.009	24	
28	89	0.006	20	
20	89	0.005	16	
14	84	0.003	13	
10	80	0.003	11	
6.3	75	0.001	6	
5	73			
3.35	68			
2	63			
1.18	58			
0.6	51			
0.425	48			
0.3	45			
0.212	42			
0.15	39			
0.063	35

Test Method		
BS 1377 : Part 2 : 1990		
Sieving	Clause 9.2	
Sedimentation	Clause 9.5

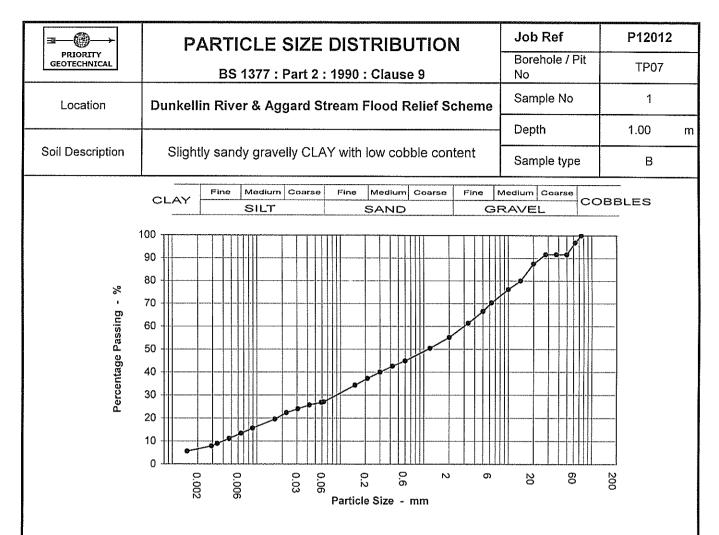
Sample Proportions		
Cobbles 4.9		
Gravel	32.0	
Sand	28.8	
Silt	25.6	
Clay	8.7

Grading Analysis		
D100	75.000	
D60	1.523	
D10	0.002	
Uniformity Coefficient 613

Sievir	ıg	Sedimen	tation
Particle Size mm	% Passing	Particle Size mm	% Passing
125	100	0.059	27
90	100	0.043	26
75	100	0.031	24
63	97	0.022	22
50	92	0.016	20
37.5	92	0.009	16
28	92	0.007	13
20	87	0.005	11
14	80	0.003	9
10	76	0.003	8
6.3	70	0.002	6
5	66		
3.35	61		
2	55		
1.18	50		
0.6	45		
0.425	43		
0.3	40		
0.212	37		
0.15	34		
0,063	27

Test Method		
BS 1377 : Part 2 : 1990		
Sieving	Clause 9.2	
Sedimentation	Clause 9.5

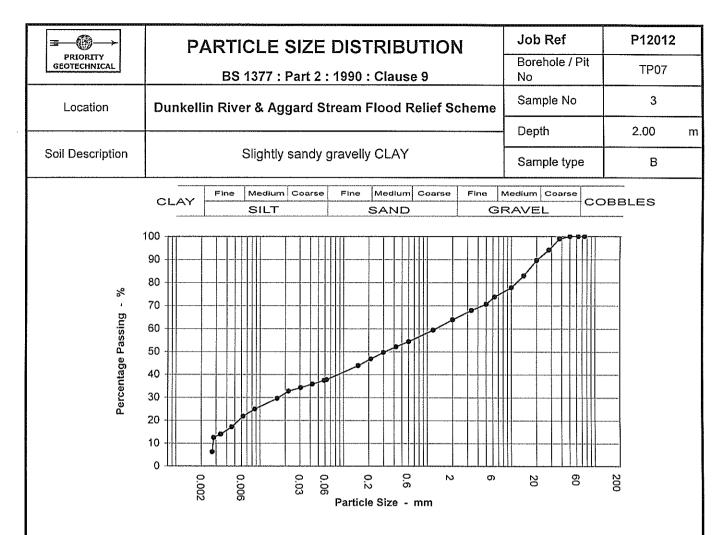
Sample Proportions		
Cobbles	4.4	
Gravel	40.6	
Sand	28.2	
Silt	20.5	
Clay	6.4

Grading Analysis		
D100	75.000	
D60	3.061	
D10	0.004	
Uniformity Coefficient	761

Sievir	Sieving		Sedimentation	
Particle Size mm	% Passing	Particle Size mm	% Passing	
125	100	0.059	37	
90	100	0.043	36	
75	100	0.031	34	
63	100	0.022	33	
50	100	0.016	30	
37.5	99	0.009	25	
28	94	0.006	22	
20	90	0.005	17	
14	83	0.003	14	
10	78	0.003	12	
6.3	74	0.003	6	
5	71			
3.35	68			
2	64			
1.18	59			
0.6	54			
0.425	52			
0.3	50			
0.212	47			
0.15	44			
0.063	38

Test Method		
BS 1377 : Part 2 : 1990		
Sieving	Clause 9.2	
Sedimentation	Clause 9.5

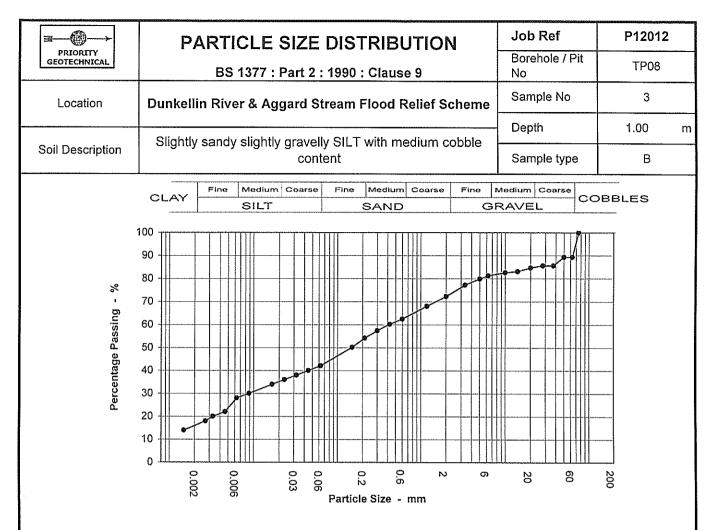
Sample Proportions		
Cobbles	0.0	
Gravel	36.1	
Sand	26.3	
Silt & Clay	31.3

Grading Analysis		
D100	50.000	
D60	1.284	
D10	0.003	
Uniformity Coefficient	465

Sievii	Sieving		Sedimentation	
Particle Size mm	% Passing	Particle Size mm	% Passing	
125	100	0.062	42	
90	100	0.045	40	
75	100	0.032	38	
63	89	0.023	36	
50	89	0.017	34	
37.5	86	0.009	30	
28	86	0.006	28	
20	85	0.005	22	
14	83	0.003	20	
10	83	0.003	18	
6.3	81	0.002	14	
5	80			
3.35	77			
2	72			
1.18	68			
0.6	62			
0.425	60			
0.3	57			
0.212	54			
0.15	50			
0.063	42

Test Method		
BS 1377 : Part 2 : 1990		
Sieving	Clause 9.2	
Sedimentation	Clause 9.5

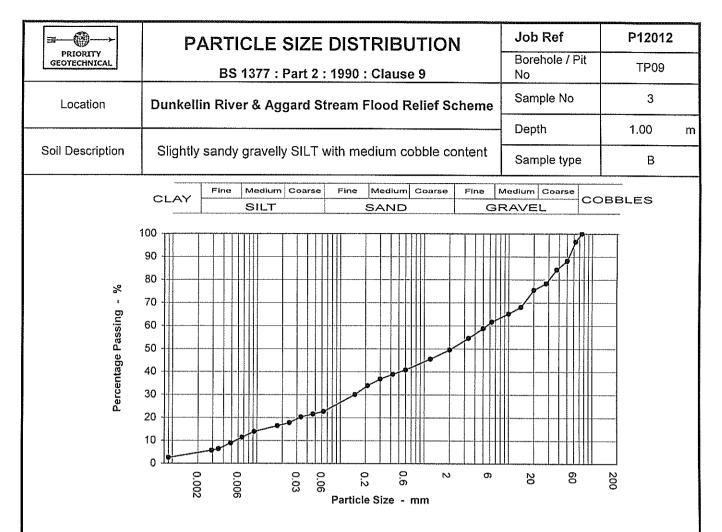
Sample Proportions		
Cobbles 10.7		
Gravel	17.1	
Sand	30.4	
Silt	26.1	
Clay	15.7

Grading Analysis		
D100	75.000	
D60	0.418	
D10		
Uniformity Coefficient	N/A

Sievir	Sieving		Sedimentation	
Particle Size mm	% Passing	Particle Size mm	% Passing	
125	100	0.063	23	
90	100	0.047	22	
75	100	0.034	20	
63	96	0.024	18	
50	88	0.018	16	
37.5	84	0.009	14	
28	78	0.007	11	
20	75	0.005	9	
14	68	0.004	6	
10	65	0.003	6	
6.3	62	0.001	3	
5	59			
3.35	55			
2	49			
1.18	45			
0.6	41			
0.425	39			
0.3	37			
0.212	34			
0.15	30			
0.063	23

Test Method		
BS 1377 : Part 2 : 1990		
Clause 9.2		
Clause 9.5

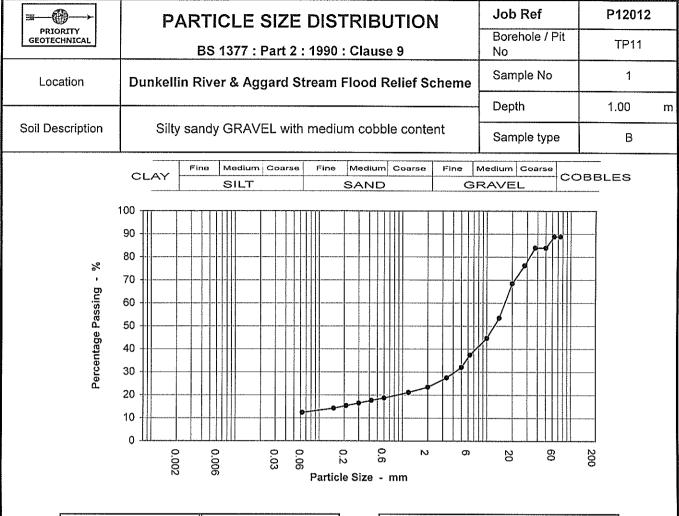
Sample Proportions			
Cobbles	5.5		
Gravel	45.1		
Sand	27.0		
Silt	18.2		
Clay	4.3

Grading Analysis		
D100	75.000	
D60	5.554	
D10	0.006	
Uniformity Coefficient	974

Sievir	ıg	Sedimen	tation
Particle Size mm	% Passing	Particle Size mm	% Passing
125	100		
90	100		
75	89		
63	89		
50	84		
37.5	84		
28	76		
20	68		
14	53		
10	45		
6.3	37		
5	32		
3.35	28		
2	23		
1.18	21		
0.6	19		
0.425	18		
0.3	16		
0.212	15		
0.15	14		
0.063	12

Test Method			
BS 1377 : Part 2 : 1990			
Sieving	Clause 9.2		
Sedimentation	N/A

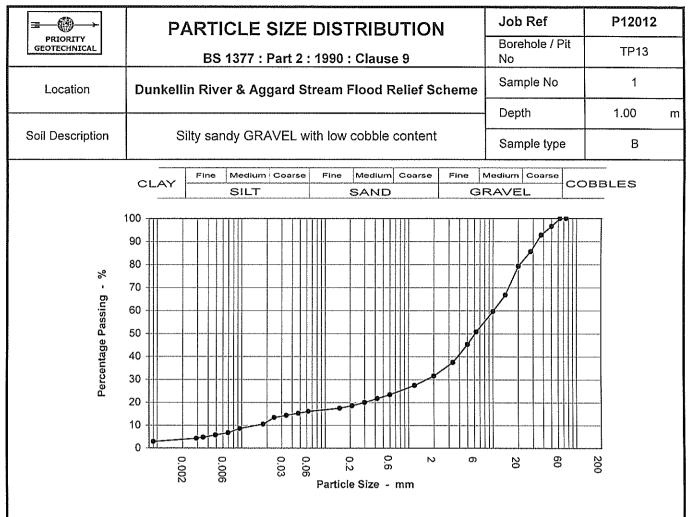
Sample Proportions		
Cobbles	12.4	
Gravel	64.1	
Sand	11.1	
Silt & Clay	12.4

Grading Analysis		
D100	90.000	
D60	16.649	
D10		
Uniformity Coefficient	N/A

Sievir	Sieving		tation
Particle Size mm	% Passing	Particle Size mm	% Passing
125	100	0.063	16
90	100	0.048	15
75	100	0.034	14
63	100	0.024	13
50	97	0.018	11
37.5	93	0.010	9
28	86	0.007	7
20	79	0.005	6
14	67	0.004	5
10	60	0.003	4
6.3	51	0.001	3
5	45		
3.35	37		
2	32		
1.18	28		
0.6	23		
0.425	22		
0.3	20		
0.212	19		
0.15	17		
0.063	16

Test Method		
BS 1377 : Part 2 : 1990		
Sieving	Clause 9.2	
Sedimentation	Clause 9.5

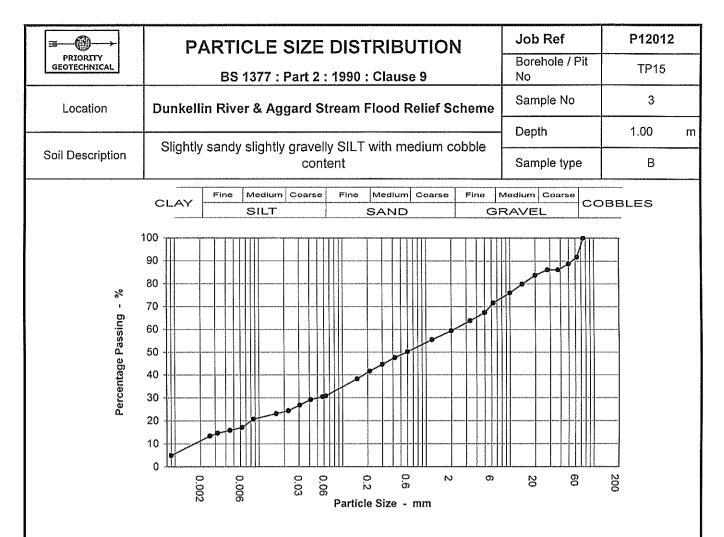
Sample Proportions			
Cobbles	0,8		
Gravel	67.6		
Sand	15.7		
Silt	12.3		
Clay	3.7

Grading Analysis		
D100	63.000	
D60	10.219	
D10	0.016	
Uniformity Coefficient	650

Sievir	ng	Sedimen	tation
Particle Size mm	% Passing	Particle Size mm	% Passing
125	100	0.058	30
90	100	0.042	29
75	100	0.031	27
63	92	0.022	24
50	89	0.016	23
37.5	86	0.009	21
28	86	0.006	17
20	84	0.005	16
14	80	0.003	15
10	76	0.003	13
6.3	72	0.001	5
5	67		
3.35	64		
2	59		
1.18	55		
0.6	50		
0.425	48		
0.3	45		
0.212	42		
0.15	38		
0.063	31

Test Method		
BS 1377 : Part 2 : 1990		
Sieving Clause 9.2		
Sedimentation Clause 9.5

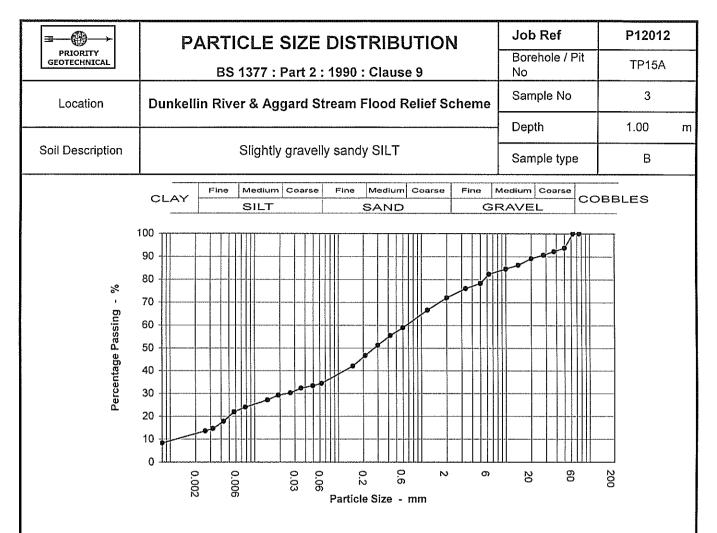
Sample Proportions			
Cobbles 9.0			
Gravel	31.7		
Sand	28.8		
Silt	20.2		
Clay	10.4

Grading Analysis			
D100	75.000		
D60	2.193		
D10	0.002		
Uniformity Coefficient	1140

Sievir	Sieving		tation
Particle Size mm	% Passing	Particle Size mm	% Passing
125	100	0.049	33
90	100	0.036	32
75	100	0.027	30
63	100	0.019	29
50	94	0.014	27
37.5	92	0.008	24
28	91	0.006	22
20	89	0.004	18
14	86	0.003	15
10	85	0.003	14
6.3	82	0.001	8
5	78		
3.35	76		
2	72		
1.18	67		
0.6	59		
0.425	55		
0.3	51		
0.212	47		
0.15	42		
0.063	34

Test Method		
BS 1377 : Part 2 : 1990		
Sieving Clause 9.2		
Sedimentation Clause 9.5

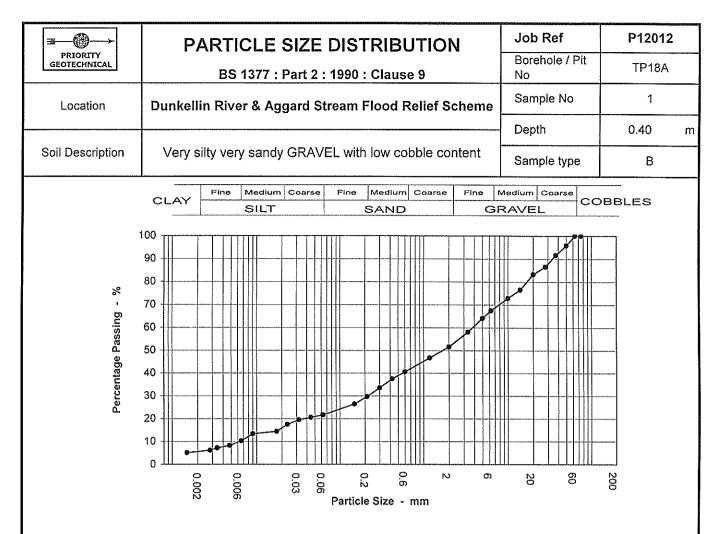
Sample Proportions		
Cobbles	1.4	
Gravel	26.5	
Sand	37.8	
Silt	22.4	
Clay	11.8

Grading Analysis		
D100	63.000	
D60	0.680	
D10	0.001	
Uniformity Coefficient 497

Sievir	Sieving		tation
Particle Size mm	% Passing	Particle Size mm	% Passing
125	100	0.062	22
90	100	0.045	21
75	100	0.032	20
63	100	0.023	17
50	96	0.017	14
37.5	92	0.009	13
28	87	0.007	10
20	83	0.005	8
14	77	0.003	7
10	73	0.003	6
6.3	67	0.002	5
5	64		
3.35	58		
2	52		
1.18	47		
0.6	41		
0.425	38		
0.3	34		
0.212	30		
0.15	26		
0.063	22

Test Method			
BS 1377 : Part 2 : 1990			
Sieving Clause 9.2			
Sedimentation Clause 9.5

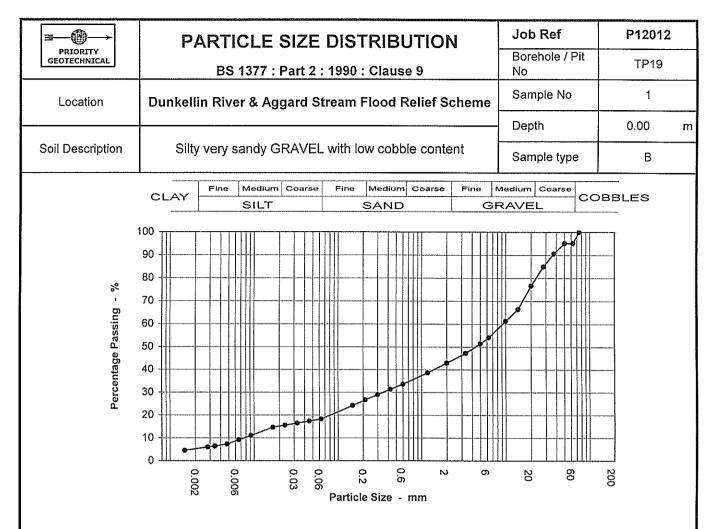
Sample Proportions		
Cobbles 1.0		
Gravel	47.5	
Sand	30.1	
Silt	15.9	
Clay	5.5

Grading Analysis			
D100 63.000			
D60	3.873		
D10	0.006		
Uniformity Coefficient	610

Sieviı	Sieving		tation
Particle Size mm	% Passing	Particle Size mm	% Passing
125	100	0.063	18
90	100	0.045	17
75	100	0.033	16
63	95	0.023	16
50	95	0.017	15
37.5	91	0.009	11
28	85	0.007	9
20	77	0.005	7
14	66	0.003	6
10	61	0.003	6
6.3	54	0.002	5
5	51	1	
3.35	47		
2	43		
1.18	39		
0.6	34		
0.425	31		
0.3	29		
0.212	27		
0.15	24		
0.063	18

Test Method		
BS 1377 : Part 2 : 1990		
Sieving Clause 9.2		
Sedimentation Clause 9.5

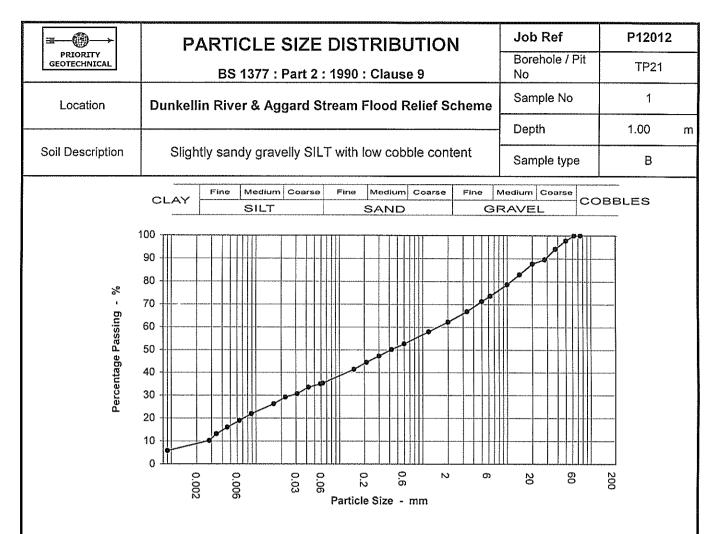
Sample Proportions			
Cobbles 4.9			
Gravel	52.2		
Sand	24.8		
Silt	13.0		
Clay	5.1

Grading Analysis		
D100	75.000	
D60	9.322	
D10	0.008	
Uniformity Coefficient 1191

Sievir	Sieving		tation
Particle Size mm	% Passing	Particle Size mm	% Passing
125	100	0.059	35
90	100	0.043	34
75	100	0.031	31
63	100	0.022	29
50	98	0.016	26
37.5	94	0.009	22
28	90	0.006	19
20	88	0.005	16
14	83	0.003	13
10	79	0.003	10
6.3	74	0.001	6
5	71		
3.35	67		
2	62		
1.18	58		
0.6	53		
0.425	50		
0.3	47		
0.212	44		
0.15	41		
0.063	35

Test Method		
BS 1377 : Part 2 : 1990		
Sieving Clause 9.2		
Sedimentation Clause 9.5

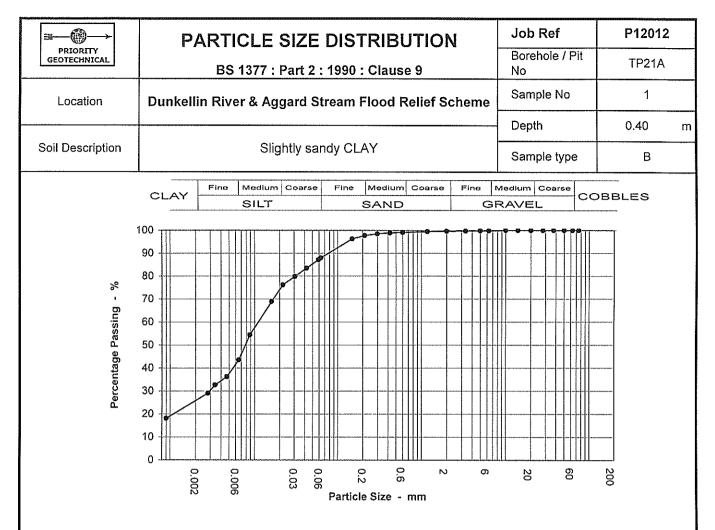
Sample Proportions		
Cobbles 0.5		
Gravel	37.2	
Sand	27.1	
Silt	26.7	
Clay	8.4

Grading Analysis				
D100 63.000				
D60	1.570			
D10	0.003			
Uniformity Coefficient 580

Sievir	Sieving		Sedimentation	
Particle Size mm	% Passing	Particle Size mm	% Passing	
125	100	0.059	87	
90	100	0.043	83	
75	100	0.031	80	
63	100	0.022	76	
50	100	0.016	69	
37.5	100	0.009	54	
28	100	0.007	44	
20	100	0.005	36	
14	100	0.003	33	
10	100	0.003	29	
6.3	100	0.001	18	
5	100			
3.35	100			
2	100			
1.18	99			
0.6	99			
0.425	99			
0.3	98			
0.212	98			
0.15	96			
0.063	88		1

Test Method		
BS 1377 : Part 2 : 1990		
Sieving Clause 9.2		
Sedimentation Clause 9.5

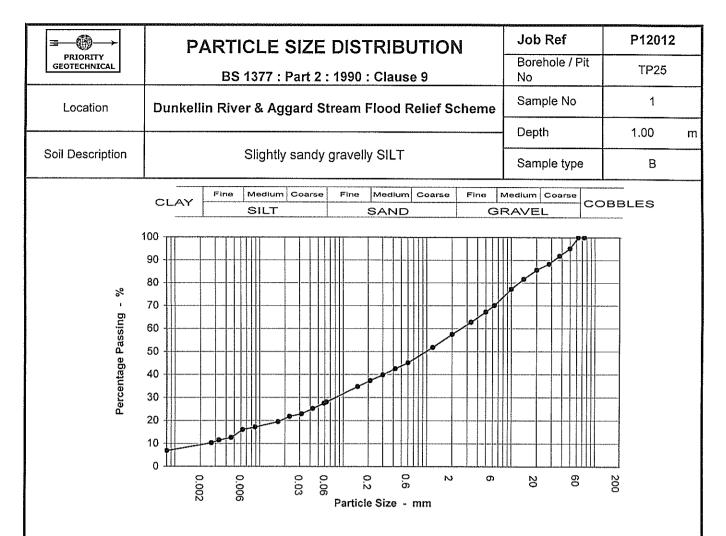
Sievir	ıg	Sediment	tation
Particle Size mm	% Passing	Particle Size mm	% Passing
125	100	0.059	27
90	100	0.043	25
75	100	0.032	23
63	100	0.023	22
50	95	0.017	19
37.5	92	0.009	17
28	88	0.006	16
20	86	0.005	13
14	82	0.003	11
10	77	0.003	10
6.3	70	0.001	7
5	67		
3.35	63		
2	57		
1.18	52		
0.6	45		
0.425	42		
0.3	40		
0.212	37		
0.15	35		
0.063	28

Test Method		
BS 1377 : Part 2 : 1990		
Sieving	Clause 9.2	
Sedimentation Clause 9.5

Sample Proportions		
Cobbles	1.1	
Gravel	41.5	
Sand	29.8	
Silt	18.6	
Clay	9.0

Grading Analysis		
D100	63.000	
D60	2.661	
D10	0.003	
Uniformity Coefficient	1050

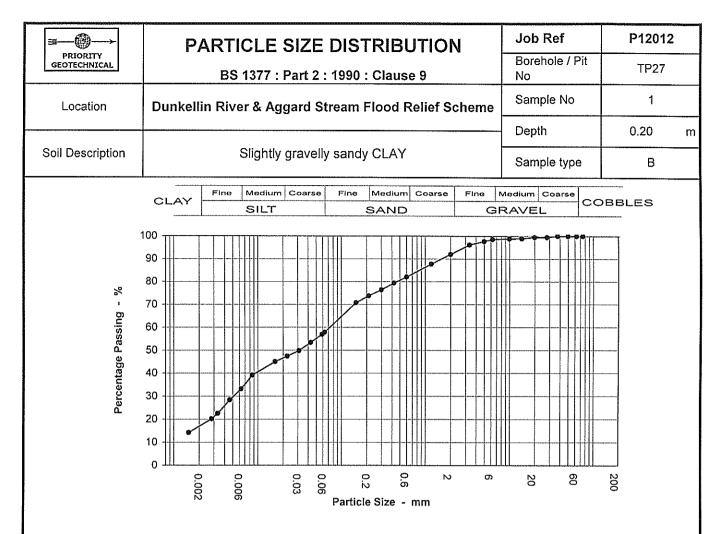
Sievir	Sieving		Sedimentation	
Particle Size mm	% Passing	Particle Size mm	% Passing	
125	100	0.059	57	
90	100	0.043	53	
75	100	0.031	50	
63	100	0.022	47	
50	100	0.016	45	
37.5	100	0.009	39	
28	99	0.006	33	
20	99	0.005	28	
14	99	0.003	23	
10	99	0.003	20	
6.3	99	0.002	14	
5	98			
3.35	96			
2	92			
1.18	88			
0.6	82			
0.425	79			
0.3	76			
0.212	74			
0.15	71			
0.063	58

Test Method		
BS 1377 : Part 2 : 1990		
Sieving	Clause 9.2	
Sedimentation Clause 9.5

Sample Proportions		
Cobbles 0.0		
Gravel	8.1	
Sand	34.9	
Silt	40.6	
Clay	16.5

Grading Analysis		
D100	37.500	
D60	0.078	
D10		
Uniformity Coefficient	N/A

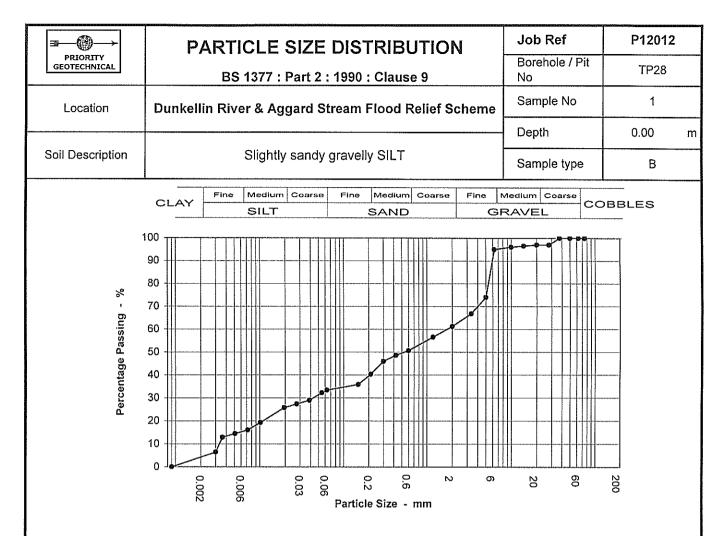
Sievir	Sieving		tation
Particle Size mm	% Passing	Particle Size mm	% Passing
125	100	0.063	33
90	100	0.055	32
75	100	0.039	29
63	100	0.028	27
50	100	0.020	26
37.5	100	0.010	19
28	97	0.007	16
20	97	0.005	14
14	97	0.004	13
10	96	0.003	6
6.3	95	0.001	0
5	74		
3.35	67		
2	61		
1.18	57		
0.6	51		
0.425	49		
0.3	46		
0.212	40		
0.15	36		
0.063	33

Test Method		
BS 1377 : Part 2 : 1990		
Sieving	Clause 9.2	
Sedimentation Clause 9.5

Sample Proportions			
Cobbles 0.0			
Gravel	38.9		
Sand	28.2		
Silt	29.6		
Clay	3.4

Grading Analysis		
D100	37.500	
D60	1.797	
D10	0.003	
Uniformity Coefficient	539

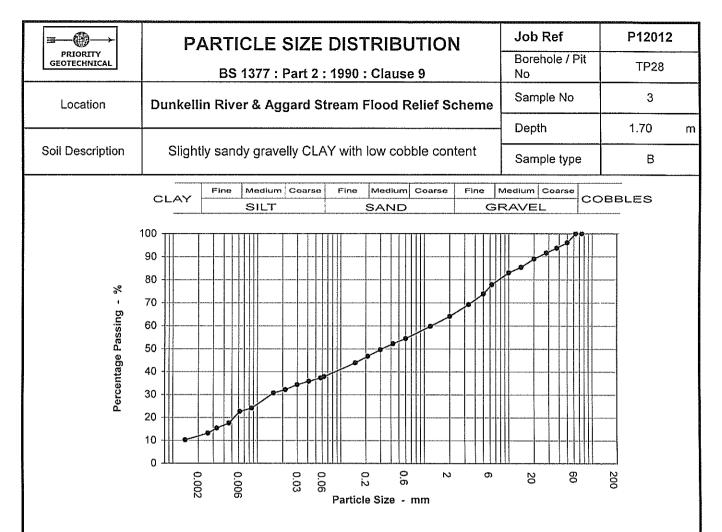
Sievir	Sieving		tation
Particle Size mm	% Passing	Particle Size mm	% Passing
125	100	0.057	37
90	100	0.041	36
75	100	0.030	34
63	100	0.022	32
50	96	0.016	31
37.5	94	0.009	24
28	92	0.006	23
20	89	0.005	18
14	85	0.003	15
10	83	0.003	13
6.3	78	0.001	10
5	74		
3.35	69		
2	64		
1.18	60		
0.6	54		
0.425	52		
0.3	50		
0.212	47		
0.15	44		
0.063	38

Test Method		
BS 1377 : Part 2 : 1990		
Sieving	Clause 9.2	
Sedimentation	Clause 9.5

Sample Proportions		
Cobbles	0.9	
Gravel	35.0	
Sand	26.5	
Silt	25.9	
Clay	11.7

Grading Analysis		
D100	63.000	
D60	1.230	
D10		
Uniformity Coefficient	N/A

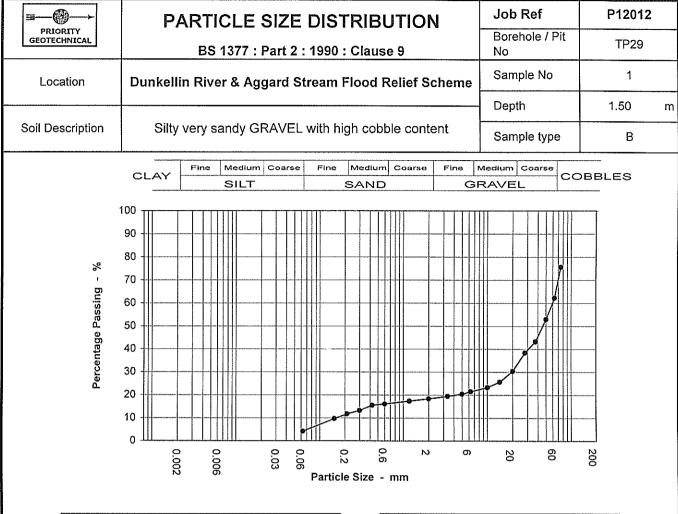
Sievir	ng	Sedimen	tation
Particle Size mm	% Passing	Particle Size mm	% Passing
125	96		
90	83		
75	76		
63	62		
50	53		
37.5	43		
28	38		
20	30		
14	26		
10	23		
6.3	21		
5	20		
3.35	19		
2	18		
1.18	17		
0.6	16		
0.425	16		
0.3	13		
0.212	12		
0.15	10		
0.063	4

Test Method			
BS 1377 : Part 2 : 1990			
Sieving Clause 9.2			
Sedimentation	N/A

Sample Proportions		
Cobbles	40.0	
Gravel	41.7	
Sand	14.2	
Silt & Clay	4.2

Grading Analysis		
D100	125.000	
D60	59,990	
D10	0.158	
Uniformity Coefficient	381

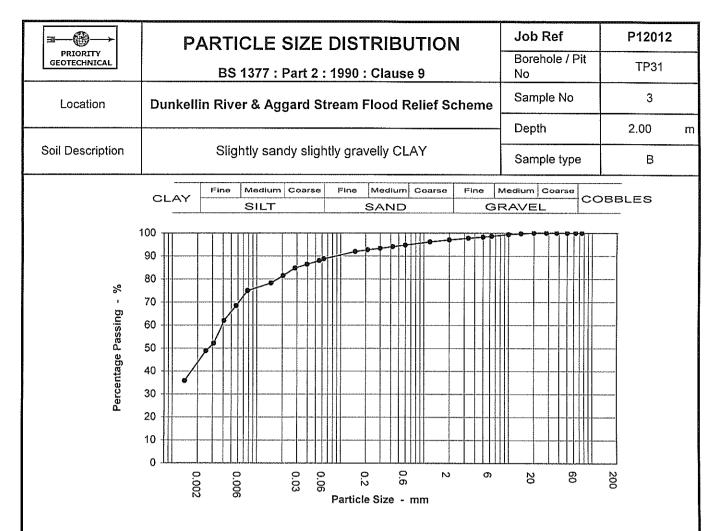
Sievir	Sieving		tation
Particle Size mm	% Passing	Particle Size mm	% Passing
125	100	0.056	88
90	100	0.040	86
75	100	0.028	85
63	100	0.021	81
50	100	0.015	78
37.5	100	0.008	75
28	100	0.006	68
20	100	0.004	62
14	100	0.003	52
10	99	0.003	49
6.3	99	0.001	36
5	98		
3.35	98		
2	97		
1.18	96	1	
0.6	95		
0.425	94		
0.3	93		
0.212	93		
0.15	92		
0.063	89

Test Method		
BS 1377 : Part 2 : 1990		
Sieving	Clause 9.2	
Sedimentation	Clause 9.5

Sample Proportions		
Cobbles	0.0	
Gravel	3.0	
Sand	8.6	
Silt	45.5	
Clay	43.0

Grading Analysis		
D100	20.000	
D60	0.004	
D10		
Uniformity Coefficient	N/A

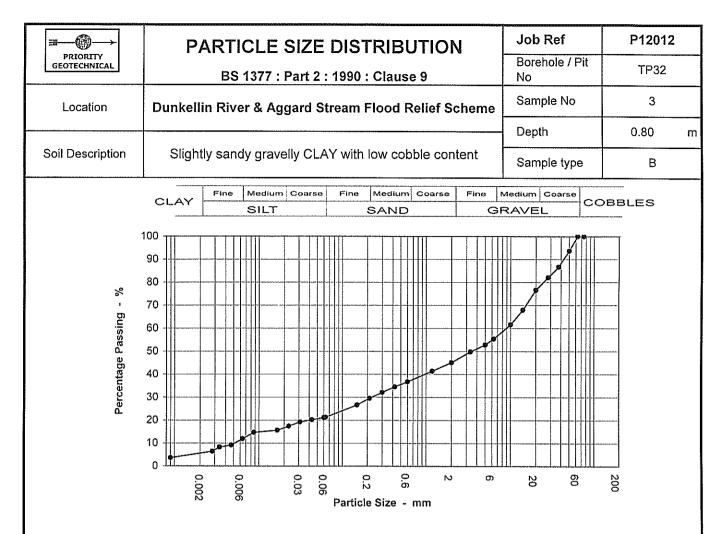
Sievir	Sieving		tation
Particle Size mm	% Passing	Particle Size mm	% Passing
125	100	0.060	21
90	100	0.043	20
75	100	0.031	19
63	100	0.023	17
50	94	0.017	16
37.5	87	0.009	15
28	82	0.006	12
20	77	0.005	9
14	68	0.003	8
10	62	0.003	6
6.3	55	0.001	4
5	53		
3.35	50		
2	45		
1.18	41		
0.6	37		
0.425	35		
0.3	32		
0.212	30		
0.15	27		
0.063	21

Test Method		
BS 1377 : Part 2 : 1990		
Sieving	Clause 9.2	
Sedimentation Clause 9.5

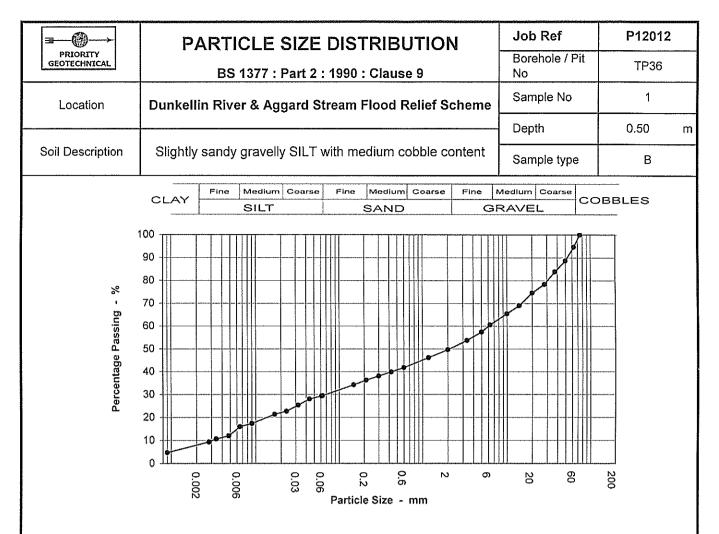
Sievir	Sieving		Sedimentation	
Particle Size mm	% Passing	Particle Size mm	% Passing	
125	100	0.061	29	
90	100	0.044	28	
75	100	0.032	25	
63	95	0.023	23	
50	89	0.017	21	
37.5	84	0.009	17	
28	78	0.007	16	
20	75	0.005	12	
14	69	0.003	11	
10	65	0.003	9	
6.3	61	0.001	5	
5	57			
3.35	54		r	
2	50			
1.18	46			
0.6	42			
0.425	40			
0.3	38			
0.212	36			
0.15	34			
0.063	29

Test Method		
BS 1377 : Part 2 : 1990		
Sieving	Clause 9.2	
Sedimentation	Clause 9.5

Sample Proportions		
Cobbles 6.7		
Gravel	43.7	
Sand	20.4	
Silt	21.9	
Clay	7.4

Grading Analysis			
D100	75.000		
D60	6.078		
D10	0.003		
Uniformity Coefficient	1958

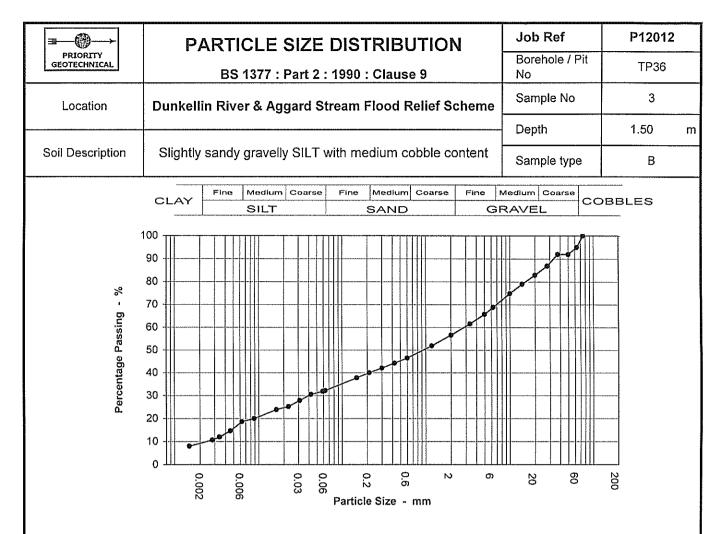
Sievir	ng	Sedimentation	
Particle Size mm	% Passing	Particle Size mm	% Passing
125	100	0.059	32
90	100	0.043	31
75	100	0.031	28
63	95	0.023	25
50	92	0.016	24
37.5	92	0.009	20
28	87	0.006	19
20	83	0.005	15
14	79	0.003	12
10	75	0.003	11
6.3	69	0.002	8
5	66		
3.35	62		
2	57		
1.18	52		
0.6	46		
0.425	44		
0.3	42		
0.212	40		
0.15	38		
0.063	32

Test Method		
BS 1377 : Part 2 : 1990		
Sieving	Clause 9.2	
Sedimentation	Clause 9.5

Sample Proportions			
Cobbles 5.7			
Gravel	37.7		
Sand	24.6		
Silt	23.0		
Clay	9.0

Grading Analysis			
D100 75.000			
D60	2.941		
D10	0.002		
Uniformity Coefficient	1178

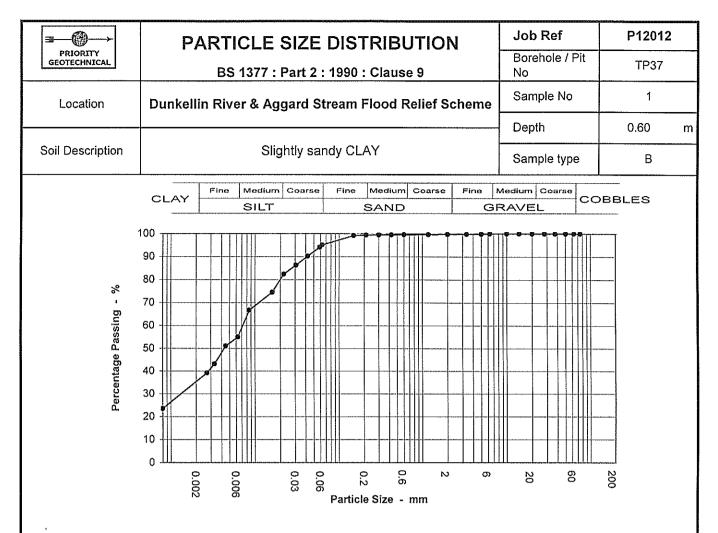
Sievir	ng	Sediment	tation
Particle Size mm	% Passing	Particle Size mm	% Passing
125	100	0.059	94
90	100	0.043	90
75	100	0.031	86
63	100	0.022	82
50	100	0.016	75
37.5	100	0.009	67
28	100	0.006	55
20	100	0.005	51
14	100	0.003	43
10	100	0.003	39
6.3	100	0.001	24
5	100		
3.35	100		
2	100		
1.18	100		
0.6	100		
0.425	99		
0.3	99		
0.212	99		
0.15	99		
0.063	95

Test Method		
BS 1377 : Part 2 : 1990		
Sieving	Clause 9.2	
Sedimentation	Clause 9.5

Sample Proportions		
Cobbles	0.0	
Gravel	0.3	
Sand	5.4	
Silt	60.9	
Clay	33.4

Grading Analysis	
D100	6.300
D60	0.007
D10	
Uniformity Coefficient	N/A

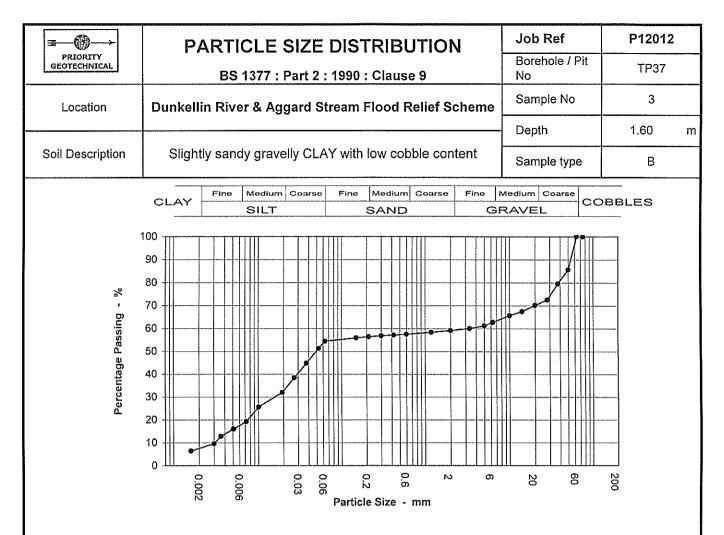
Sieviı	ıg	Sedimentation			
Particle Size mm	% Passing	Particle Size mm	% Passing		
125	100	0.063	54		
90	100	0.053	51		
75	100	0.038	45		
63	100	0.027	38		
50	86	0.019	32		
37.5	80	0.010	26		
28	73	0.007	19		
20	70	0.005	16		
14	67	0.004	13		
10	66	0.003	10		
6.3	63	0.002	6		
5	61				
3.35	60				
2	59				
1.18	58				
0.6	58				
0.425	57				
0.3	57		·		
0.212	56				
0.15	56				
0.063	54

Test Method						
BS 1377 : Part 2 : 1990						
Sieving	Clause 9.2					
Sedimentation	Clause 9.5

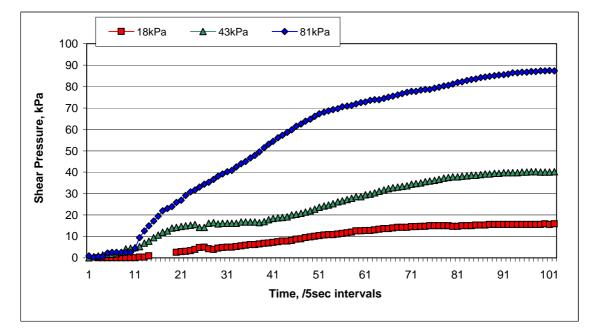
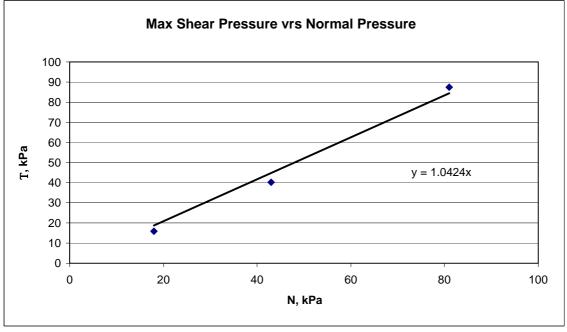
Location Depth Test Date Natural Moisture content Shear rate Soil description Preparation

TP01 3.0 m 13/06/13 9.70% 1mm/ min Sightly sandy slightly gravelly SILT Recompacted (2.5kg) at natural moisture content

46	0
0	kPa

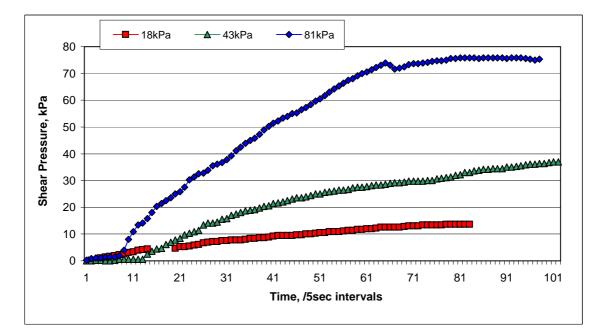
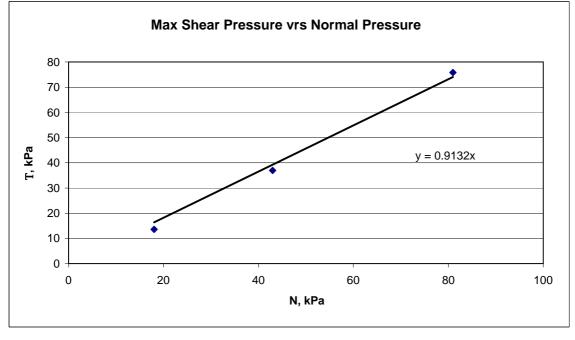
Location Depth Test Date Natural Moisture content Shear rate Soil description Preparation TP04 1.0 m 07/02/2014 11.23% 1mm/ min Slightly sandy gravelly SILT Recompacted (2.5kg) at natural moisture content

42 <sup>o</sup>
0 kPa

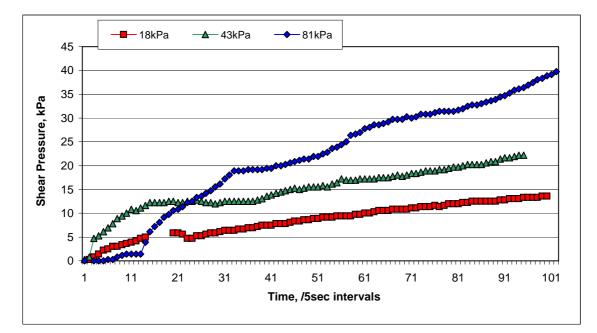
Location Depth Test Date Natural Moisture content Shear rate Soil description Preparation TP12 1.0 m 07/02/2014 27.78% 1mm/ min Slightly sandy slightly gravelly SILT Recompacted (2.5kg) at natural moisture content

27 <sup>o</sup>
0 kPa

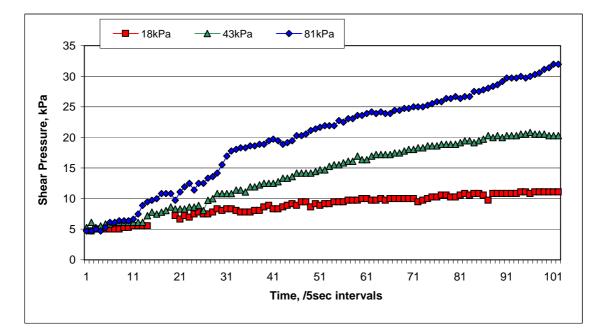
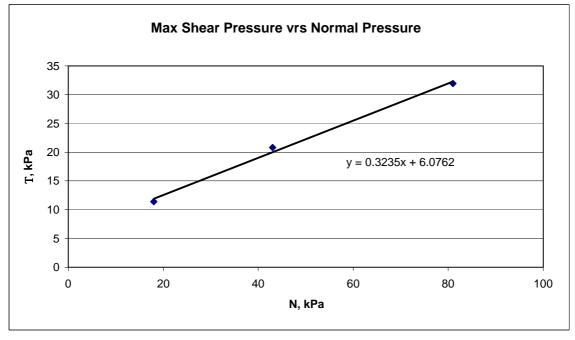
Location Depth Test Date Natural Moisture content Shear rate Soil description Preparation TP14 0.5m 17/06/14 24.62% 1mm/ min Slightly sandy slightly gravelly SILT Recompacted (2.5kg) at natural moisture content

18	0
6	kPa

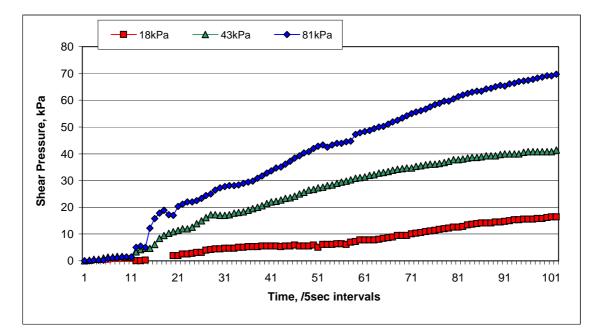
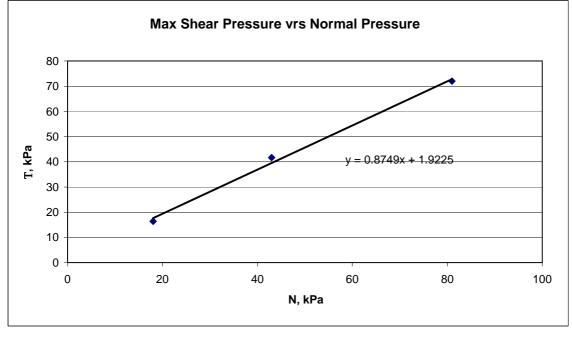
Location Depth Test Date Natural Moisture content Shear rate Soil description Preparation TP21 1.0m 07/02/2014 10.03% 1mm/ min Slightly sandy gravelly SILT Recompacted (2.5kg) at natural moisture content

41 <sup>°</sup>
2 kPa

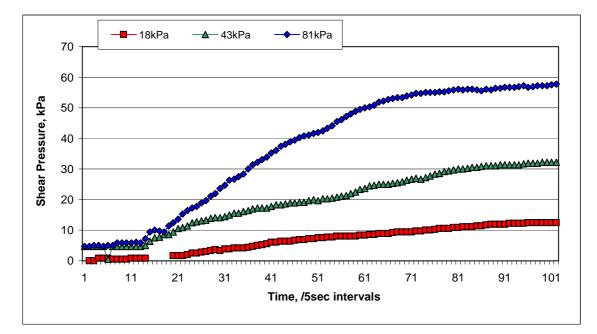
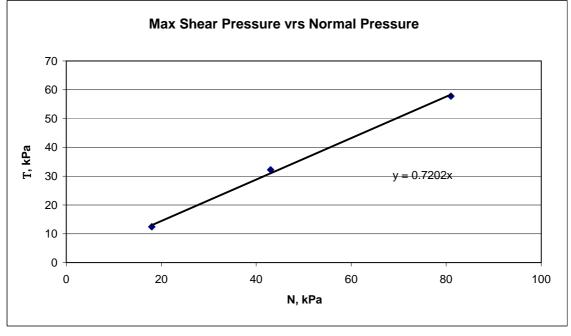
TP25 1.0m 17/06/14 8.84% 1mm/ min Slightly sandy gravelly SILT Recompacted (2.5kg) at natural moisture content

36 <sup>o</sup>
0 kPa

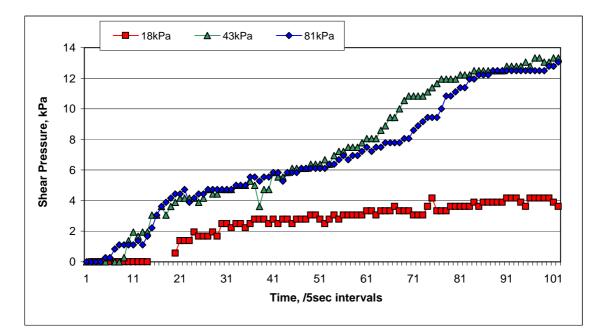
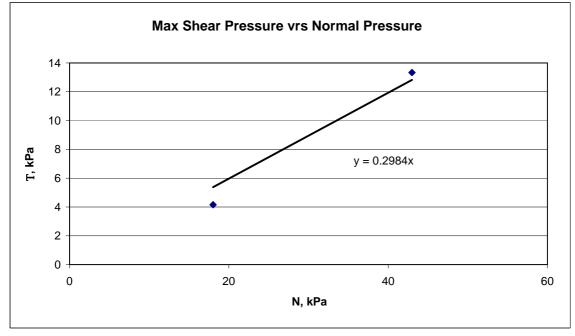
Location Depth Test Date Natural Moisture content Shear rate Soil description Preparation TP28 1.7m 07/02/2014 43.14% 1mm/ min Slightly sandy gravelly CLAY Recompacted (2.5kg) at natural moisture content

17 <sup>o</sup>
0 kPa

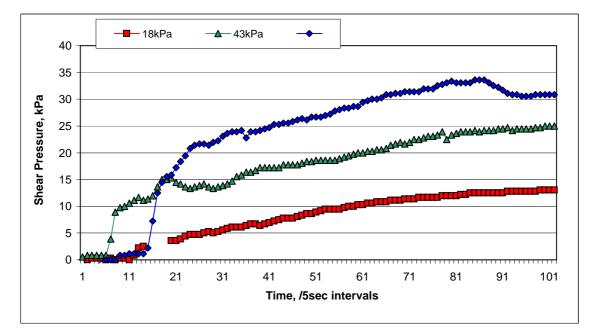
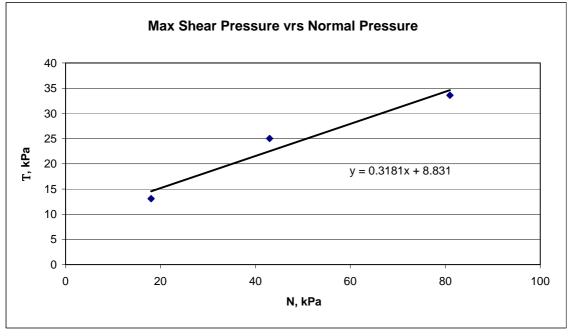
Location Depth Test Date Natural Moisture content Shear rate Soil description Preparation TP31 2.0m 07/02/2014 21.25% 1mm/ min Slightly andy slightly gravelly CLAY Recompacted (2.5kg) at natural moisture content

18 <sup>0</sup>
9 kPa

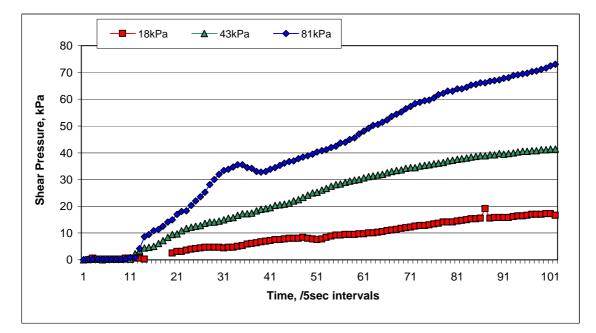
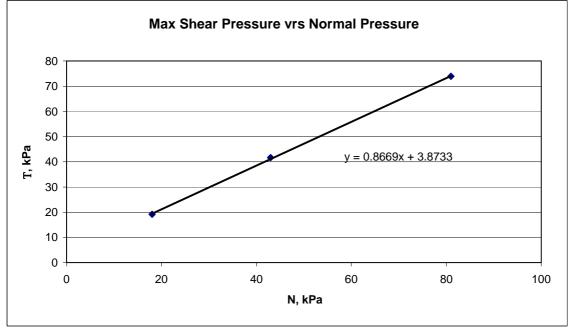
TP36 1.5m 07/02/2014 8.28% 1mm/ min Slightly sandy gravelly SILT Recompacted (2.5kg) at natural moisture content

40 <sup>°</sup>
4 kPa

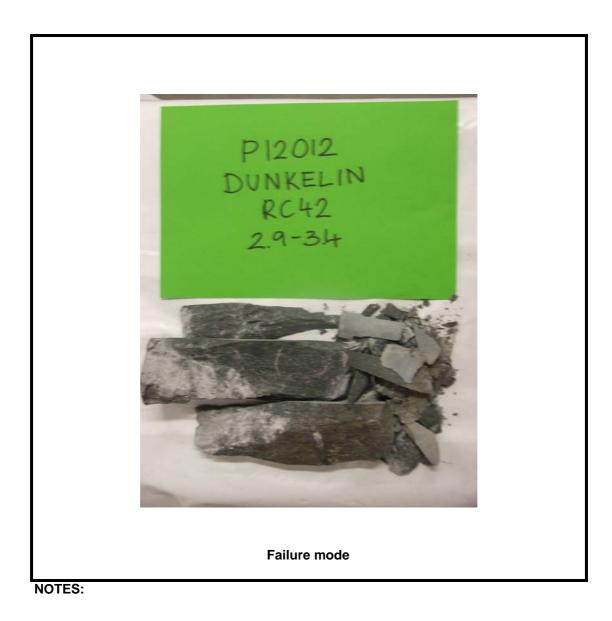
Job Name Job Number	Dunkelin P12012	]
Borehole: Depth:	RC42 2.9-3.4	m
Rock Type	Limestone	
Bulk Density Load at Failure, P	2.70 469.6	Mg/m <sup>3</sup> kN
Stress at Failure	103.57	MPa

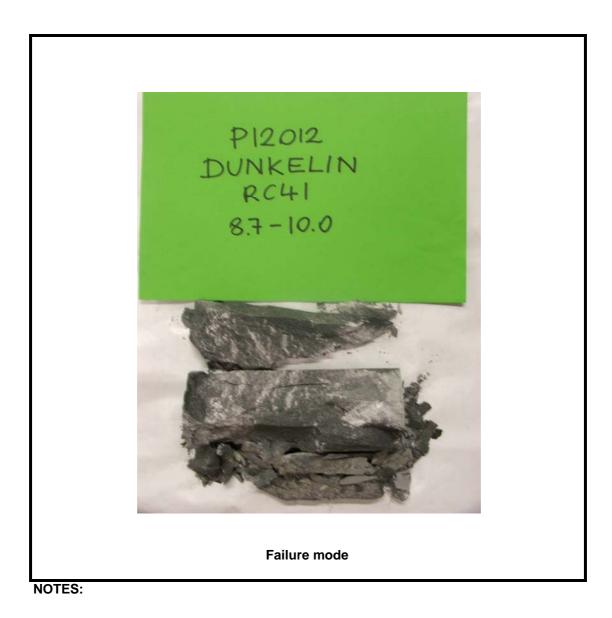
Job Name Job Number	Dunkelin P12012		
Borehole: Depth:	RC41 8.7-10		m
Rock Type	Limestone		
Bulk Density Load at Failure, P		2.70 422.4	Mg/m <sup>3</sup> kN
Stress at Failure		93.17	MPa

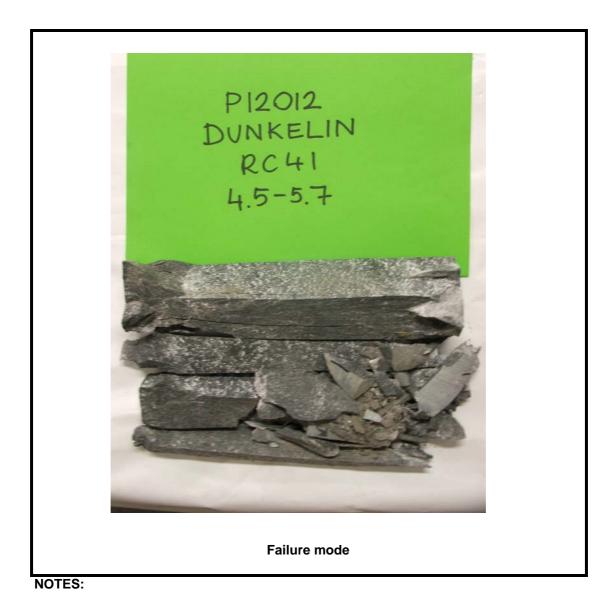
Job Name Job Number	Dunkelin P12012		
Borehole: Depth: Rock Type	RC41 4.5-5.7 Limestone		m
Bulk Density Load at Failure, P		2.69 271.2	Mg/m <sup>3</sup> kN

59.87 MPa

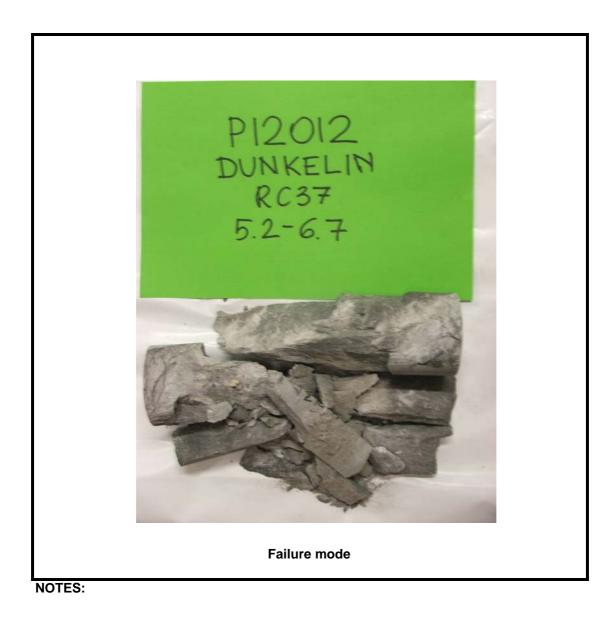
Dunkelin Job Name Job Number P12012 **RC37** Borehole: Depth: 5.2-6.7 m Rock Type Limestone 2.69 Mg/m<sup>3</sup> **Bulk Density** Load at Failure, P 366.6 kN Stress at Failure 80.87 MPa

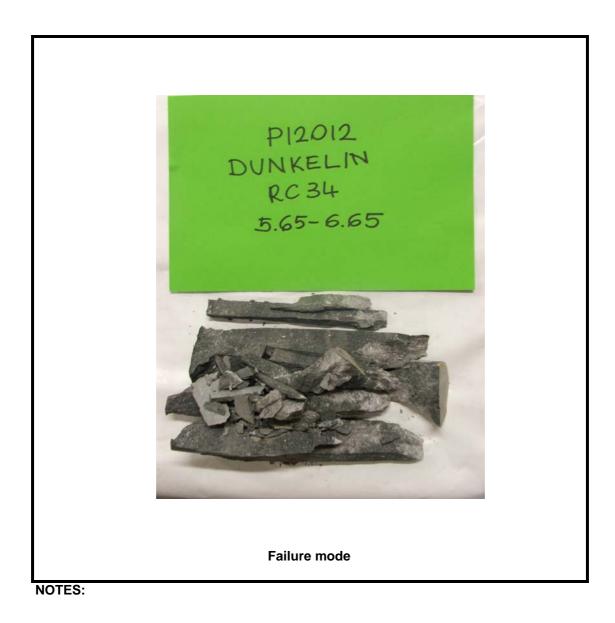
Job Name Job Number	Dunkelin P12012	]
Borehole: Depth:	RC34 5.65-6.65	]  m
Rock Type	Limestone	[···
Bulk Density Load at Failure, P	2.70 263.11	Mg/m <sup>3</sup> kN
Stress at Failure	74.5	MPa

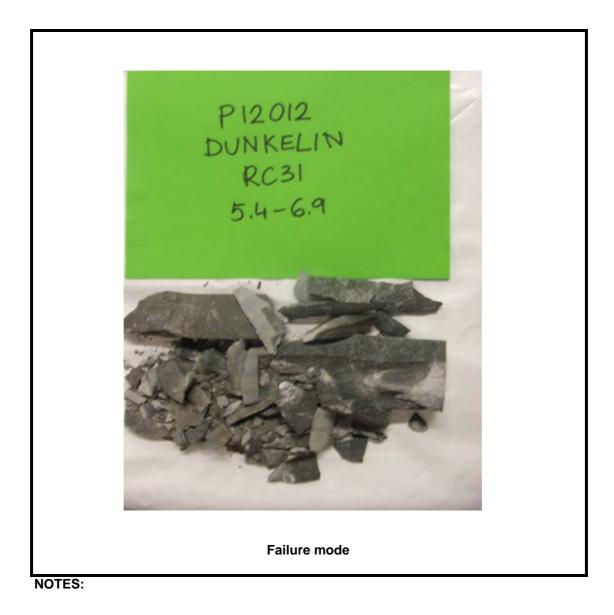
Job Name Job Number	Dunkelin P12012		
Borehole: Depth:	RC31 5.4-6.9	m	
Rock Type	Limestone	•	
Bulk Density Load at Failure, F		2.71 Mg/m <sup>3</sup> 61.7 kN	
Stress at Failure	9	9.64 MPa

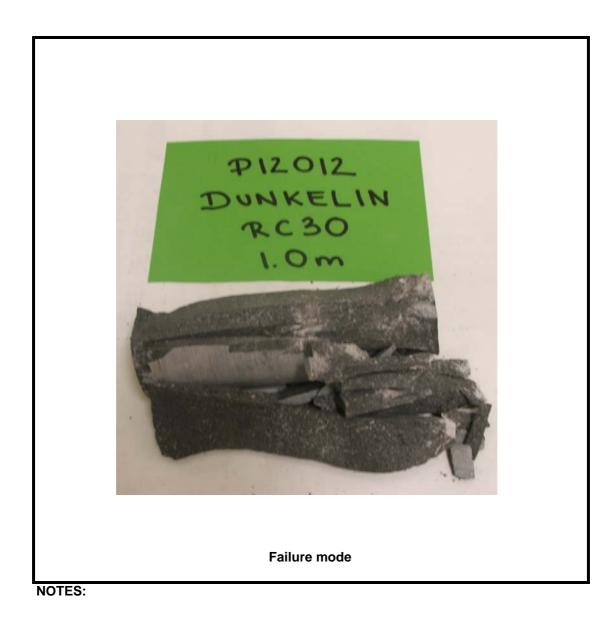
Job Name	Dunkelin
Job Number	P12012
Borehole:	RC30
Depth:	1 m
Rock Type	Limestone
Bulk Density	2.70 Mg/m <sup>3</sup>
Load at Failure, P	296.2 kN
Stress at Failure	81.54 MPa

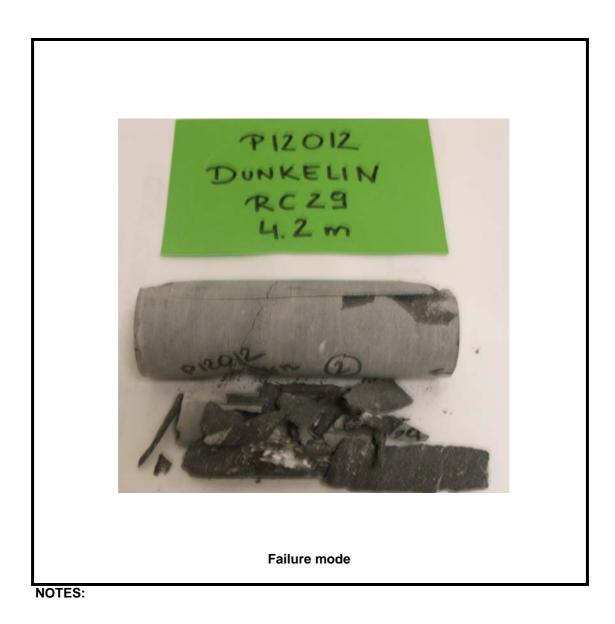
Job Name	Dunkelin
Job Number	P12012
Borehole:	RC29
Depth:	4.2 m
Rock Type	Limestone
Bulk Density	2.70 Mg/m <sup>3</sup>
Load at Failure, P	318.1 kN
Stress at Failure	87.64 MPa
