# Dunkellin River and Aggard Stream Flood Relief Scheme

# Response to An Bord Pleanála

r					
Client:	Galway County Council	Galway County Council			
Project Title:	Dunkellin River and Aggard S	Dunkellin River and Aggard Stream Flood Relief Scheme			
Document Title:	Response to An Bord Pleanál	Response to An Bord Pleanála			
Document No:	MGE0260RP0012				
Text Pages:	48 Appendices: 6

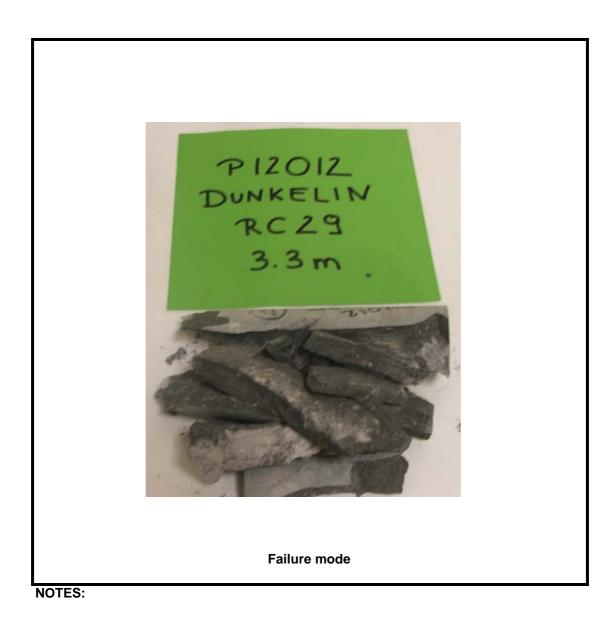
Job Name	Dunkelin
Job Number	P12012
Borehole:	RC29
Depth:	3.3 m
Rock Type	Limestone
Bulk Density	2.70 Mg/m <sup>3</sup>
Load at Failure, P	260.5 kN
Stress at Failure	71.74 MPa

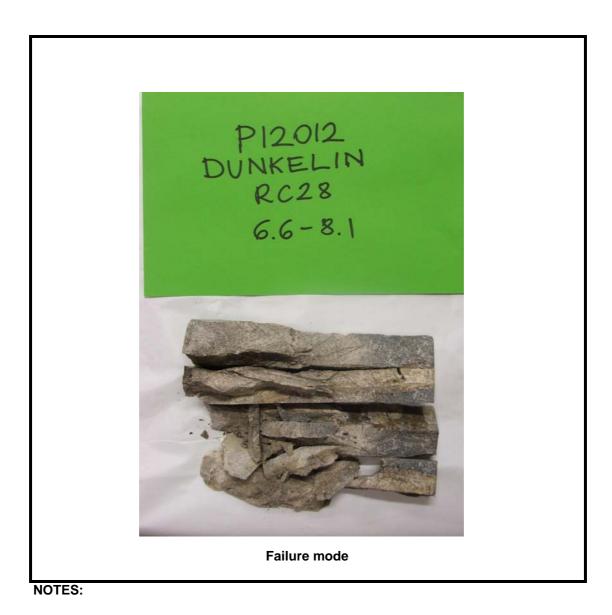
Job Name Job Number	Dunkelin P12012		
Borehole: Depth:	RC28 6.6-8.1		m
Rock Type	Limestone		
Bulk Density Load at Failure, P		2.71 132.2	Mg/m <sup>3</sup> kN
Stress at Failure		36.43	MPa

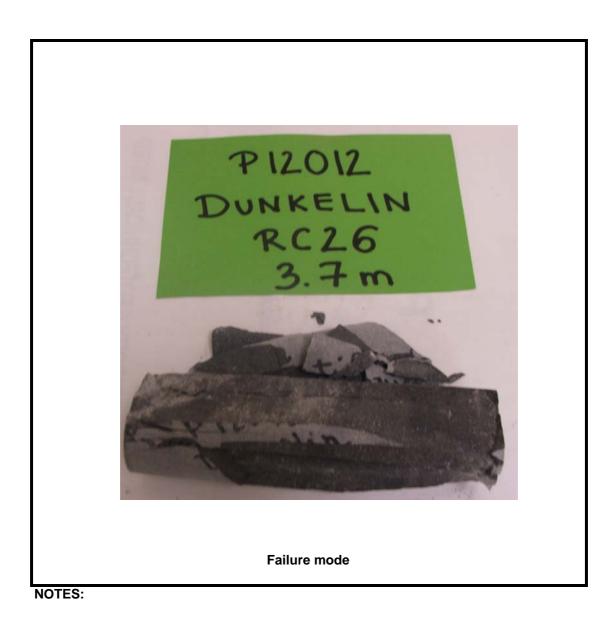
Job Name Job Number	Dunkelin P12012		
Borehole: Depth: Rock Type	RC26 Limestone	3.7	m
Bulk Density Load at Failure, P		2.71 279.9	Mg/m <sup>3</sup> kN
Stress at Failure		77.14	МРа

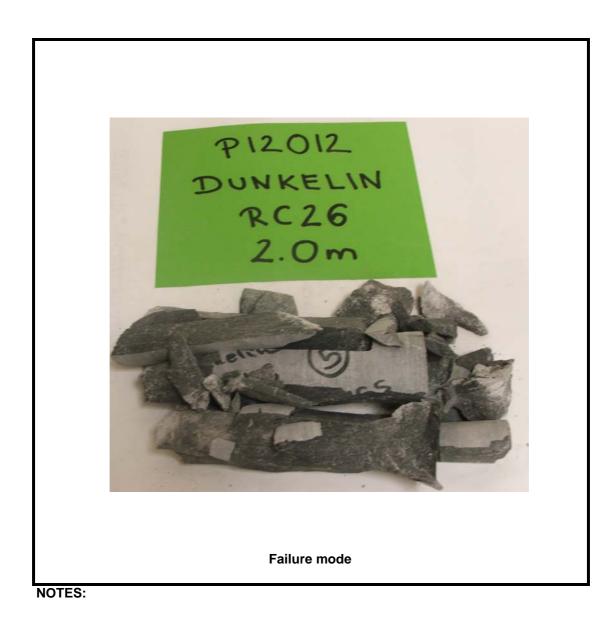
Job Name Job Number	Dunkelin P12012	
Borehole: Depth: Rock Type	RC26 2 m Limestone	
Bulk Density Load at Failure, P	2.70 Mg/m <sup>3</sup> 244.8 kN	
Stress at Failure	67.44 MPa

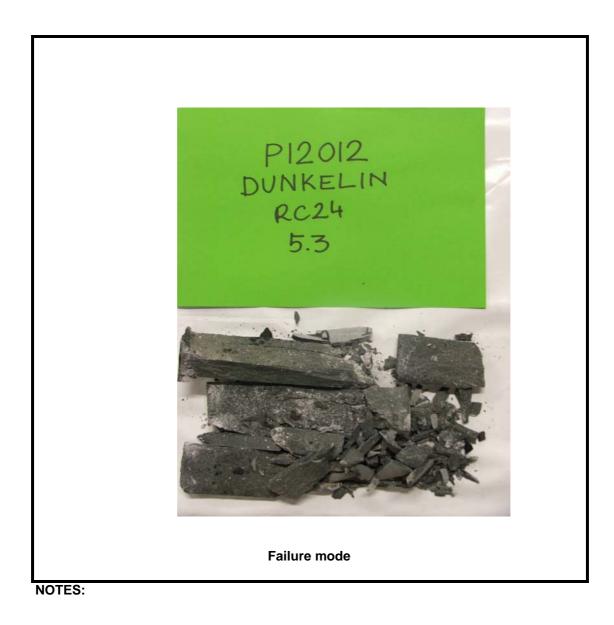
Job Name	Dunkelin
Job Number	P12012
Borehole:	RC24
Depth:	5.3 m
Rock Type	Limestone
Bulk Density	2.69 Mg/m <sup>3</sup>
Load at Failure, P	195 kN
Stress at Failure	53.73 MPa

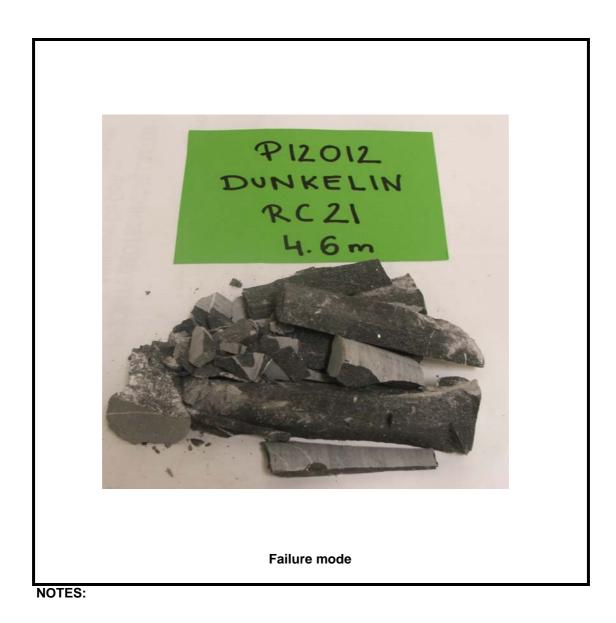
Job Name	Dunkelin
Job Number	P12012
Borehole:	RC21
Depth:	4.6 m
Rock Type	Limestone
Bulk Density	2.70 Mg/m <sup>3</sup>
Load at Failure, P	292.1 kN
Stress at Failure	82.95 MPa

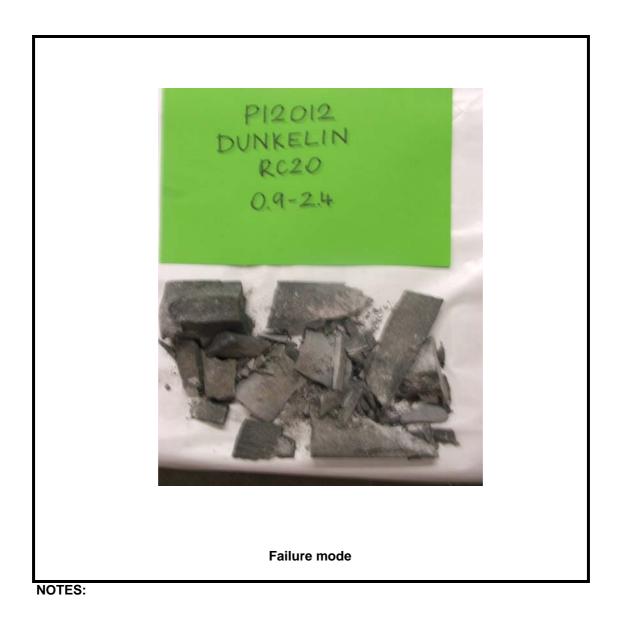
Job Name Job Number	Dunkelin P12012		
Borehole: Depth:	RC20 0.9-2.4	m	
Rock Type	Limestone		
Bulk Density Load at Failure, P		2.70 Mg/m <sup>3</sup> 32.5 kN	
Stress at Failure	9	95.4 MPa

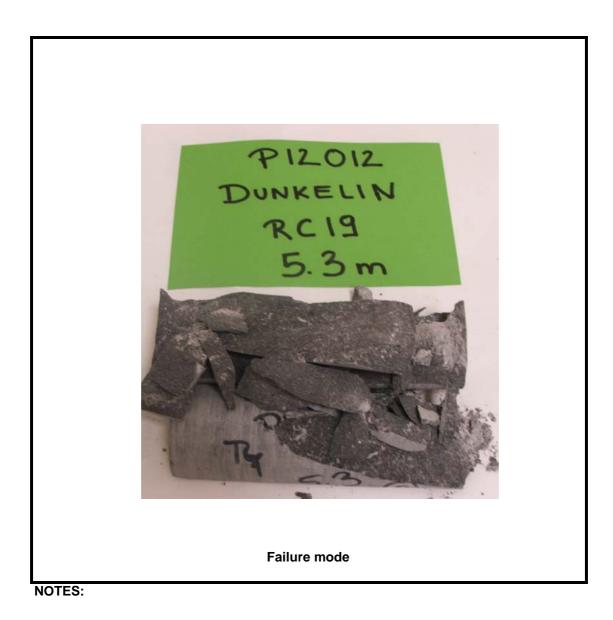
Job Name	Dunkelin
Job Number	P12012
Borehole:	RC19
Depth:	5.3 m
Rock Type	Limestone
Bulk Density	2.70 Mg/m <sup>3</sup>
Load at Failure, P	238.8 kN
Stress at Failure	67.75 MPa

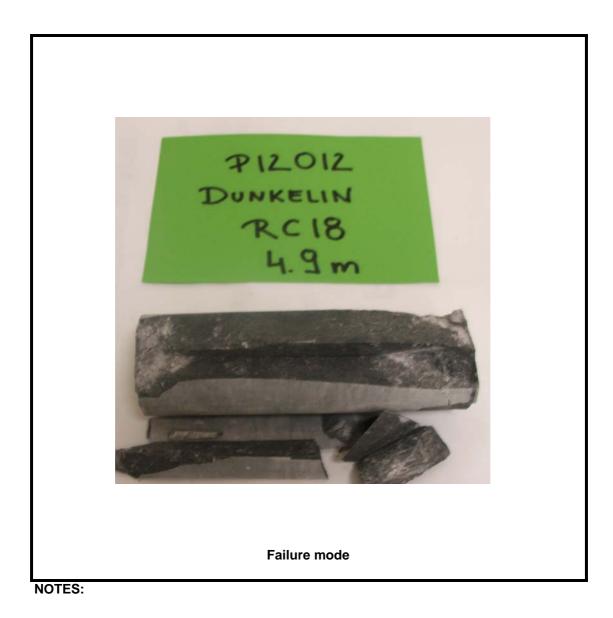
Job Name	Dunkelin
Job Number	P12012
Borehole:	RC18
Depth:	4.9 m
Rock Type	Limestone
Bulk Density	2.71 Mg/m <sup>3</sup>
Load at Failure, P	260 kN
Stress at Failure	71.64 MPa

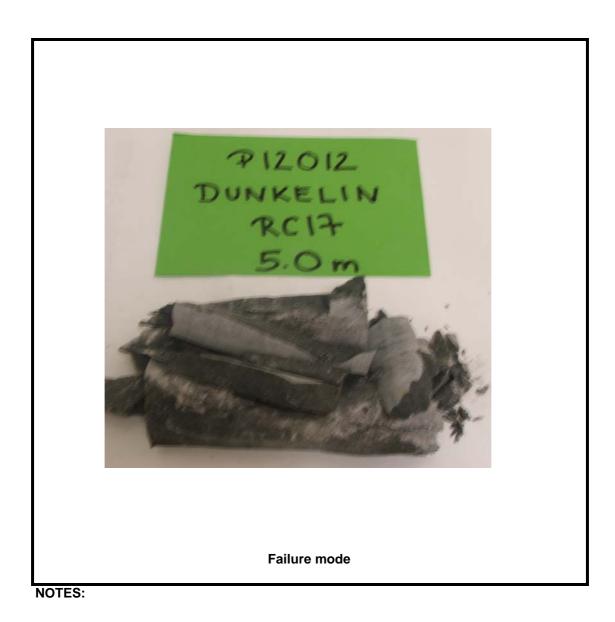
Job Name Job Number	Dunkelin P12012	
Borehole: Depth: Rock Type	RC17 5 m Limestone	
Bulk Density Load at Failure, P	2.71 Mg/m <sup>3</sup> 290.4 kN	
Stress at Failure	82.45 MPa

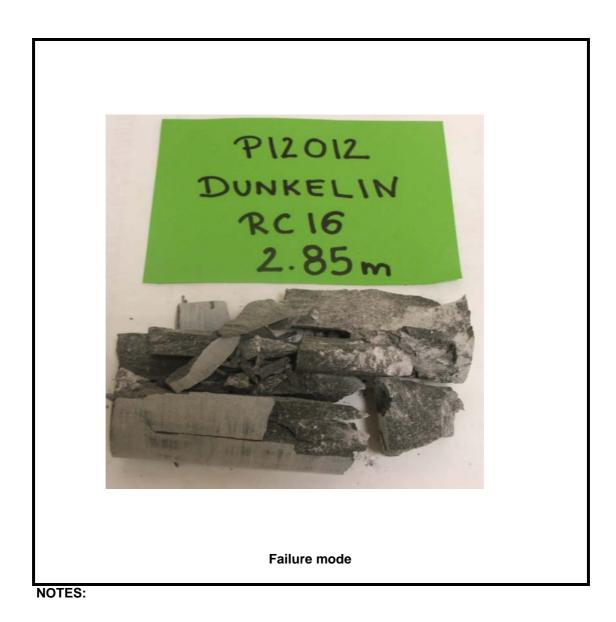
Job Name	Dunkelin
Job Number	P12012
Borehole:	RC16
Depth:	2.85 m
Rock Type	Limestone
Bulk Density	2.70 Mg/m <sup>3</sup>
Load at Failure, P	345.4 kN
Stress at Failure	95.14 MPa

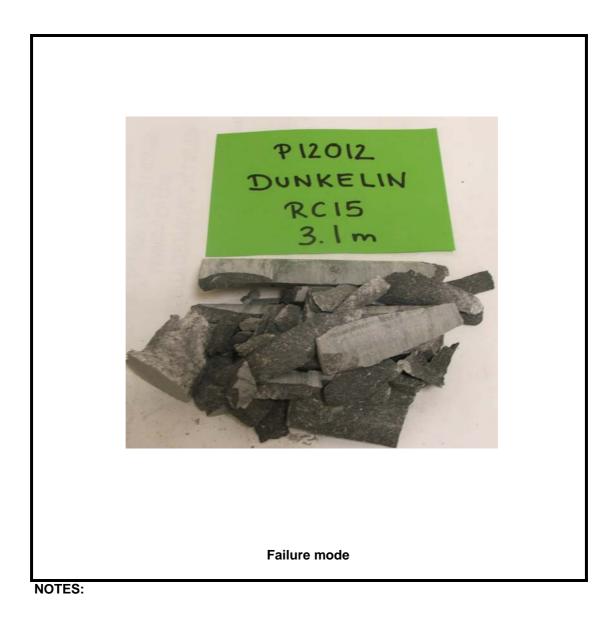
Job Name Job Number	Dunkelin P12012		
Borehole: Depth: Rock Type	RC15 Limestone	3.1	m
Bulk Density Load at Failure, P		2.70 306.6	Mg/m <sup>3</sup> kN
Stress at Failure		84.44	MPa

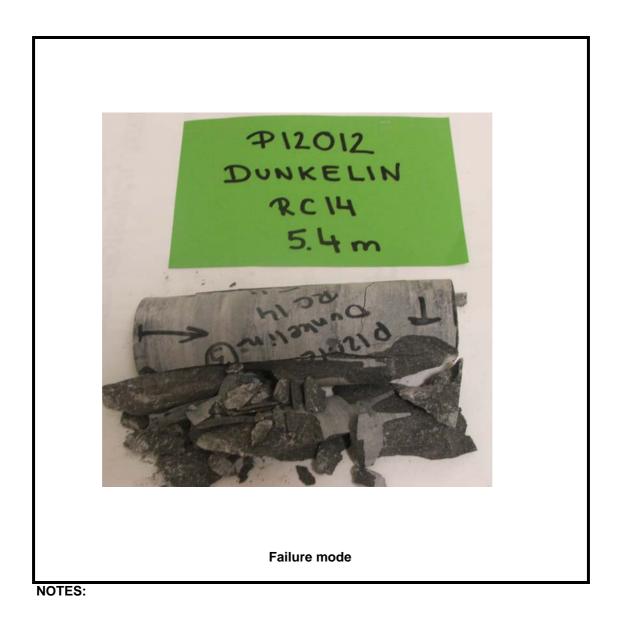
Job Name	Dunkelin
Job Number	P12012
Borehole:	RC14
Depth:	5.4 m
Rock Type	Limestone
Bulk Density	2.71 Mg/m <sup>3</sup>
Load at Failure, P	190.8 kN
Stress at Failure	52.53 MPa

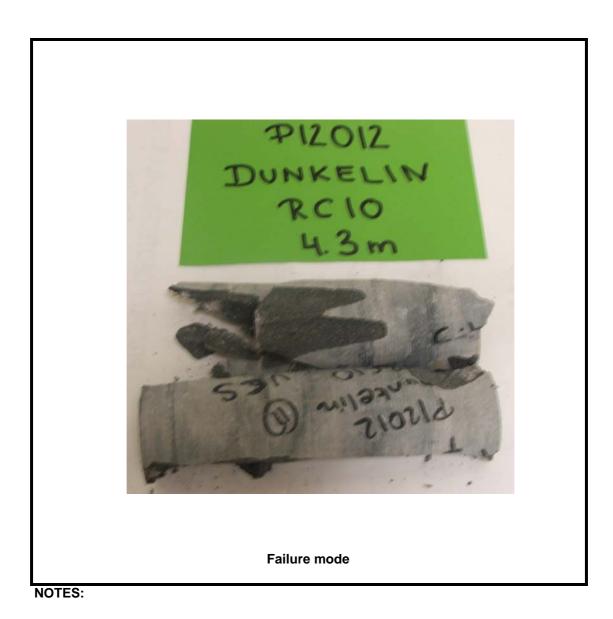
Job Name Job Number	Dunkelin P12012		
Borehole: Depth: Rock Type	RC10 Limestone	4.3	m
Bulk Density Load at Failure, P	Linestone	2.70 232.6	Mg/m <sup>3</sup> kN
Stress at Failure		66.05	MPa

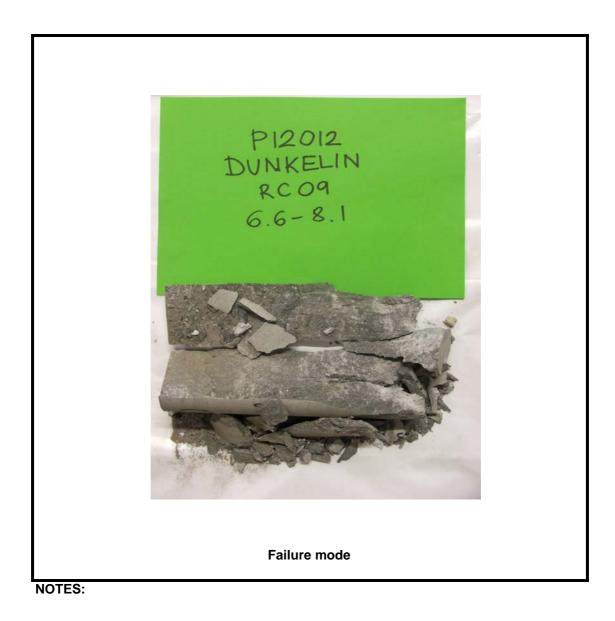
Job Name Job Number	Dunkelin P12012		]
Borehole: Depth:	RC09 6.6-8.1		m
Rock Type	Limestone		
Bulk Density Load at Failure, P		2.67 240.9	Mg/m <sup>3</sup> kN
Stress at Failure		66.34	MPa
